Bridge M0591 Inspection Report

Asset #M0591(Record Change)

SH 25/Independ. Co. over BLUE CREEK

Team Lead: Seth Foreman Inspection Date: 08/14/2025

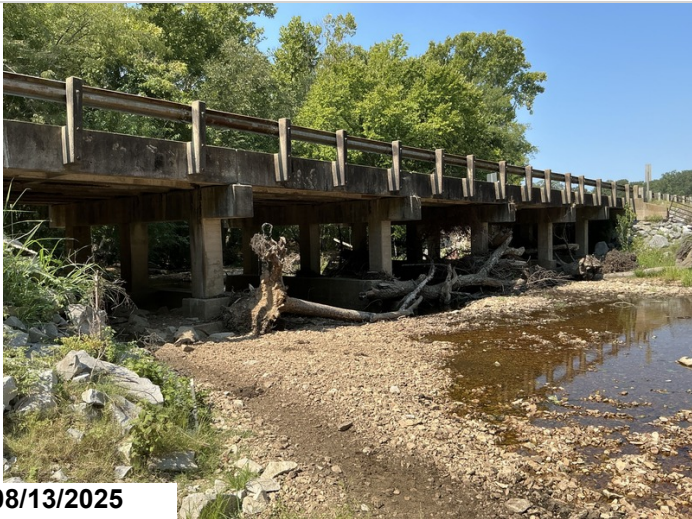
Elevation with Log Mile running to the east.

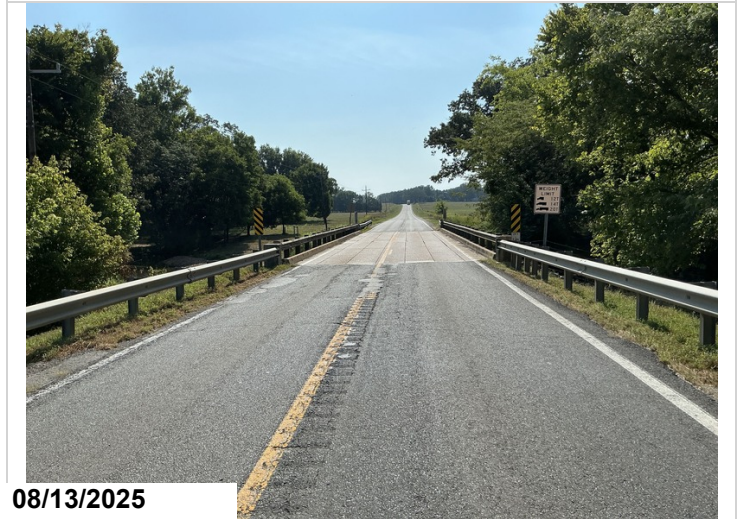
Roadway with Log Mile running West to East.

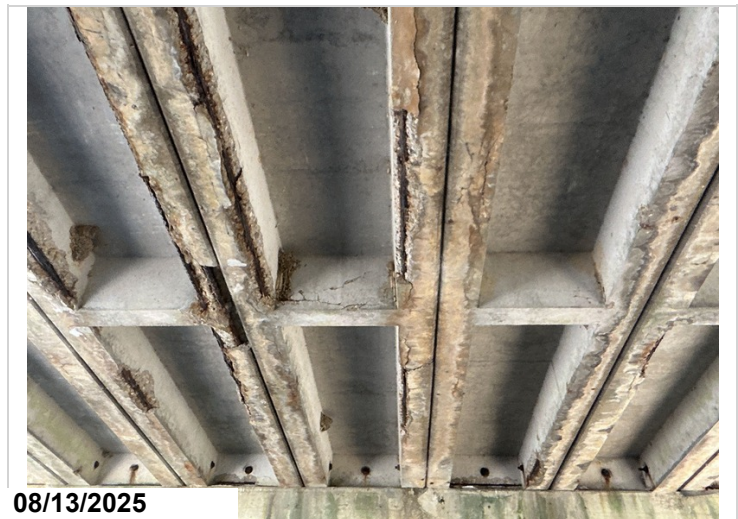
Undersurface photo.

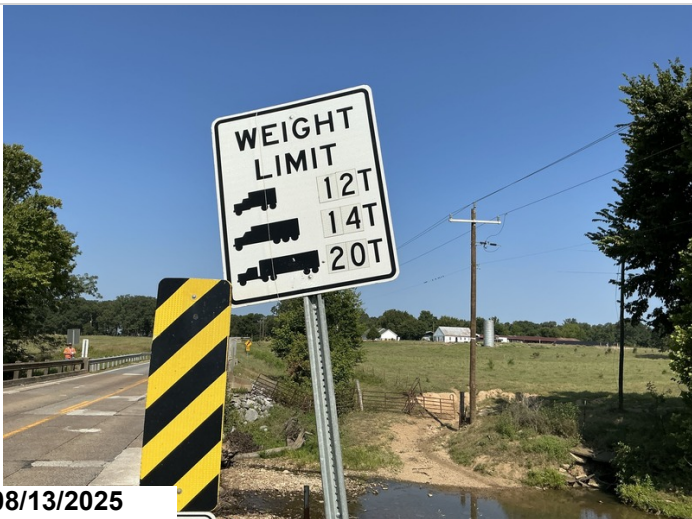
Load posting sign at abutment 2.

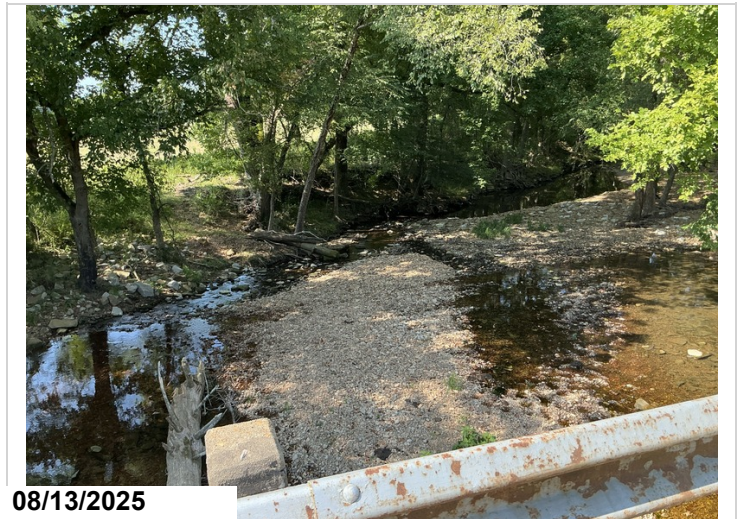
Right channel.

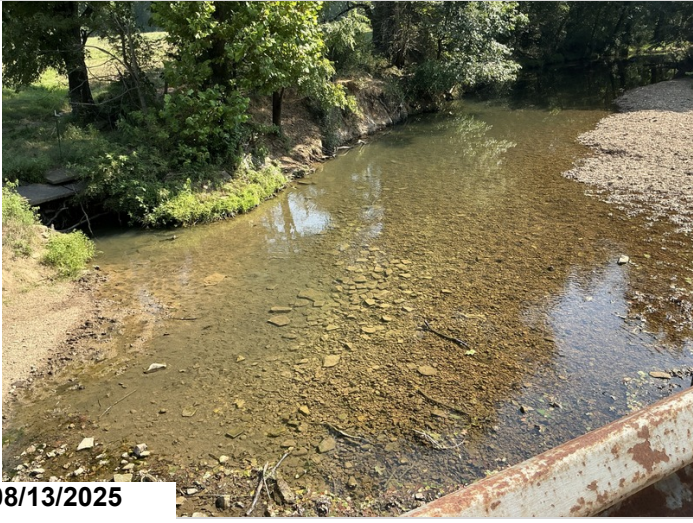
Left channel.

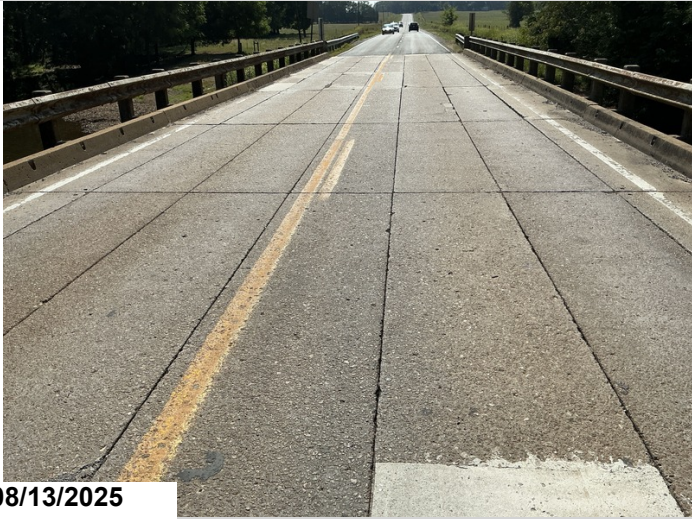
Overall deck.

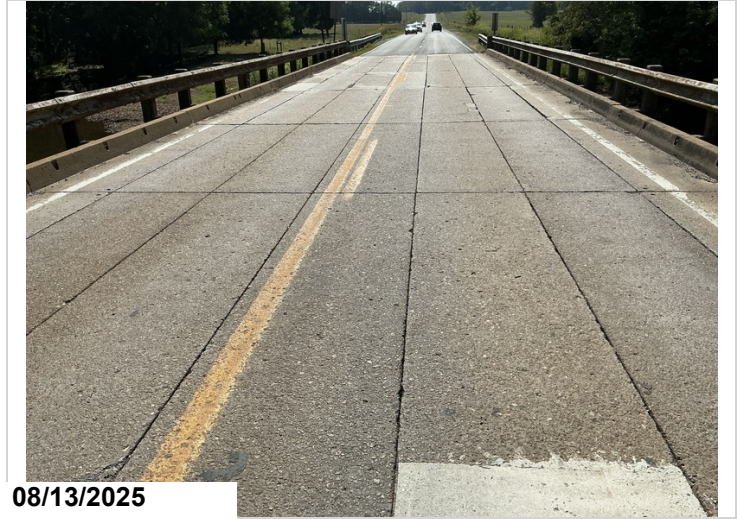
Overall deck.

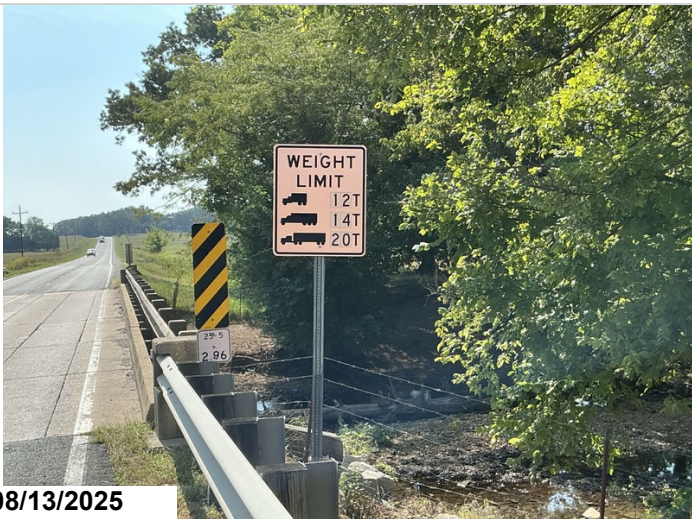
Load posting sign at abutment 1.

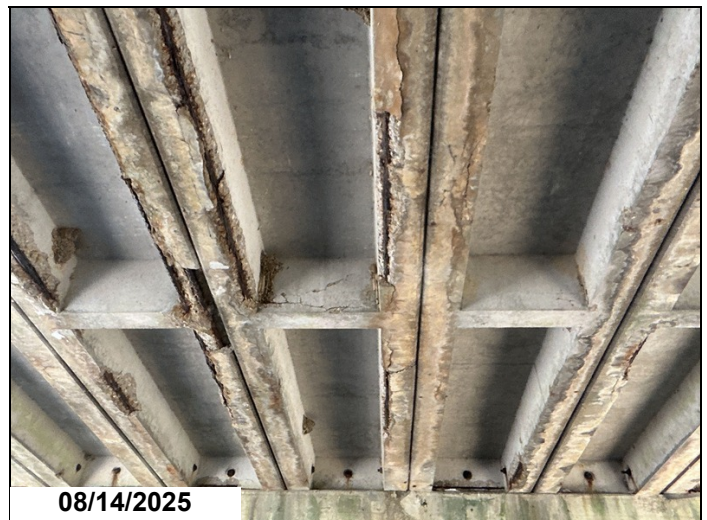
Undersurface photo.

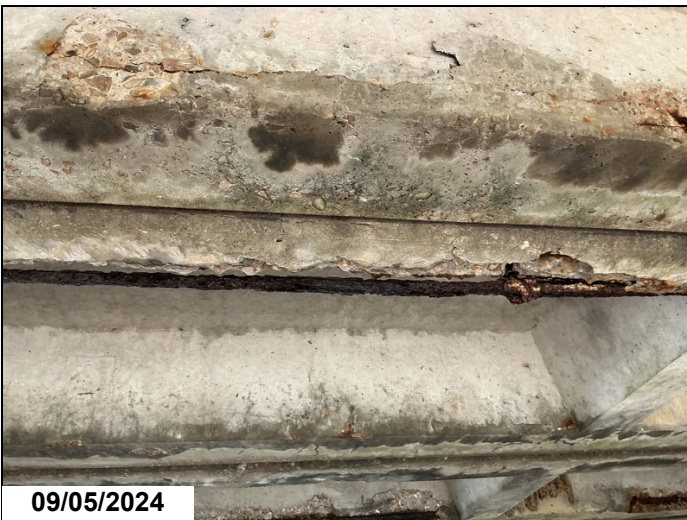
Units that have spalls with rebar exposed that have lost adhesion to concrete: Span 6 unit 6.

Exposed rebar right leg unit 6 span 6.

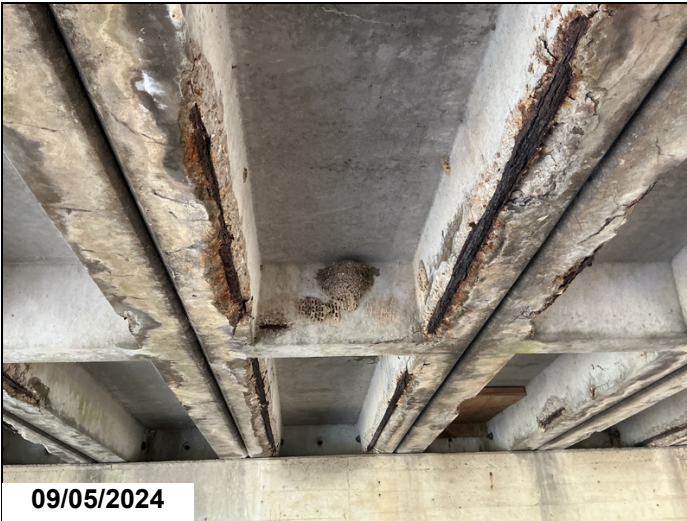
Exposed rebar to left and right leg unit 4 span 6.

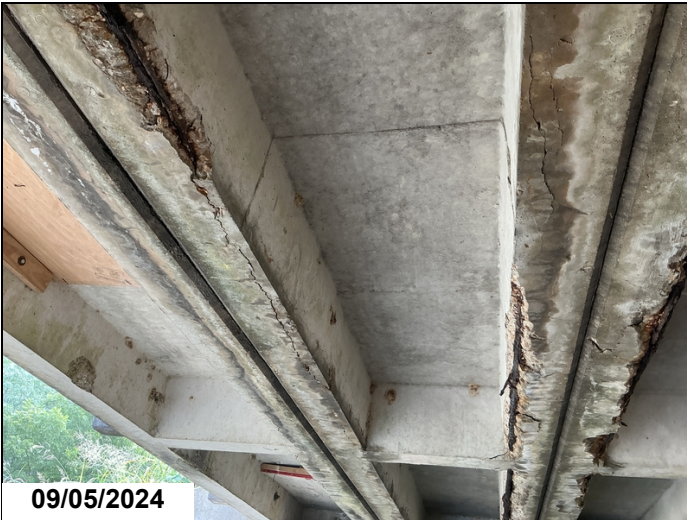
Exposed rebar to left and right leg unit 2 span 6.

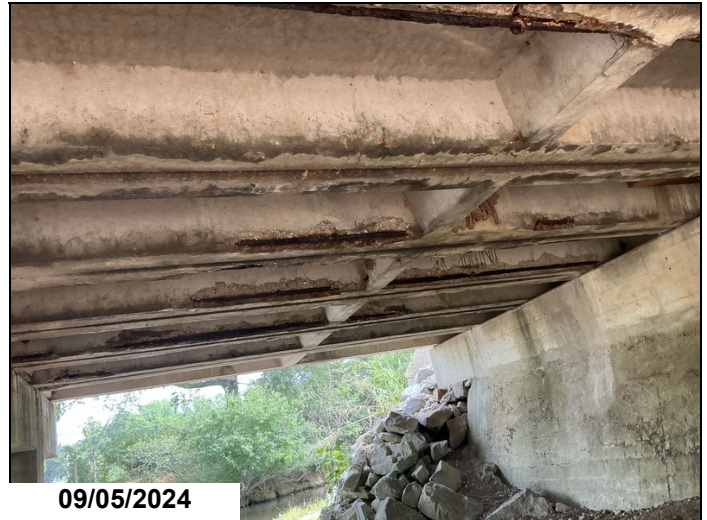
Undersurface span 6.

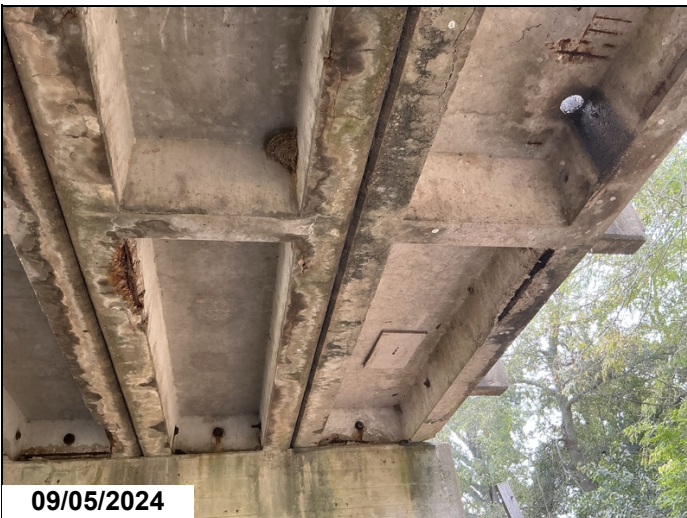
Exposed rebar left leg unit 6 and right leg unit 7 span 5.

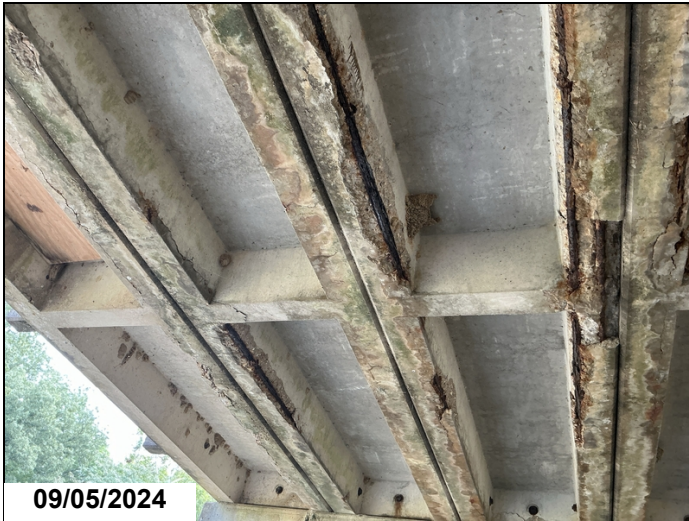
Exposed rebar left leg unit 2 and left and right leg unit 3 span 5.

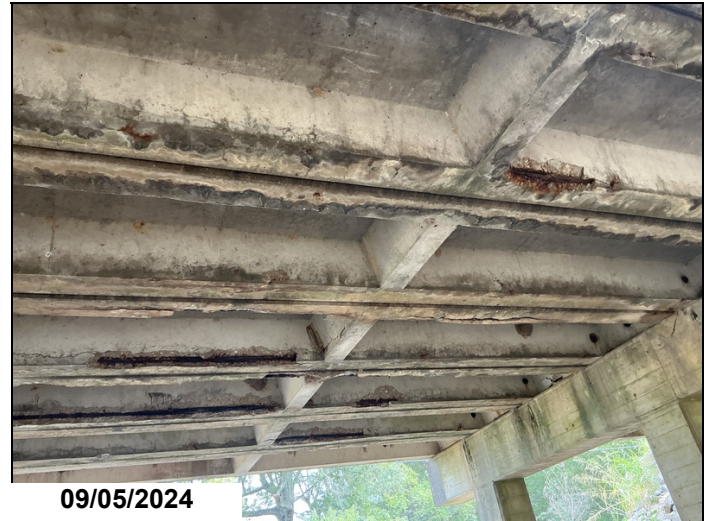
Undersurface span 5.

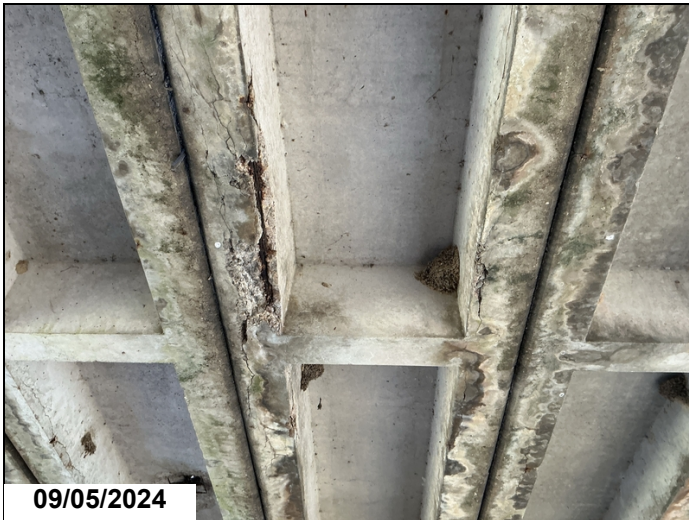
Exposed rebar left leg unit 5 span 4.

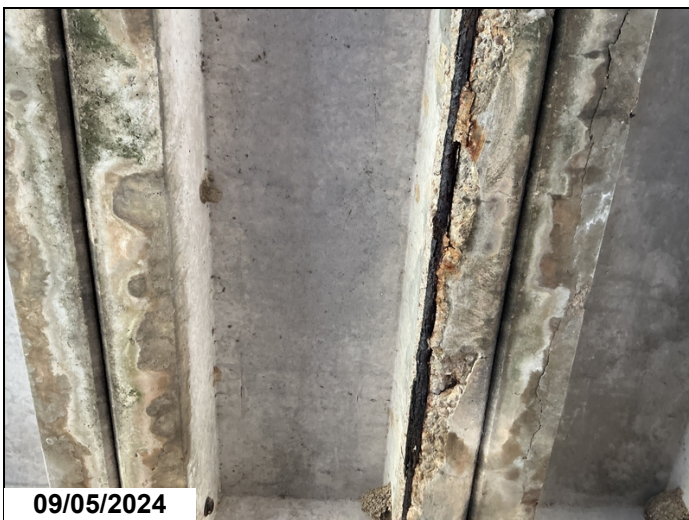
Exposed rebar right leg unit 3 span 3.

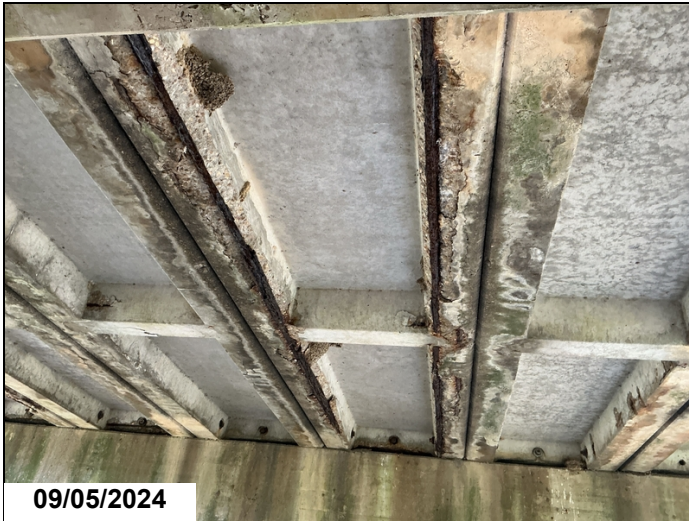
Exposed rebar left and right leg unit 5 span 2.

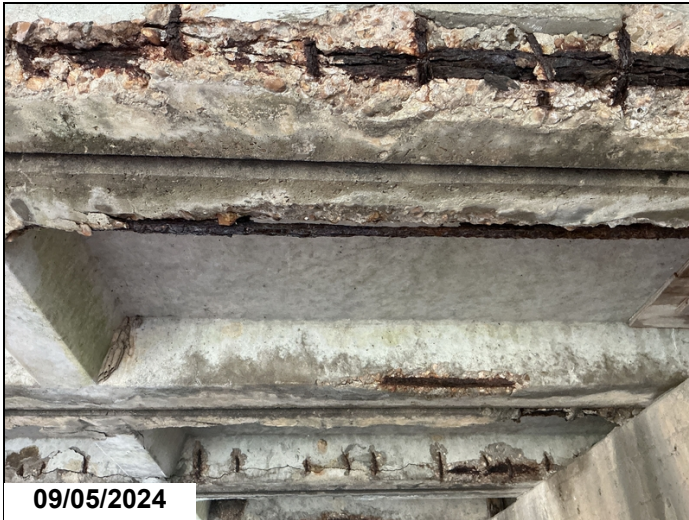
Exposed rebar left leg unit 3 span 1.

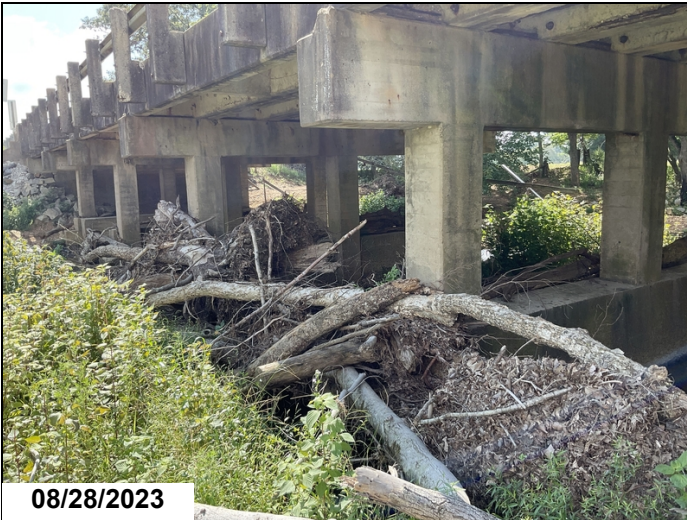
Drift @ Spans 1 - 5.

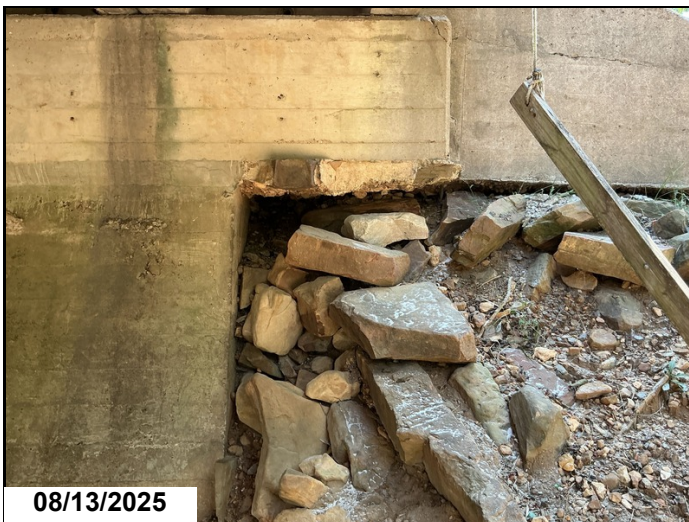
Erosion to wing and right side of abutment 2.

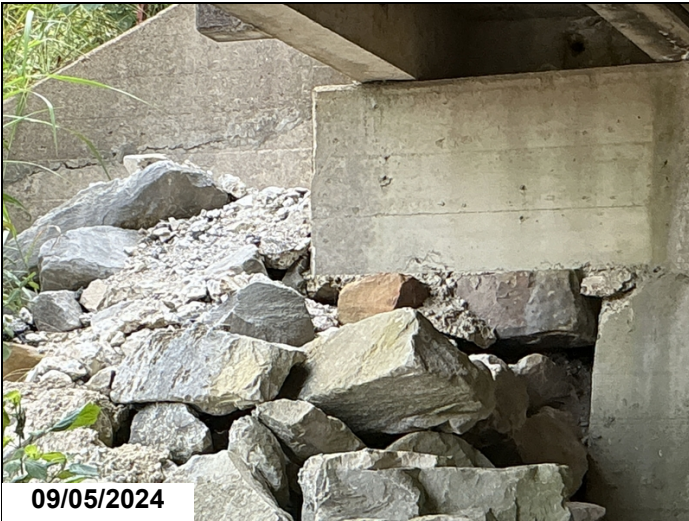
Erosion to wing and left side of abutment 2.
