Bridge 01879 Inspection Report

SH 367/Jackson Co. over WHITE RIVER RELIEF

Location: 4.35 MI SW JCT SH 14

Team Lead: Floyd Haley Inspection Date: 09/03/2024

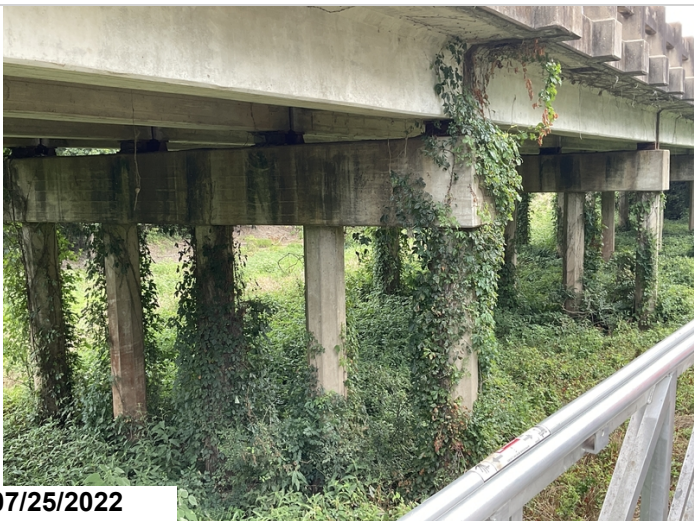
Vegetation @ Spans 11, 12 & 13.

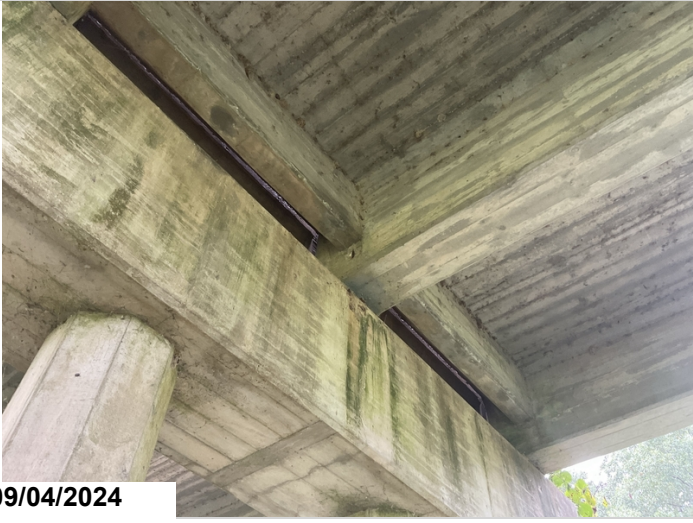
Bent 15, ahead, g2: exp rebar

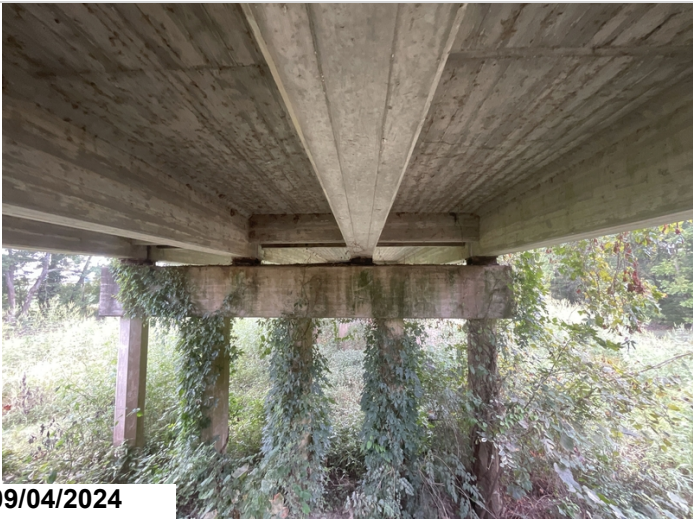
Bent 15 bearings. All cs3

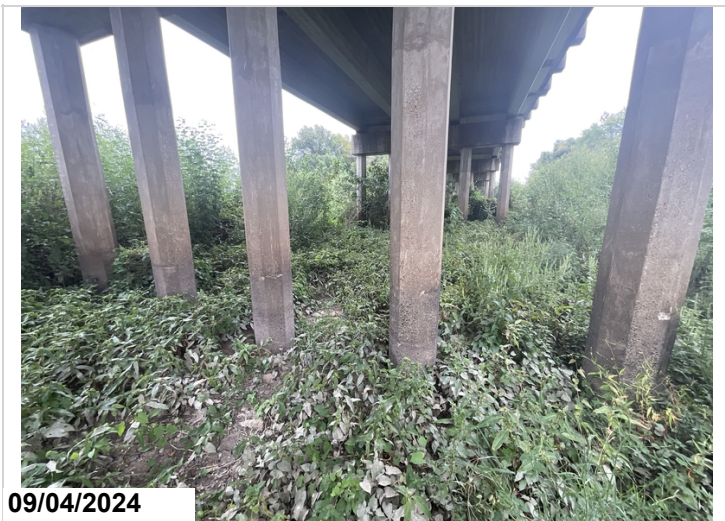
Typical piles

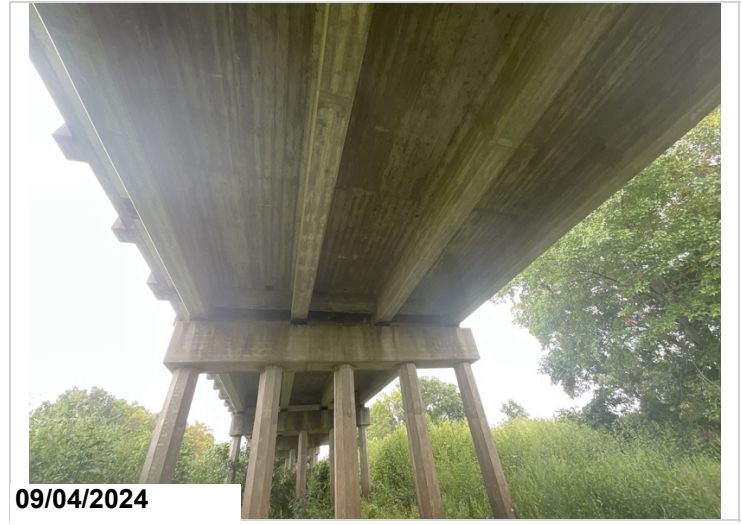
Typical undersurface

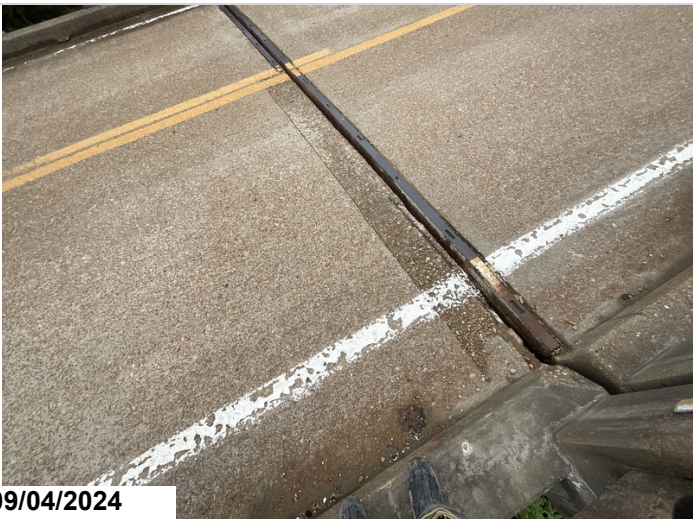
Bent 8, left. 4ft rebar

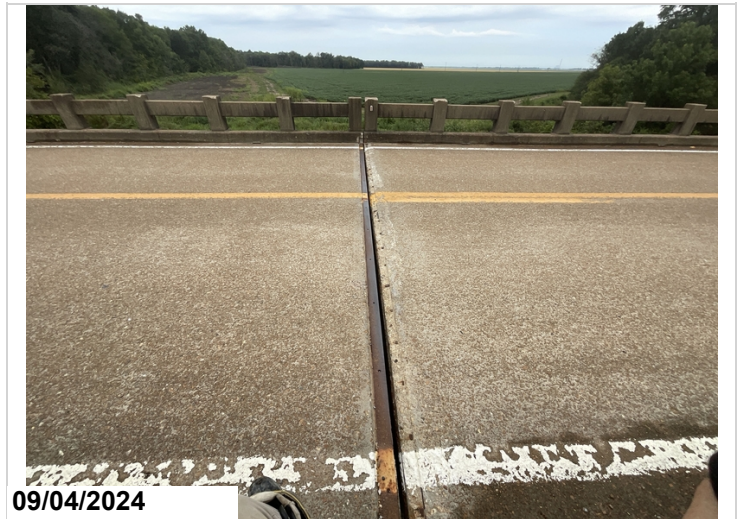
Bent 4, 3 is similar

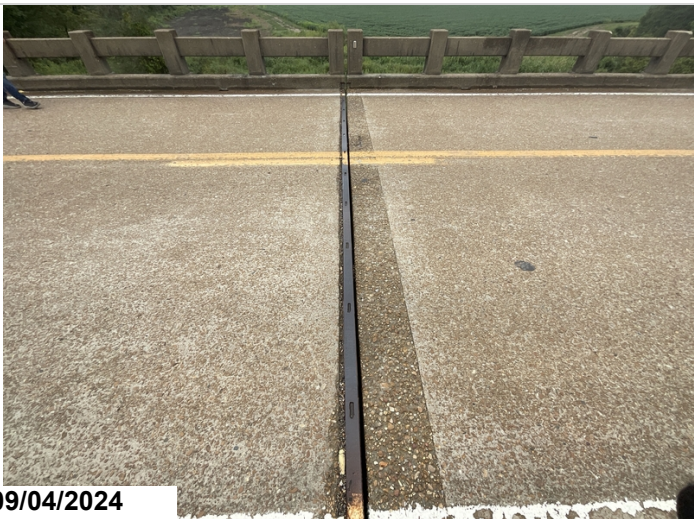
Bent 3. No joint armor ahead side

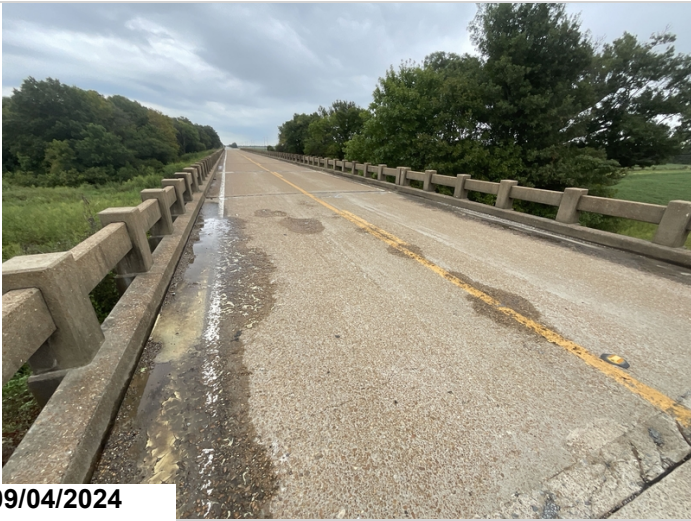
Typical deck

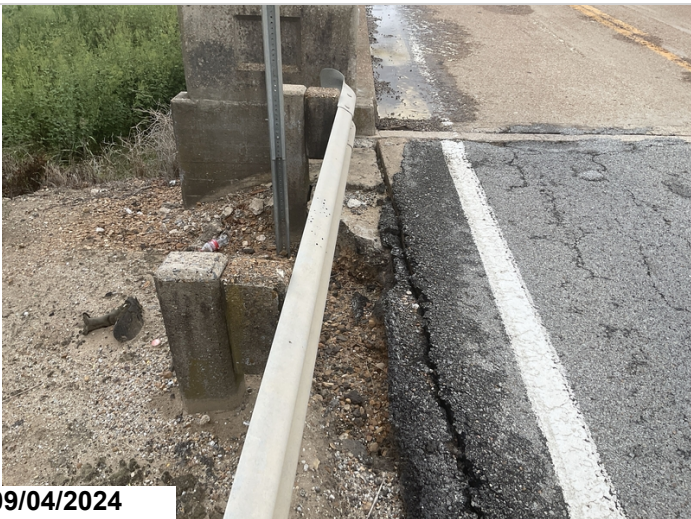
Abutment 1, left. Settlement and erosion at curb

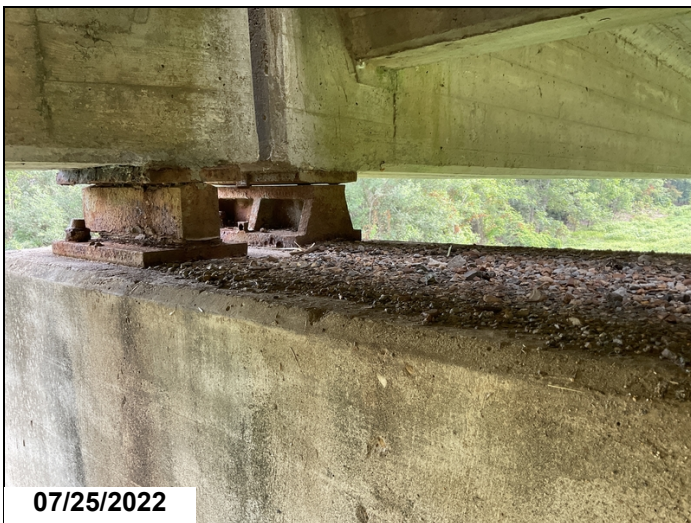
Bent 6 - Fixed Brg. 1, 3
Fixed brg 1.

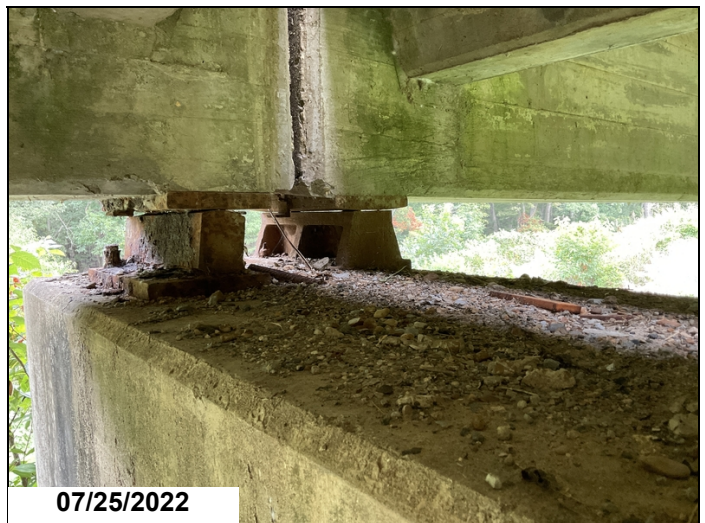
Bent 14 - fixed brg 1 & 4 moveable brg 1

Bent 14 - fixed brg 1 & 4

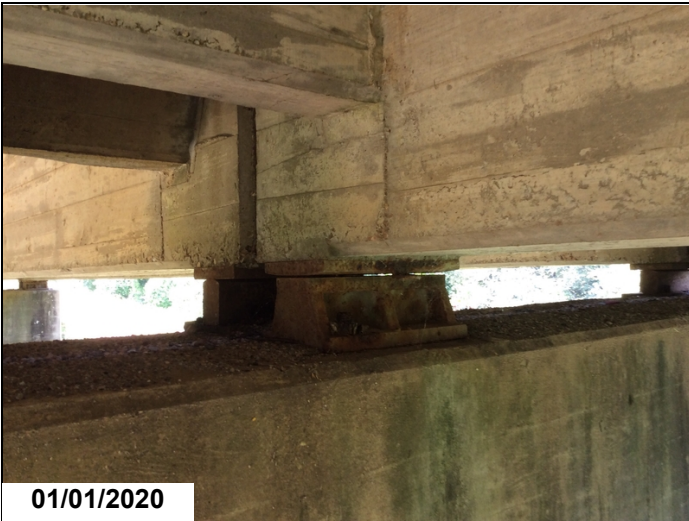
Fixed Bearing 2 @ BOS 4 is non bearing.

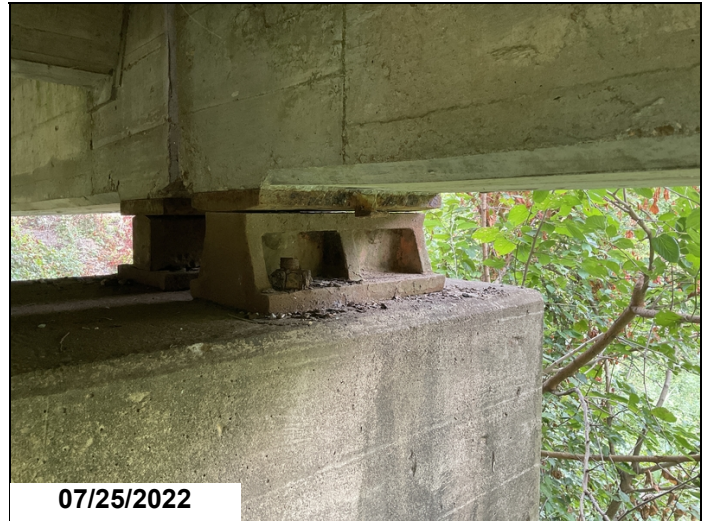
Bearings that are non-bearing:
Bent 1 - Fixed Brg.1

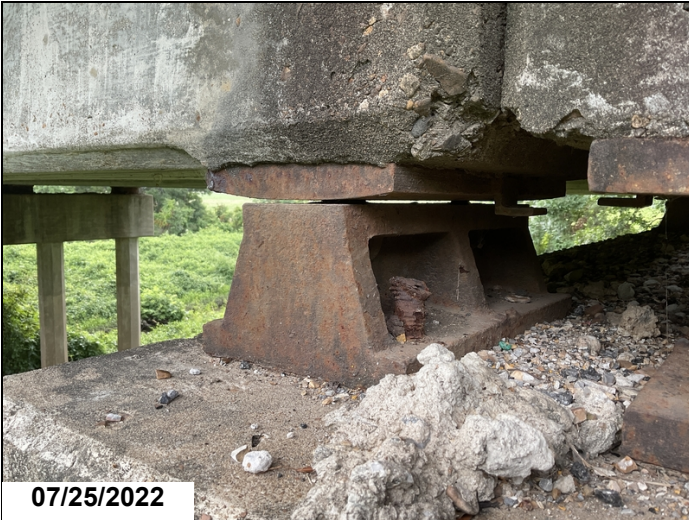
Bent 2 - Fixed Brg. 1 & 4 Moveable Brg. 1
Fixed brg 1

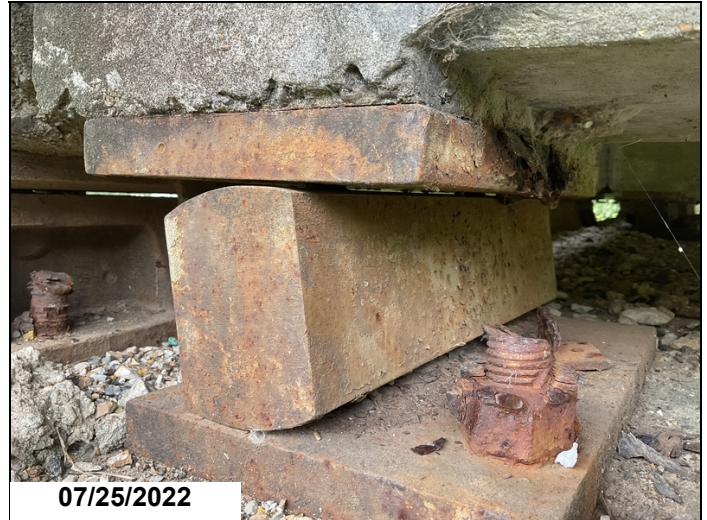
Bent 2 - Fixed Brg. 1 & 4 Moveable Brg. 1
Moveable brg 1.

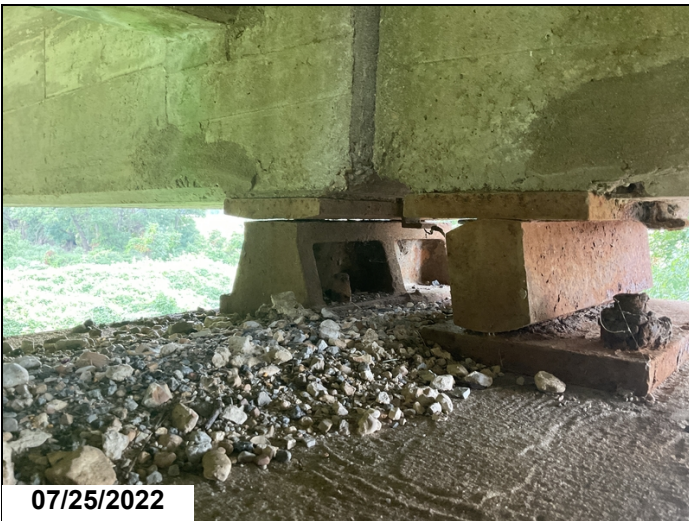
Bent 2 - Fixed Brg. 1 & 4 Moveable Brg. 1
Fixed brg 4.

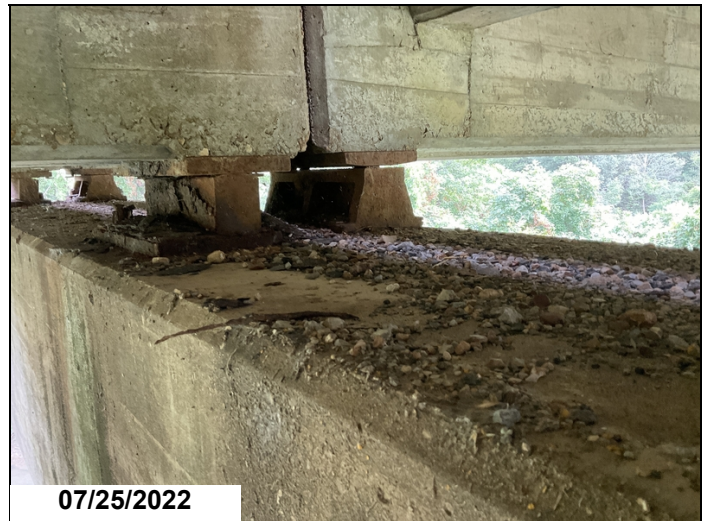
Bent 3 - Fixed Brg. 2, 3
Fixed brg 2.

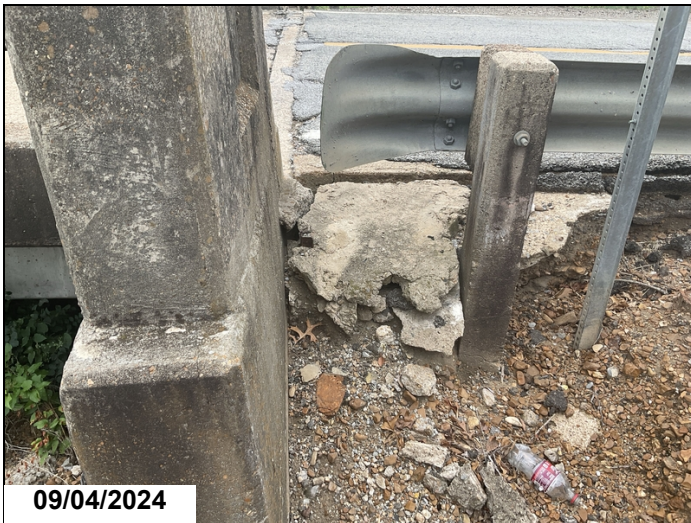
Abutment 1: has rotated ahead with settlement at the approach.

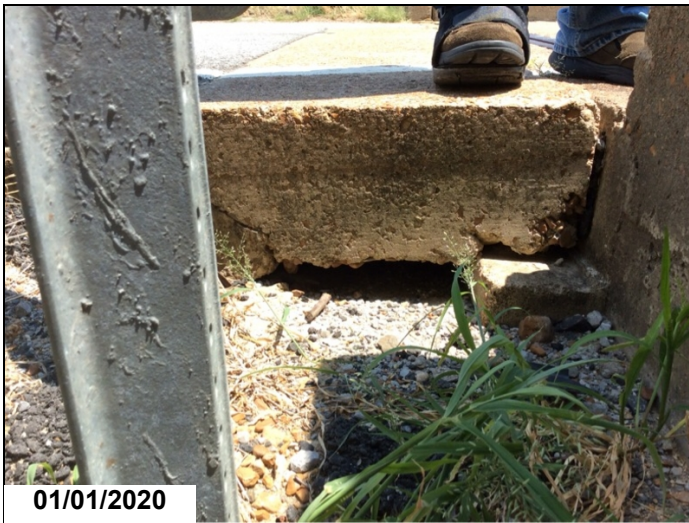
Approach roadway at Abutment 2 has erosion 8" below and 8' back under roadway.

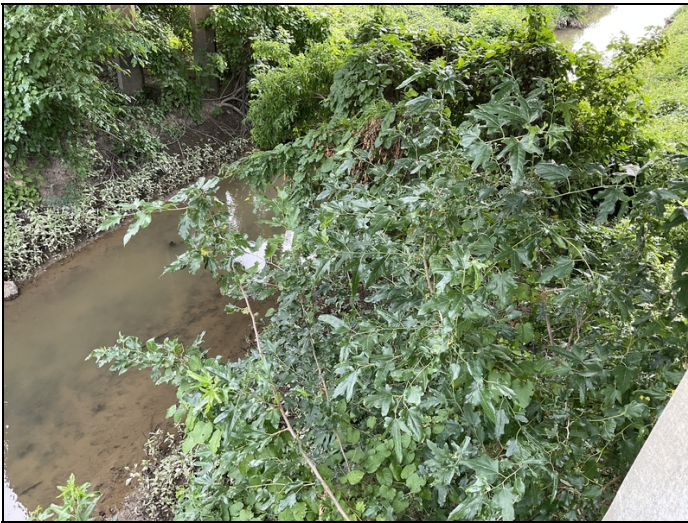
Vegetation @ Spans 3, 4, 11, 12 & 13.

Vegetation @ Spans 4, 11, 12 & 13.
Span 4.

A-64 - Vegetation Removal Requested (Yes)

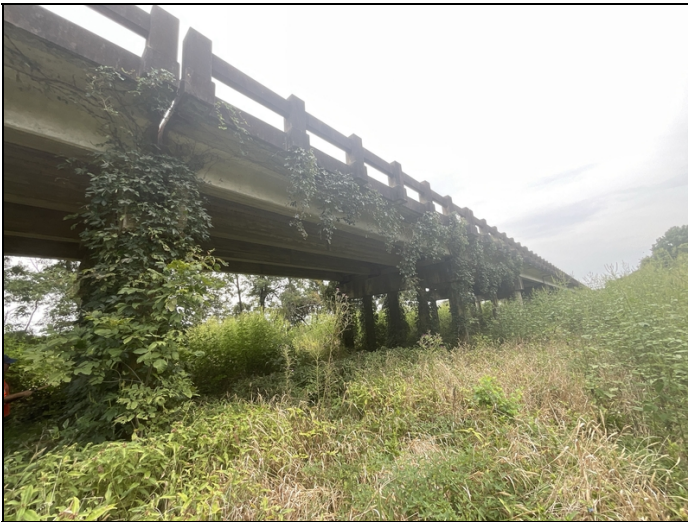
Vegetation span 12
