## Bridge 01881 Inspection Report

Asset #01881(Routine)

SH 367/Jackson Co. over WHITE RIVER RELIEF

Team Lead: Floyd Haley Inspection Date: 09/03/2024

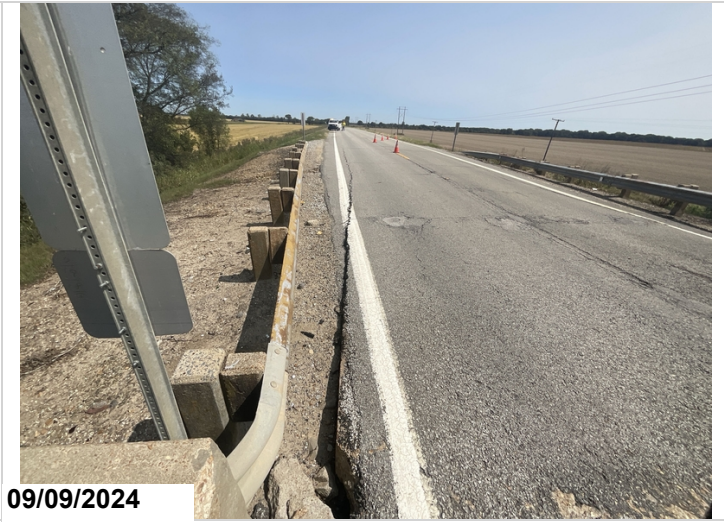
Abutment 2, approach voids

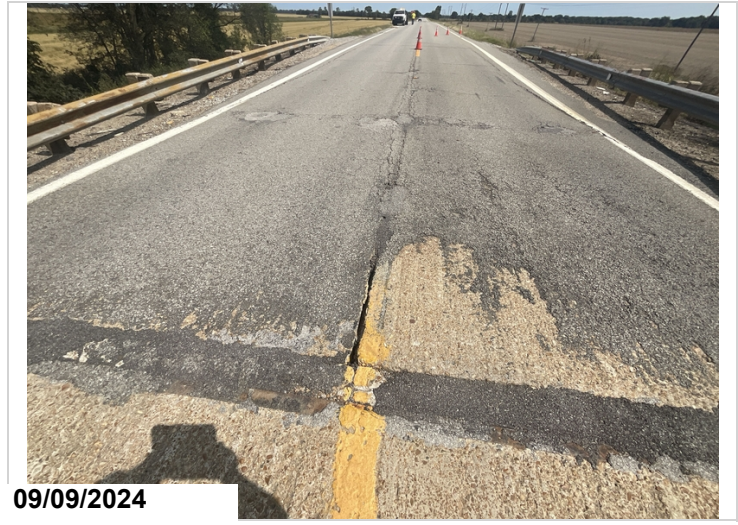
Abutment 2 approach voids

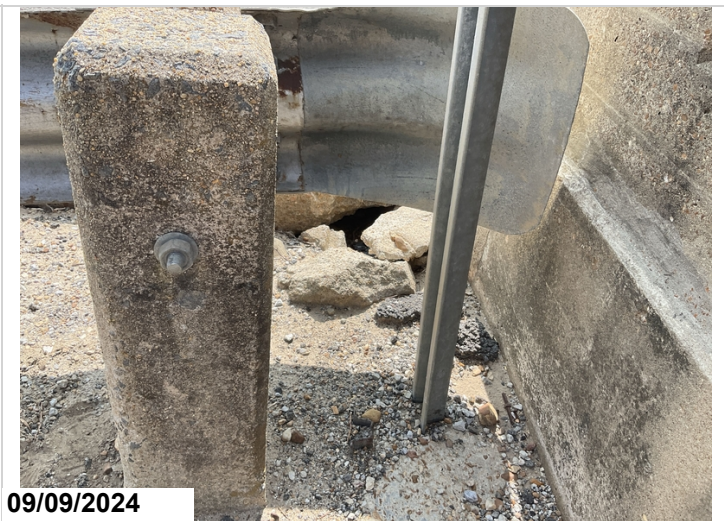
Abutment 2, both sides of the approach have voids

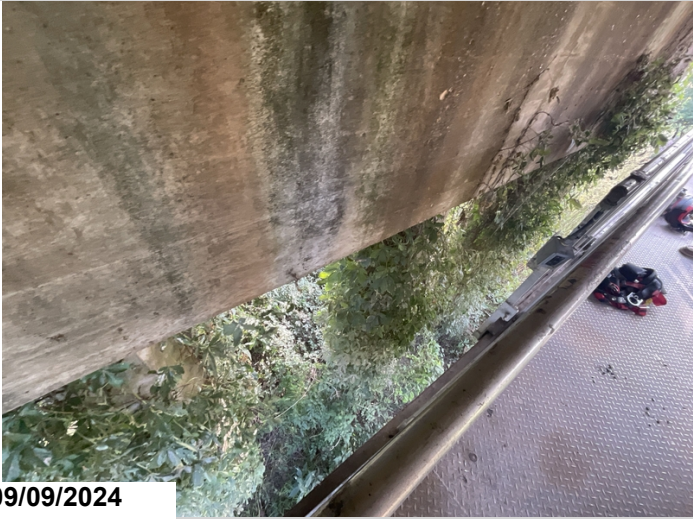
Bent 3 vegetation

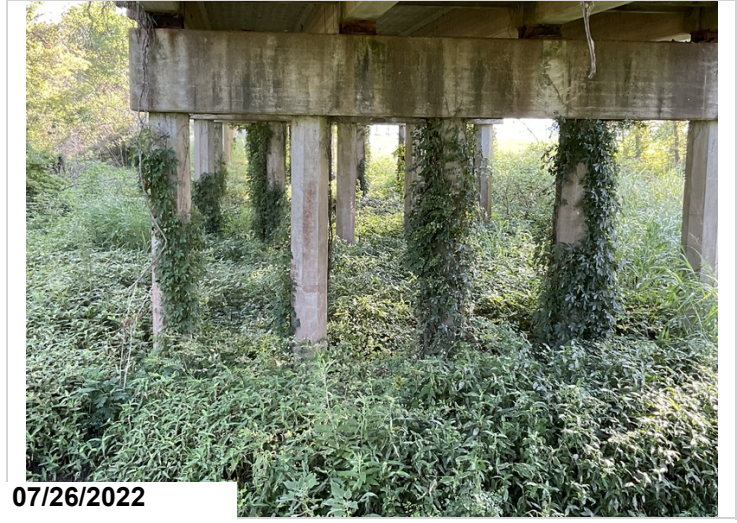
Vegetation buildup spans 1- 5.

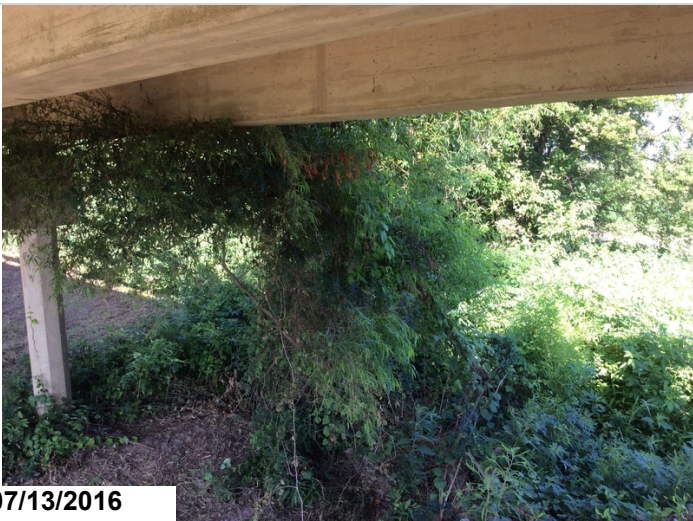
Tree growing under Left side of bridge @ Span 12.

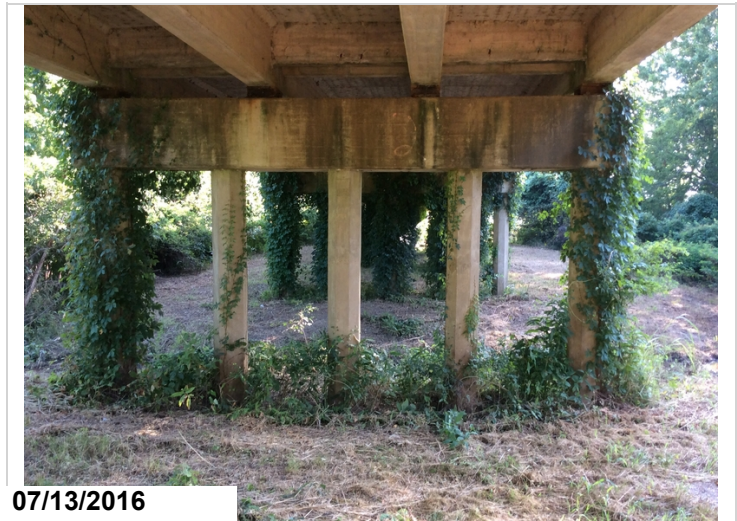
Heavy vegetation growth on piles & caps.

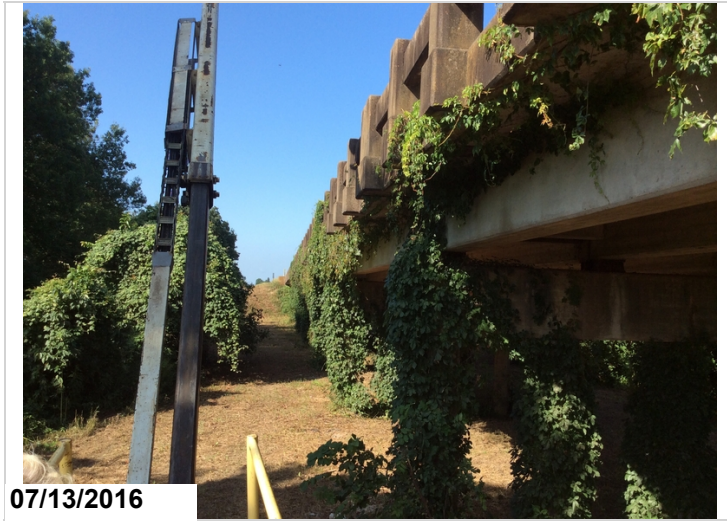
Heavy vegetation @ Bents 2 through 10 Right side of bridge.

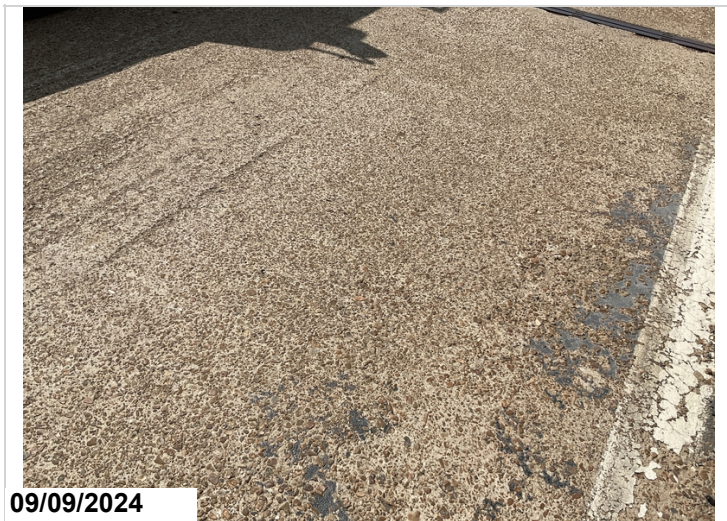
Deck has abrasion throughout

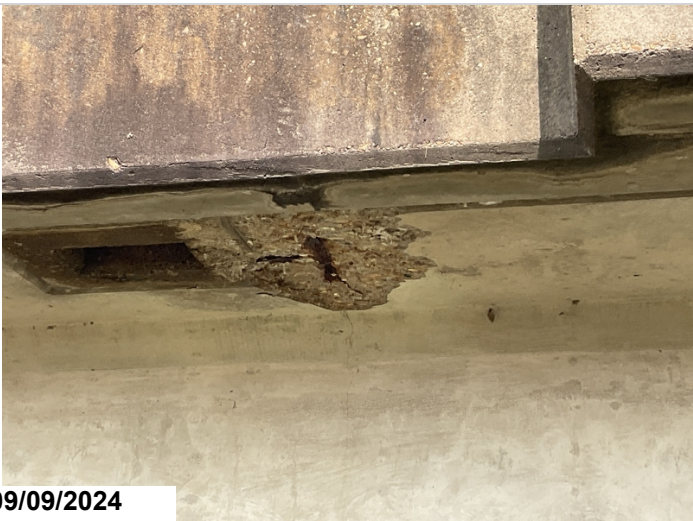
Span 12, right, 1lf cs3

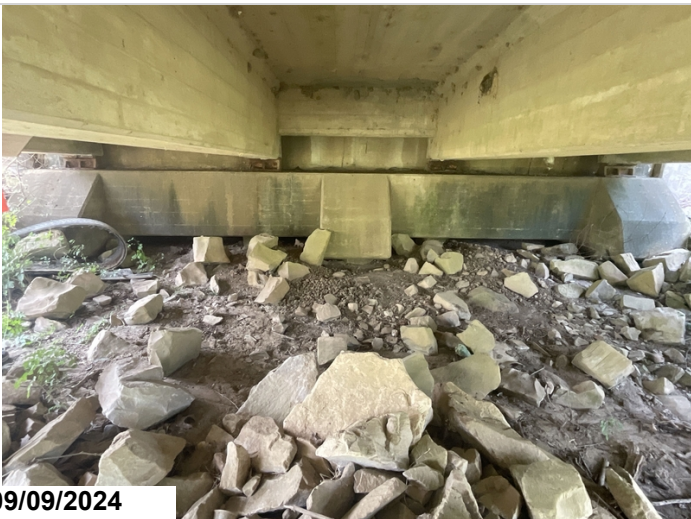
Abutment 1, left:

Abutment 1: has minor scour with 2 piles exposed. 16LF CS2

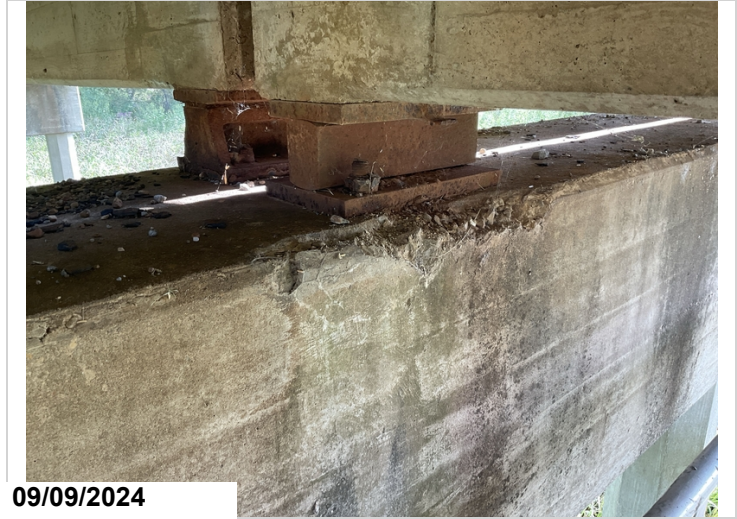
Bent 25, back, under bearing 3, cap: has a 2' spill. 2LF CS3

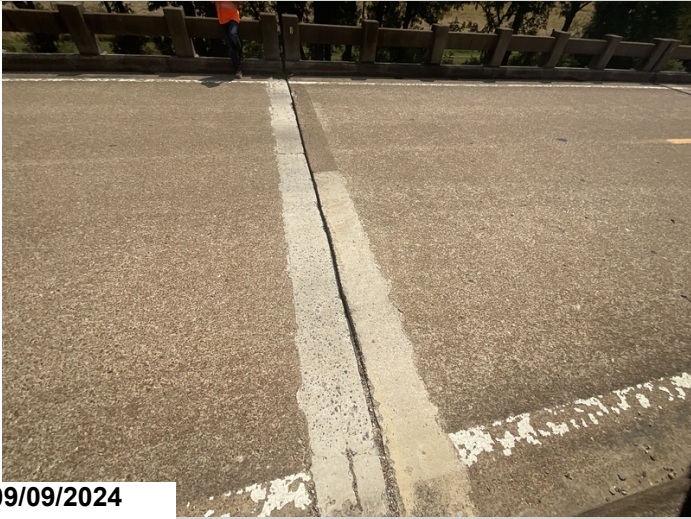
Bent 6: has no joint

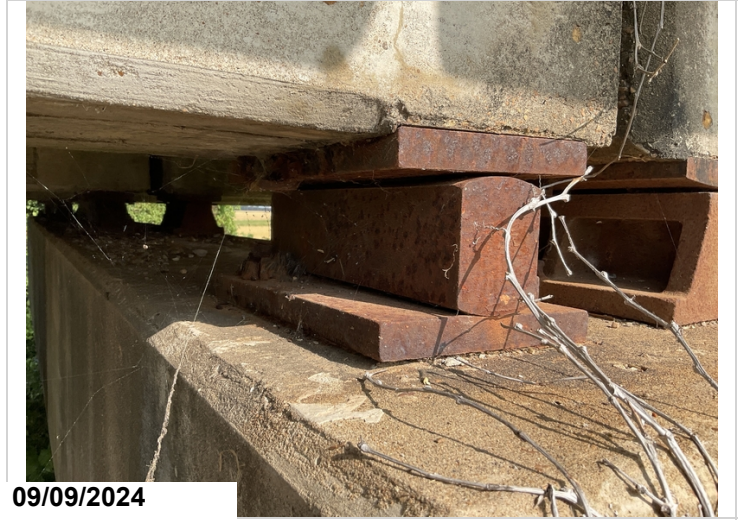
Bent 10, back, bearing 4 is non bearing. 1EA CS3

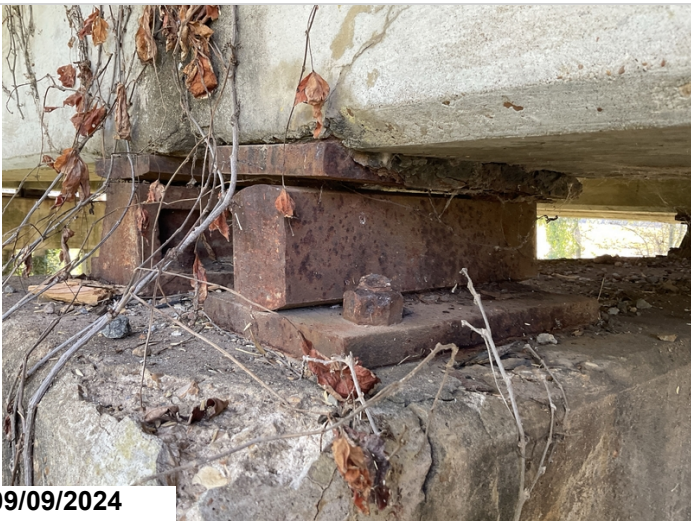
Bent 7, back, bearing 1: is non bearing. 1EA CS3

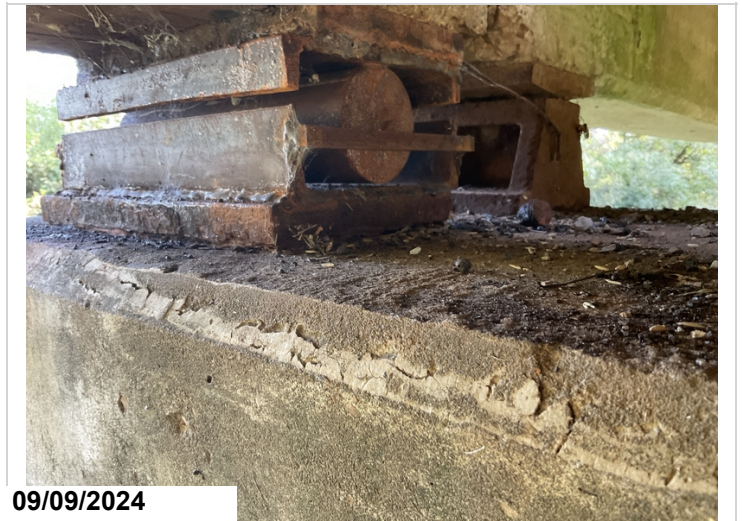
Bent 2, back, bearings 1 and 4: are non bearing. 2EA CS3

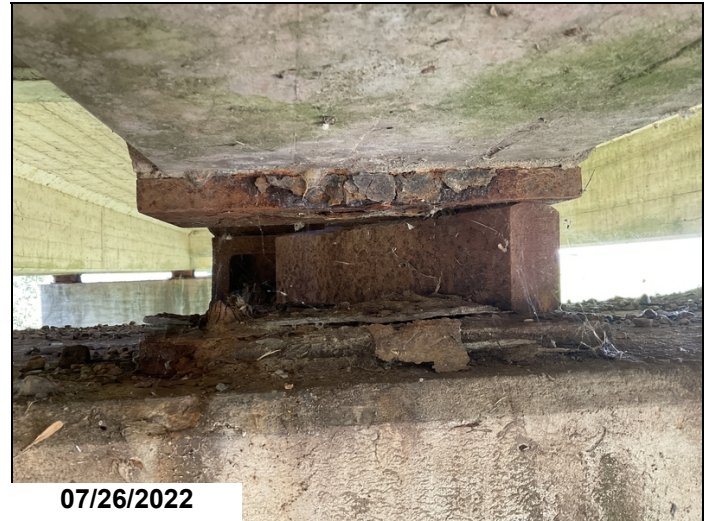
Moveable Bearing 3 at end of Span 8 has rotated out from under girder.

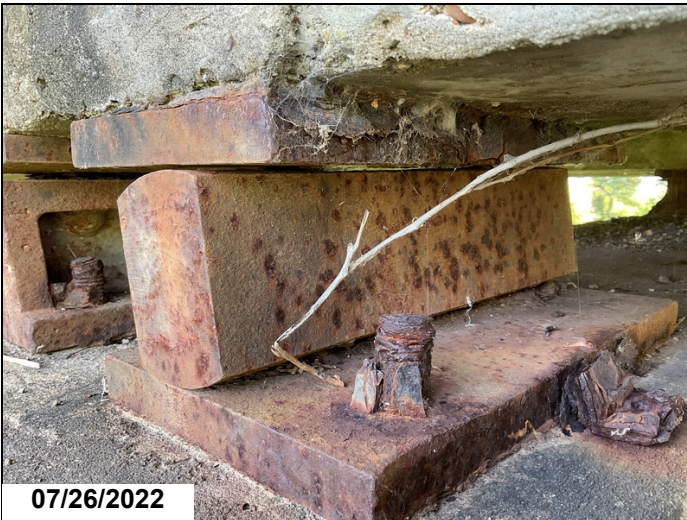
Moveable Bearings are NON-BEARING at:  
Bent 2 - Bearings 1 & 4.  
Bearing 1.

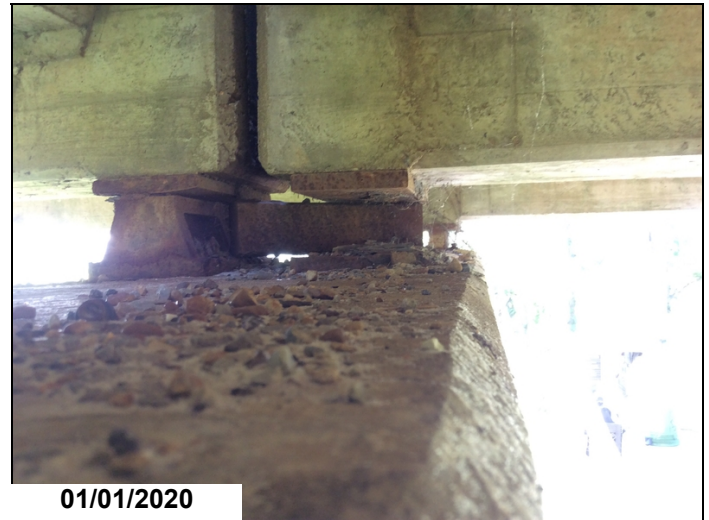
Bent 8 - Moveable bearing 3 (back side) at End of span has rotated Ahead out of place.

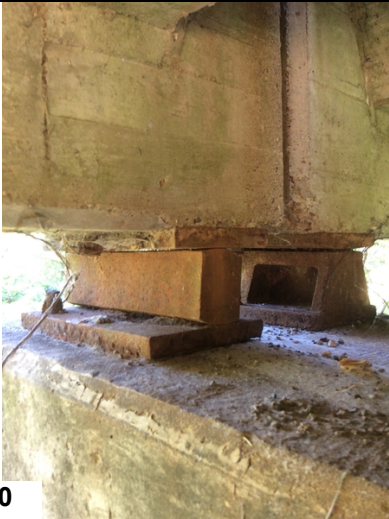
Bent 24 - Fixed bearing 3 (ahead side) is non bearing.

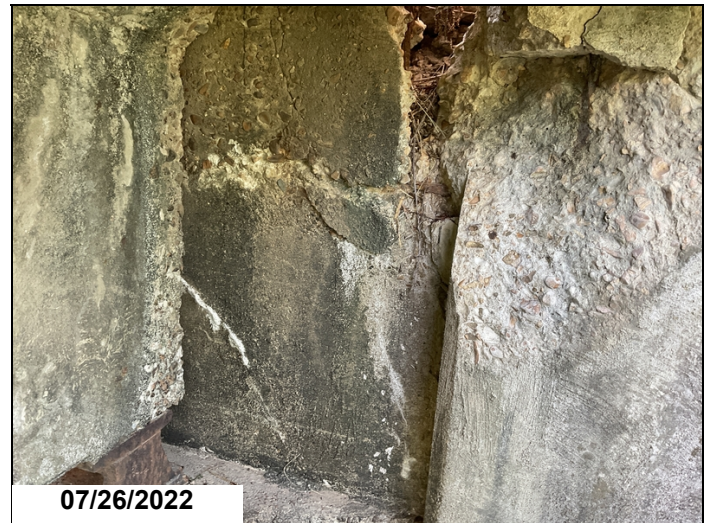
Settlement @ abutment 1.

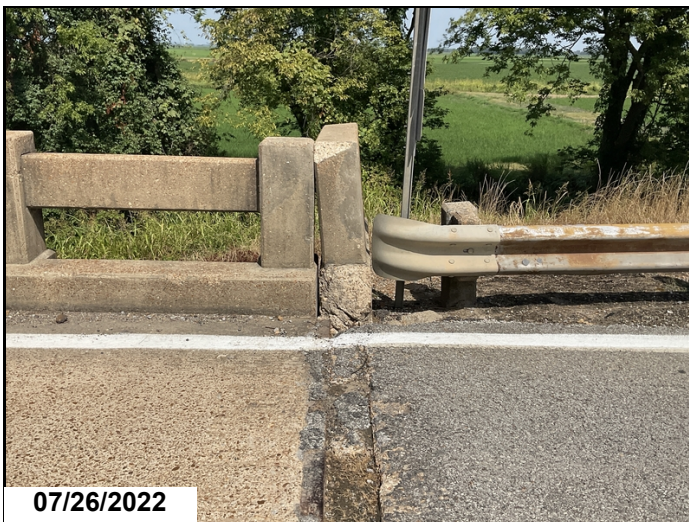
Settlement @ Abutment 2.

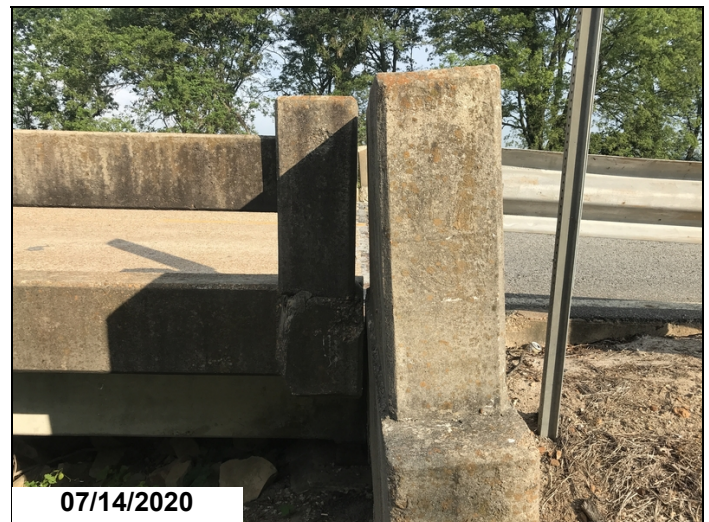
Settlement @ Abutment 2.

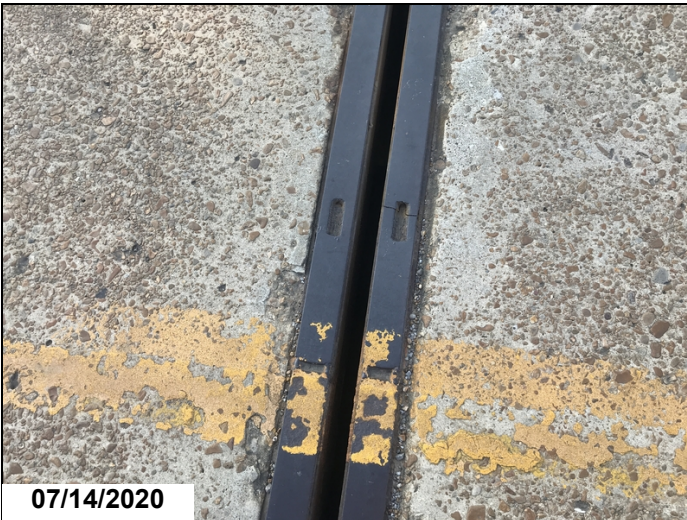
Span 27: Broke road iron at End of span.

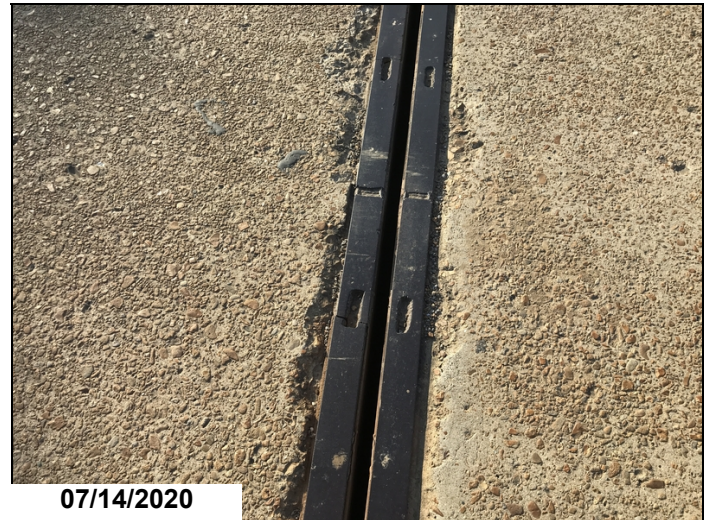
Span 3: Broke road iron @ End of span.

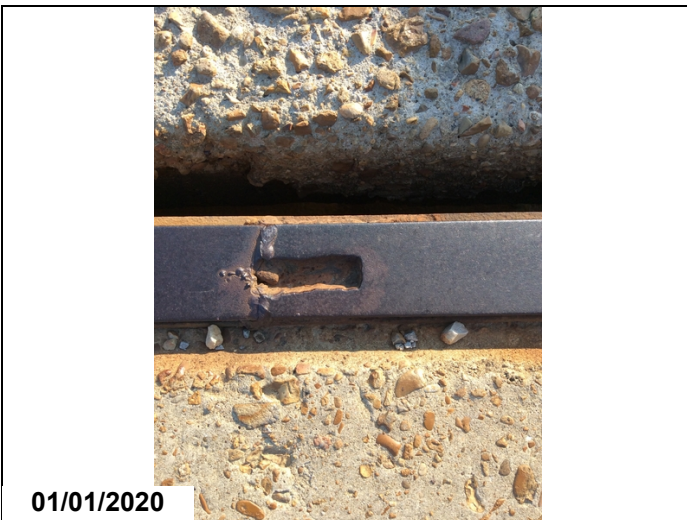
Span 2: Broke road iron @ Beginning of span.

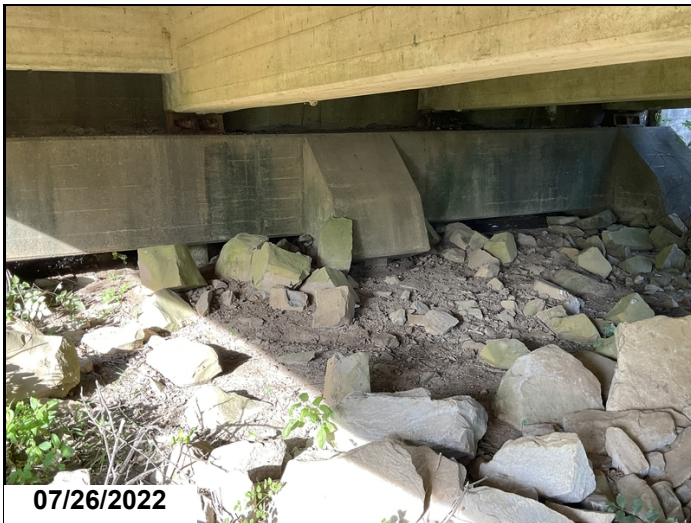
Erosion @ abutment 1 with 2 piles exposed.

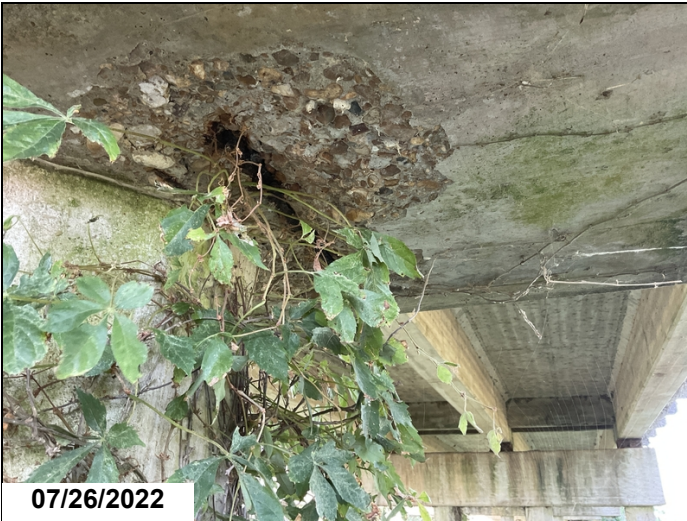
Bent 09, right, back, over pile 5: has a spall with exposed rebar. 1LF CS3

Spalls with rebar exposed at Bents 4, 9, 23, 25 & 32.  
Rt side of @ bent 9.

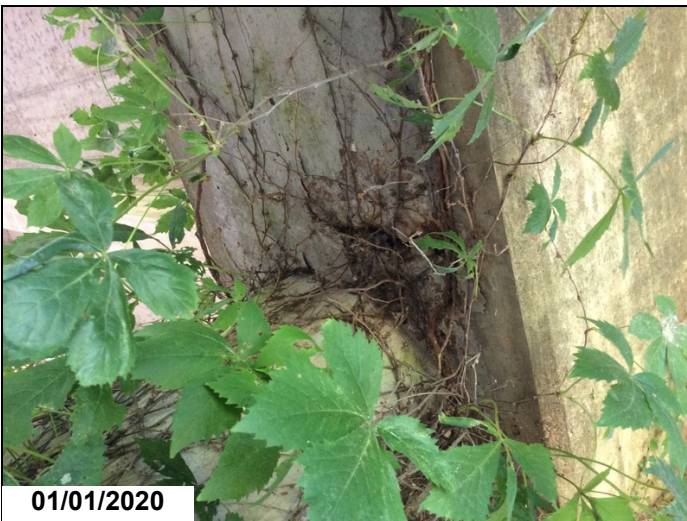
Bent 23, back, cap: has a spall with exposed rebar. 2LF CS3

Bent 23, back, underside, cap: has 3 spalls with exposed rebar. 3LF CS3

Spalls with rebar exposed to bottom of Cap @ Bent 23.

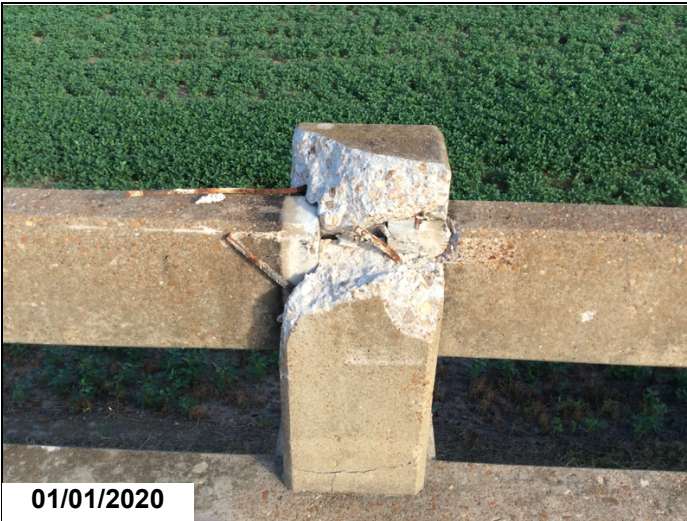
Collision damage to concrete bridge rail post @ Span 23  
Left side.

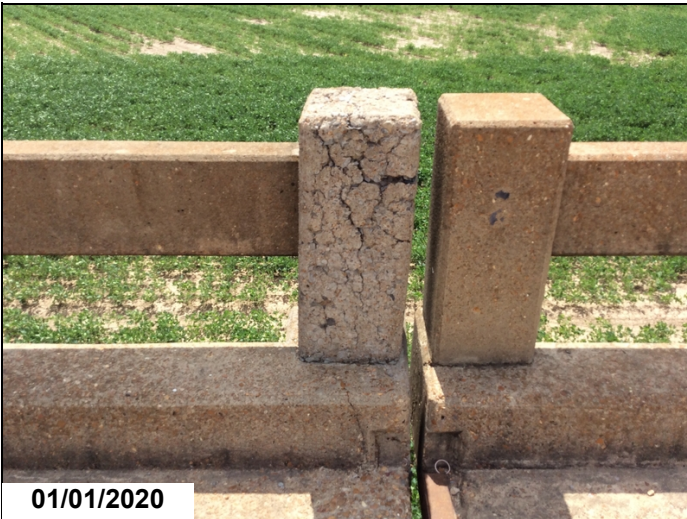
Concrete Bridge Rail  
Cracks and spalls, some with rebar exposed, to rail and or posts at Spans 1, 17 thru 19, 23, 24, 25, 30, 31 & 36  
Span 30, post 6.

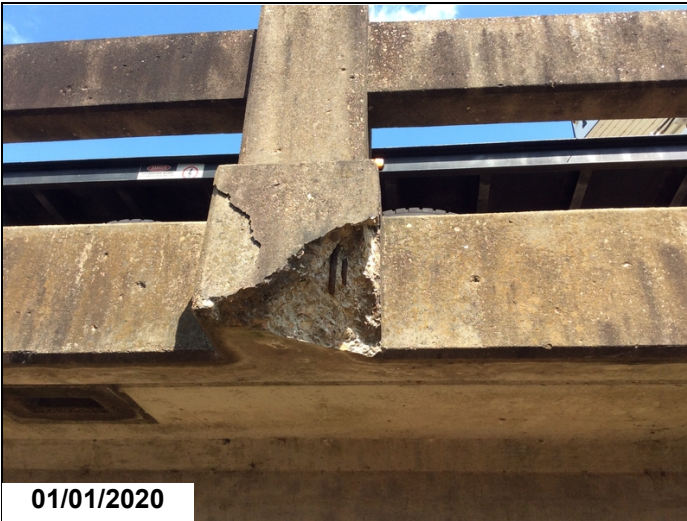
Cracks @ Spalls to bottom of Post 7 @ EOS 31.

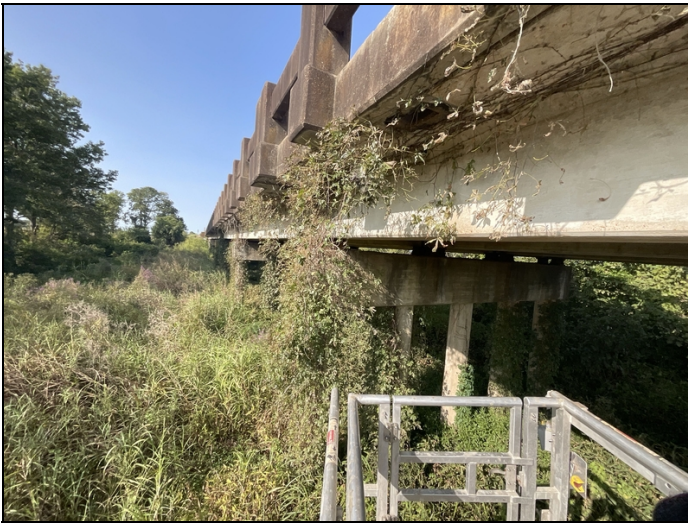
Vegetation growth is widespread.

**A-64 - Vegetation Removal Requested (Yes)**

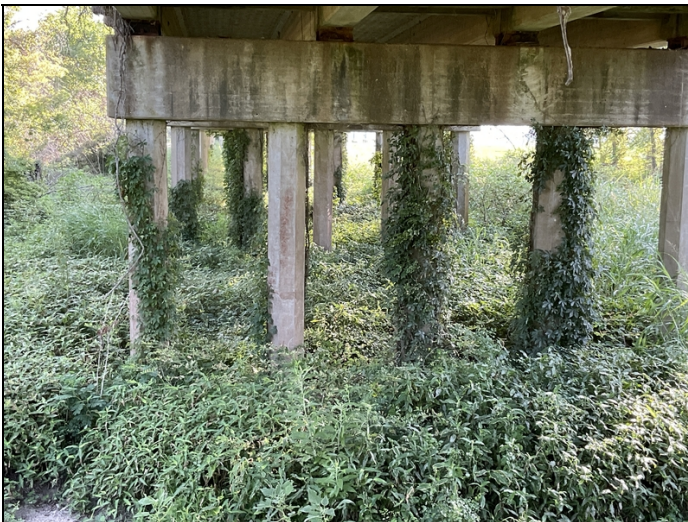
Bent 3 vegetation

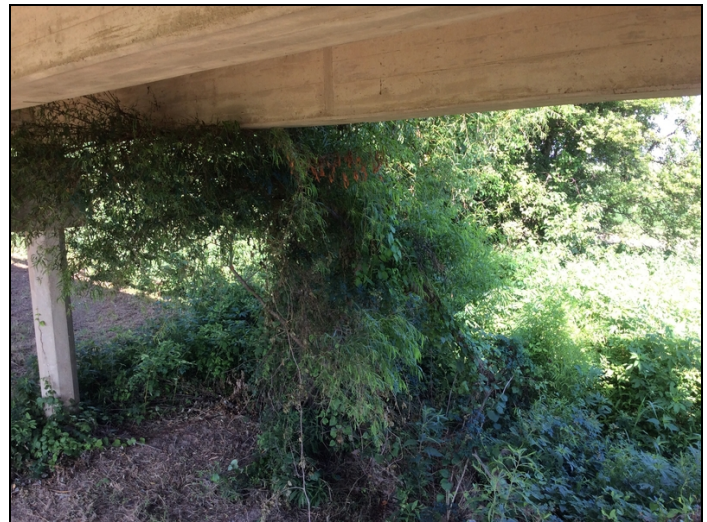
Vegetation buildup spans 1- 5.

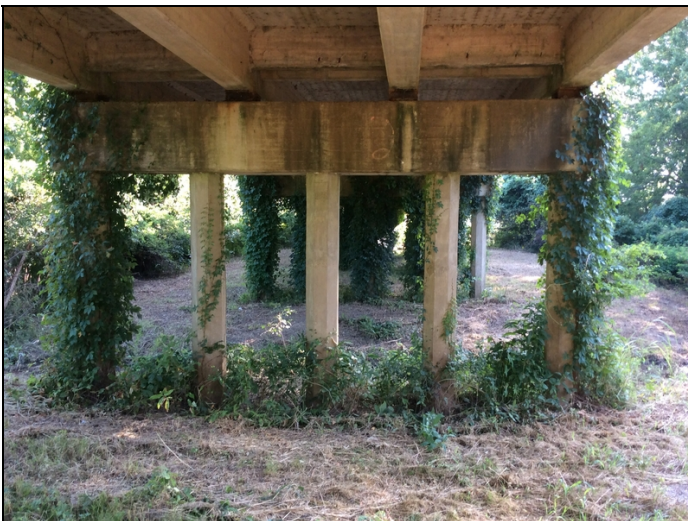
Tree growing under Left side of bridge @ Span 12.

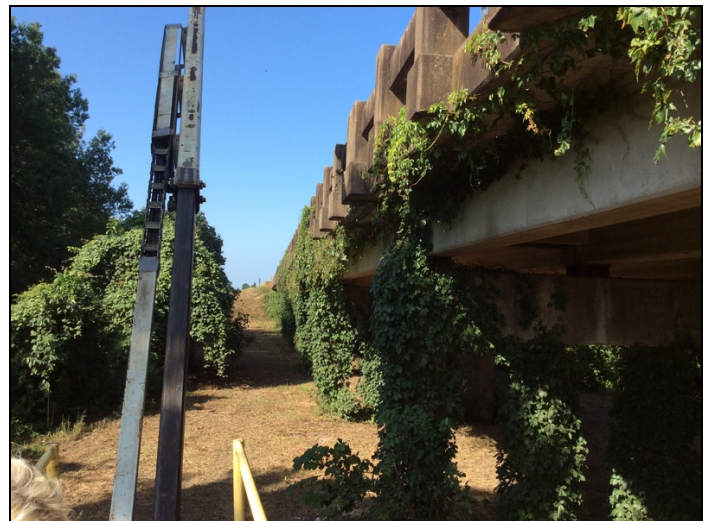
Heavy vegetation growth on piles & caps.
