Bridge 01883 Inspection Report

Route:367 Section:21 Log:4.989

National Bridge Inventory Data Sheet

Asset #01883(Routine, Underwater type 2)
SH 367/Jackson Co. over WHITE RIVER RELIEF
Location: 1.05 MI SW JCT SH 14
Team Lead: Floyd Haley Inspection Date: 08/26/2024

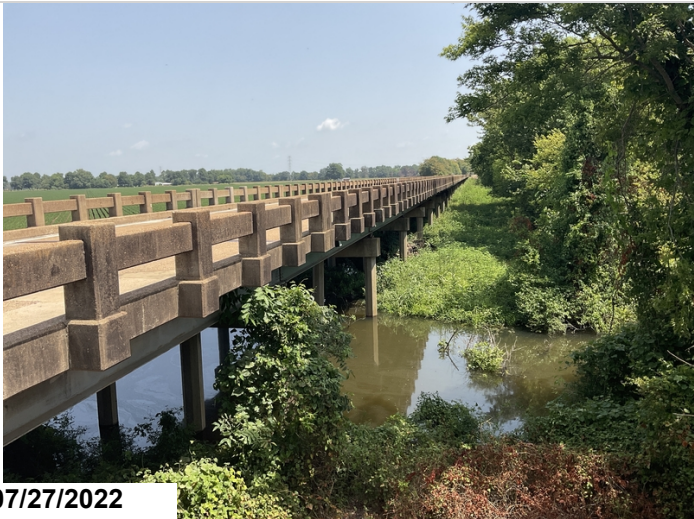
Elevation with log mile going right.

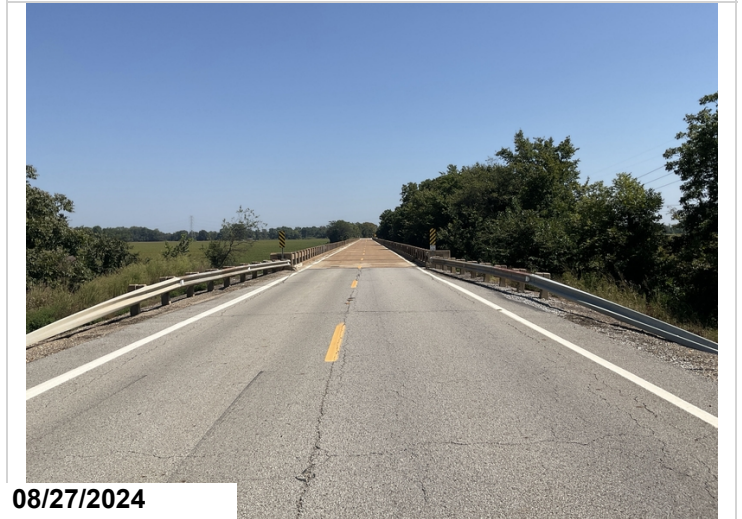
Inspection direction.

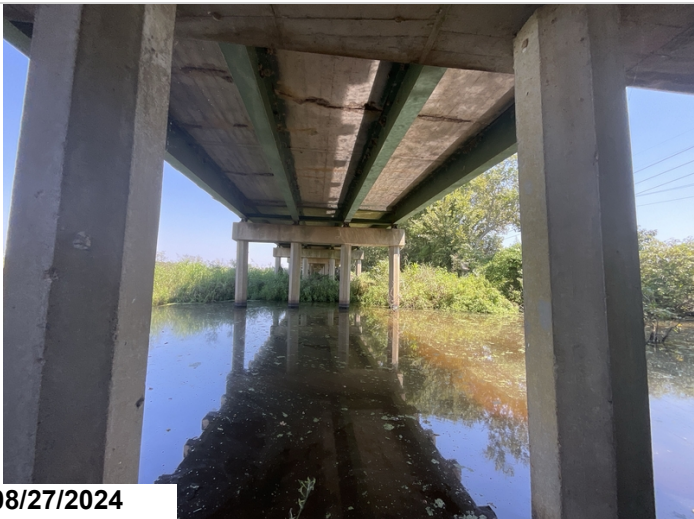
Typical undersurface

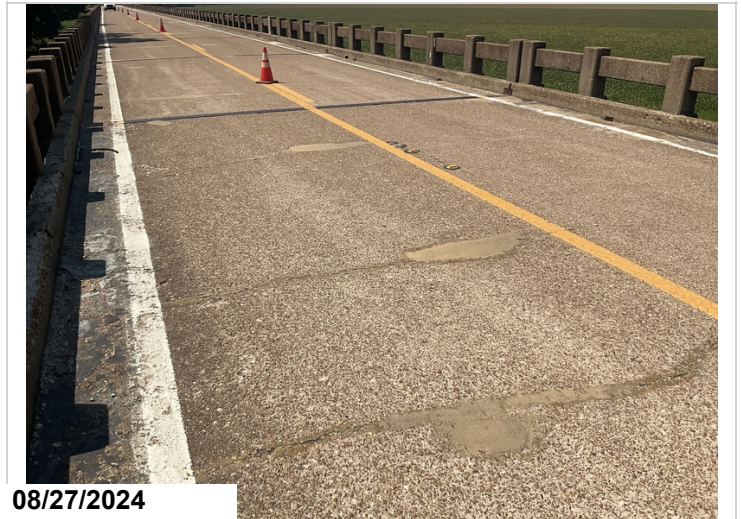
Typical deck

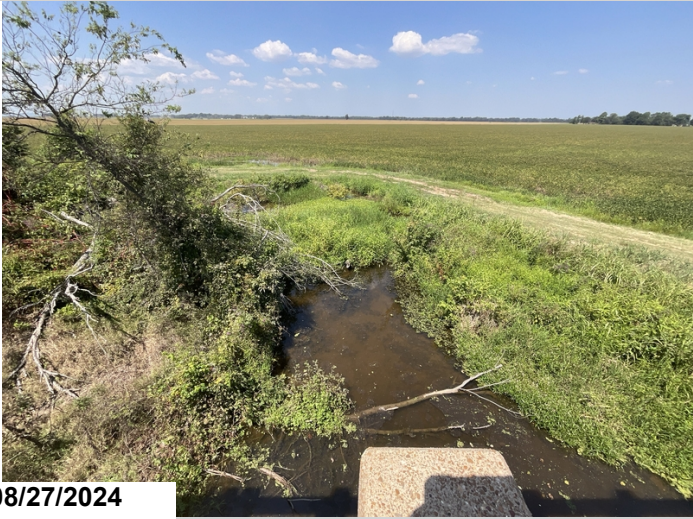
Upstream/left

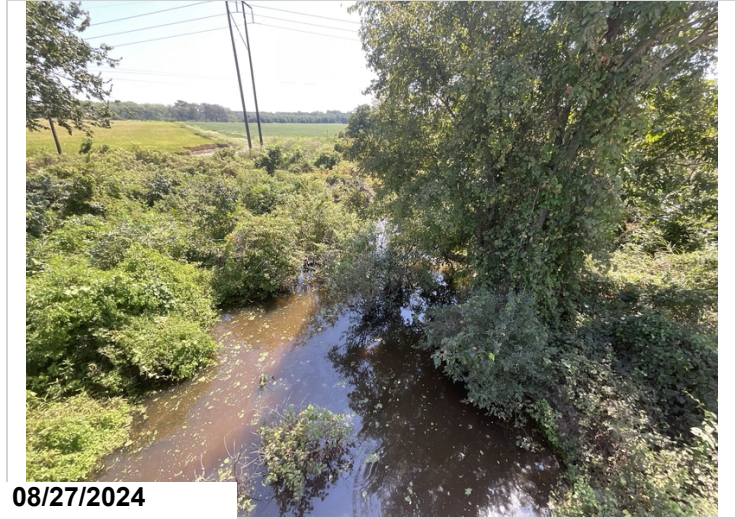
Downstream/right

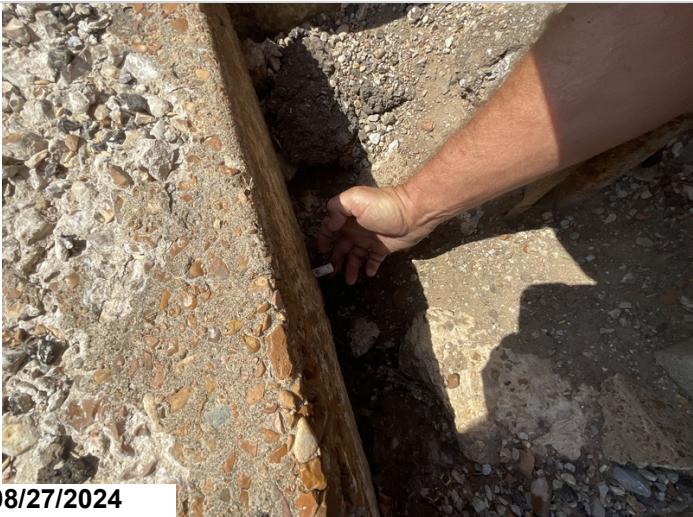
Abutment 2 left: Void under slab. Probing did not produce an end to the void on this side. On the right side, the void was 4' back under the approach slab.

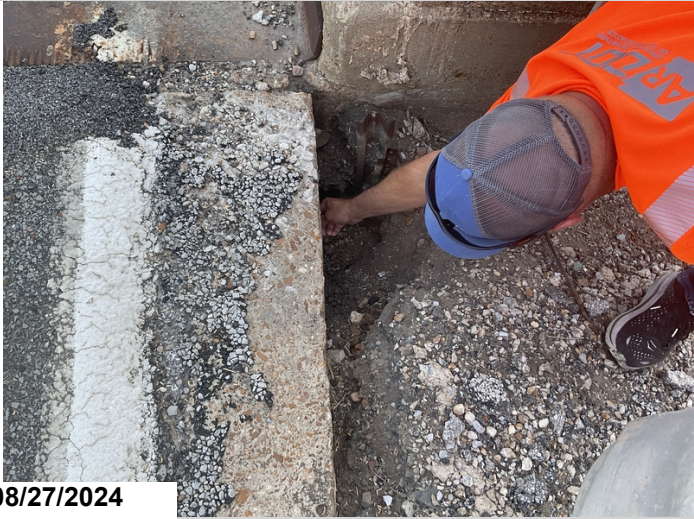
Abutment 1, right: 6' folding rule inserted all the way. Left side similar. Void presumed to go all the way across.

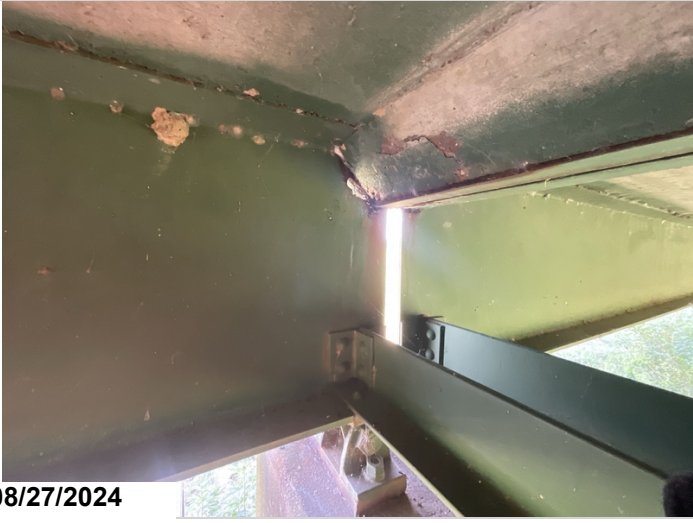
Bent 10, back, girder 1: has a 4" x1.5" hole at the haunch. 1LF CS3

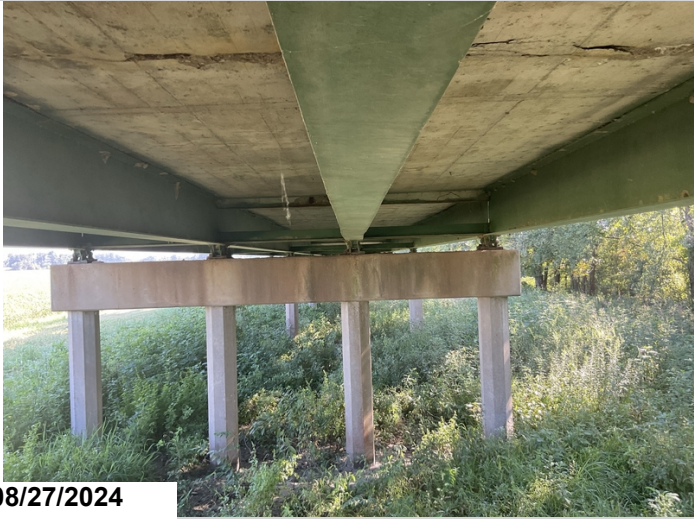
Span 5, girder 3: is bowed halfway between midspan and bent 5. 2LF CS3

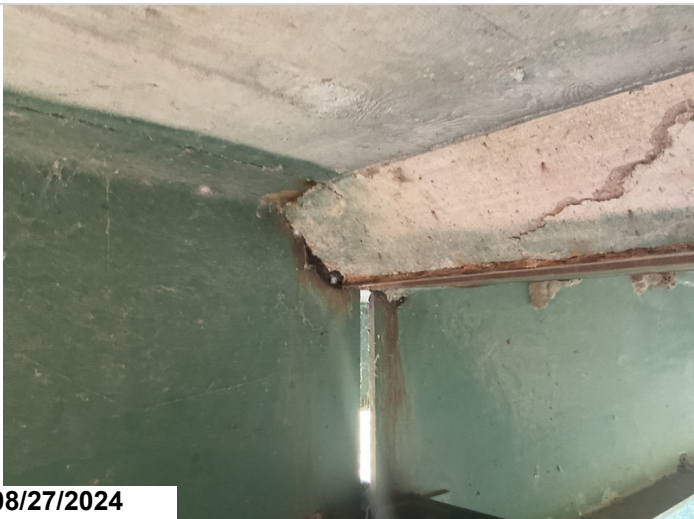
Bent 3, back, girder 2: has a 1/2" hole at the haunch. 1LF CS3

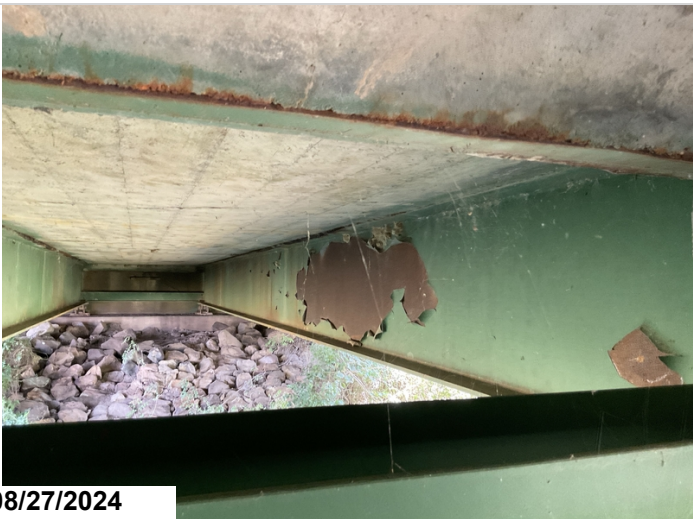
Span 31, girder 3: has a large area of peeled paint at midspan. 36SF CS4

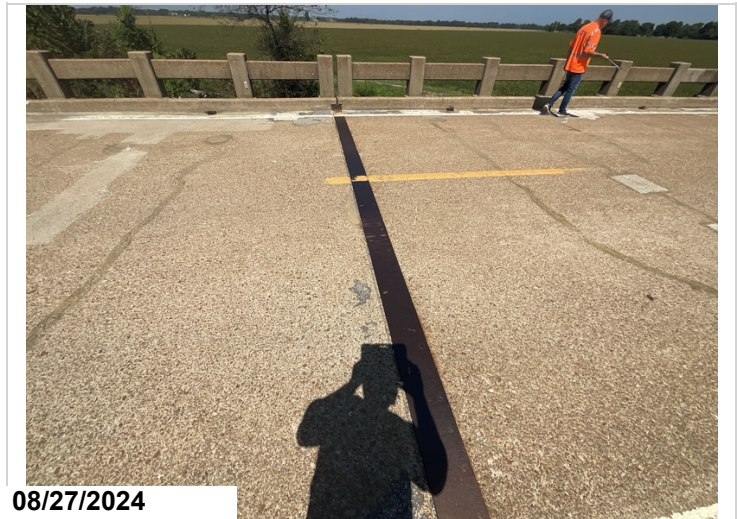
Bent 1: typical joint

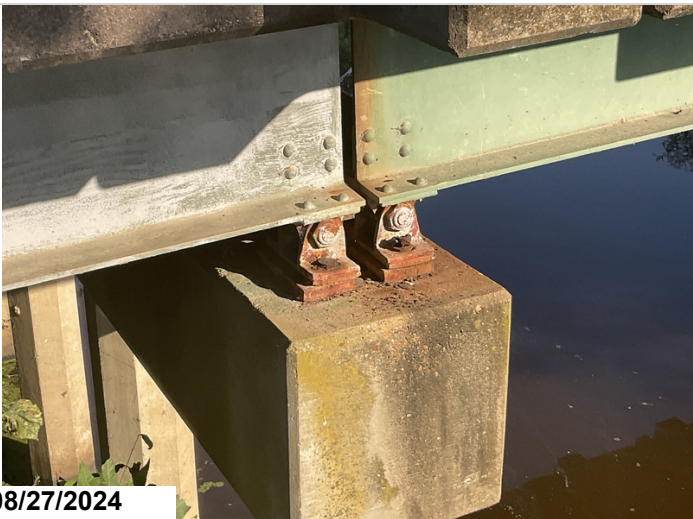
Bent 1, back, bearing 4: the masonry plate is beginning to slide out. Bearings 3 and 4 on the ahead side are similar. 3EA CS3

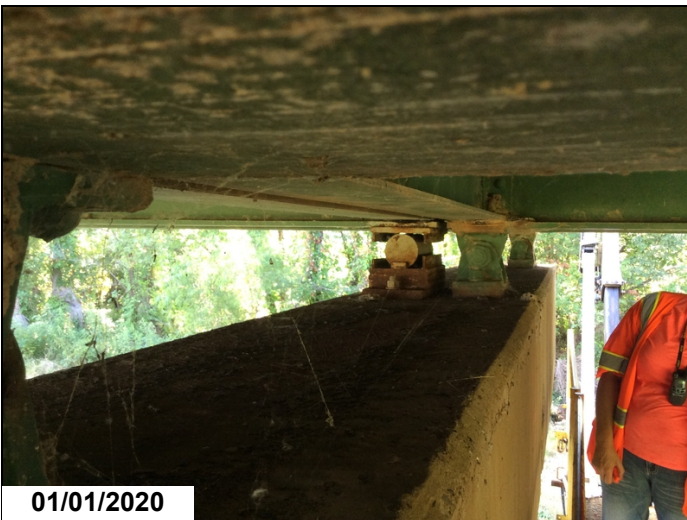
Moveable bearings @ Bent 4 are non bearing.

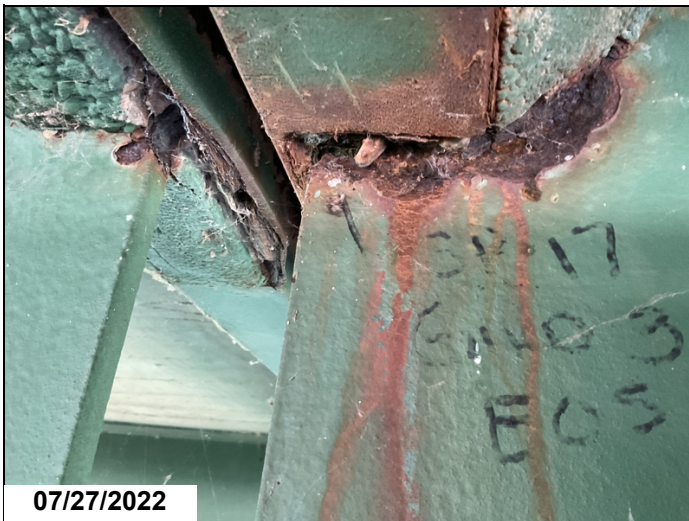
Girders 1 & 3 at Span 17
Girder 3.

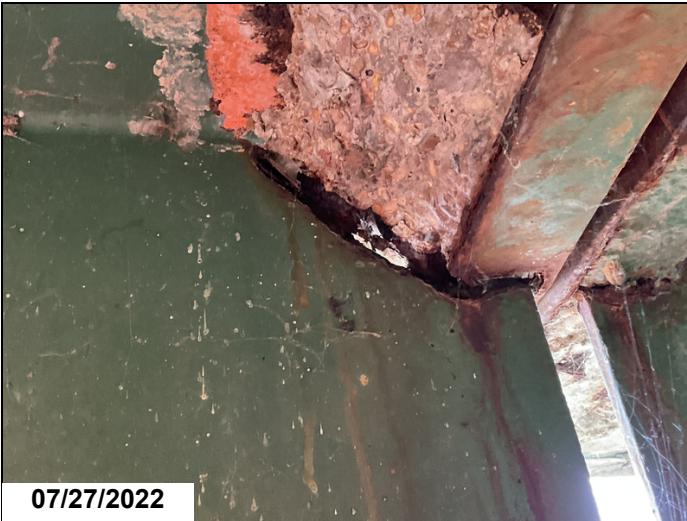
Girders 1 & 4 at Span 5
Girder 1.

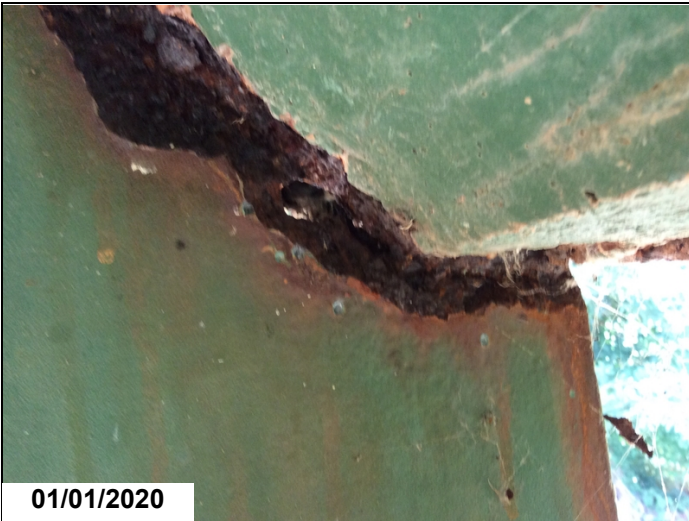
Hole in web below paving haunch @ Girder 4 @ BOS 19.

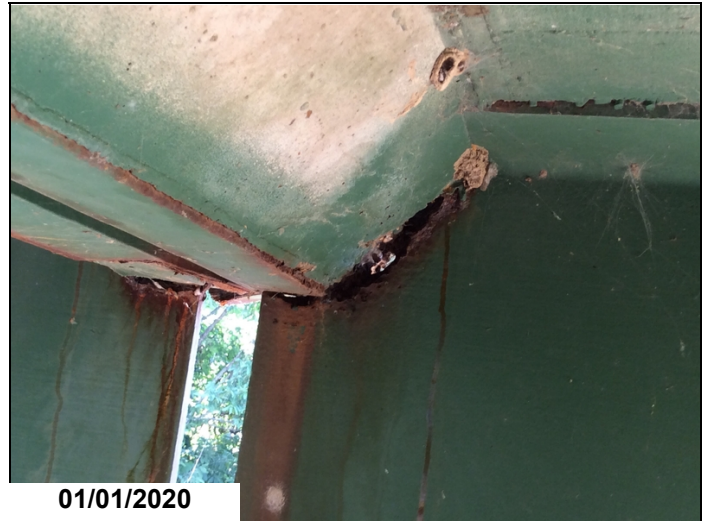
Holes in web below paving haunch @ Girder 4 EOS 13.

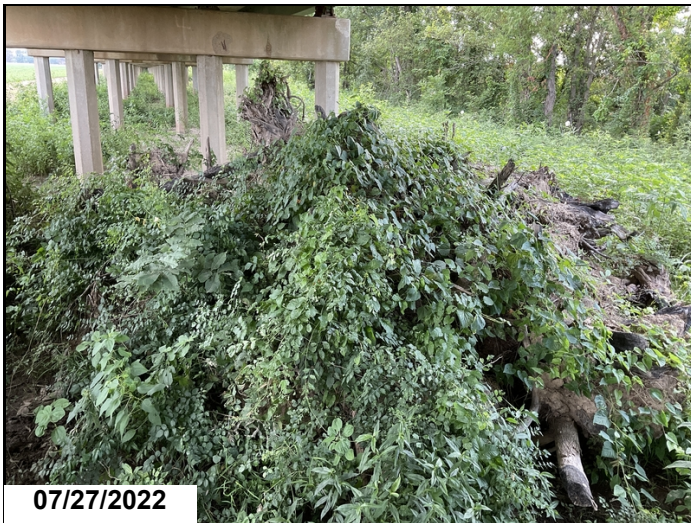
Span 4: Large pile of debris (brush) pushed up in pile under bridge that does not allow snooper access.

Span 4: Large pile of debris (brush) pushed up in pile under bridge.

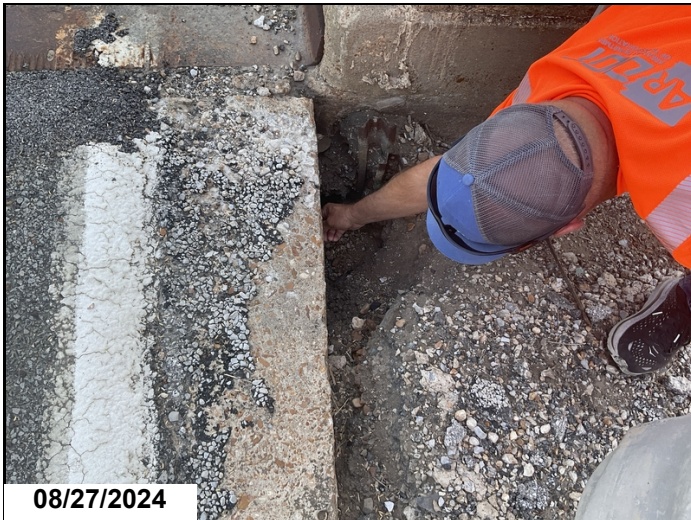
Voids are present under the approach slabs at both abutments. Penetration is unknown at abutment 1. Abutment 2 left is unknown, right is 4'

Abutment 1, right: 6' folding rule inserted all the way. Left side similar. Void presumed to go all the way across.

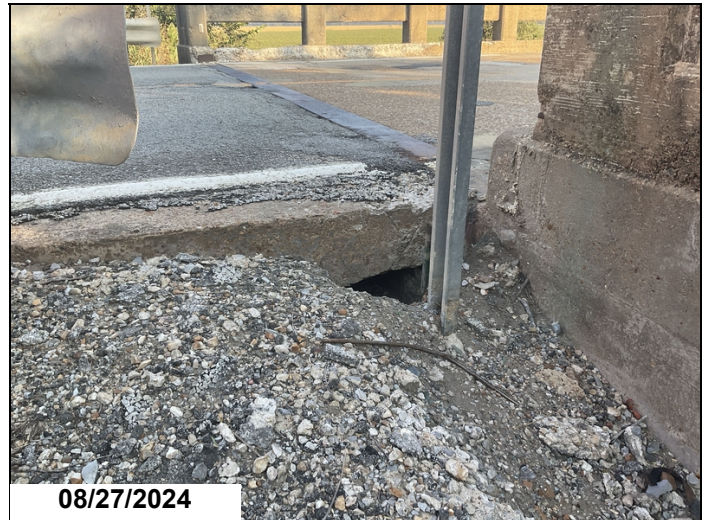
Abutment 1, right: voids under approach slab.

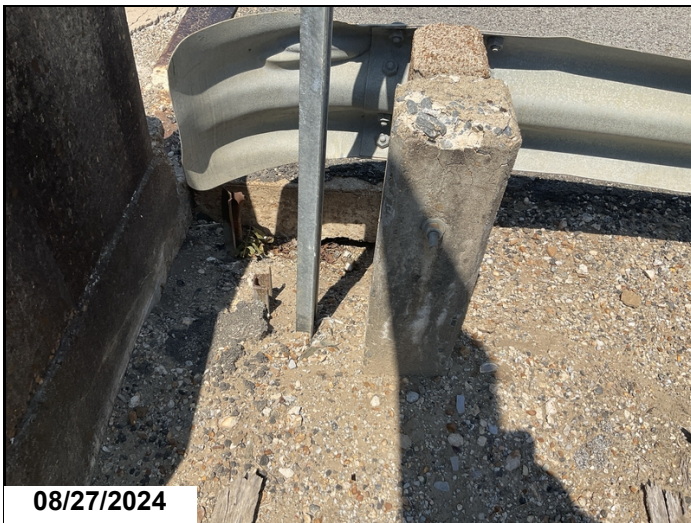
Full 6' ruler inserted into voids without reaching the end.

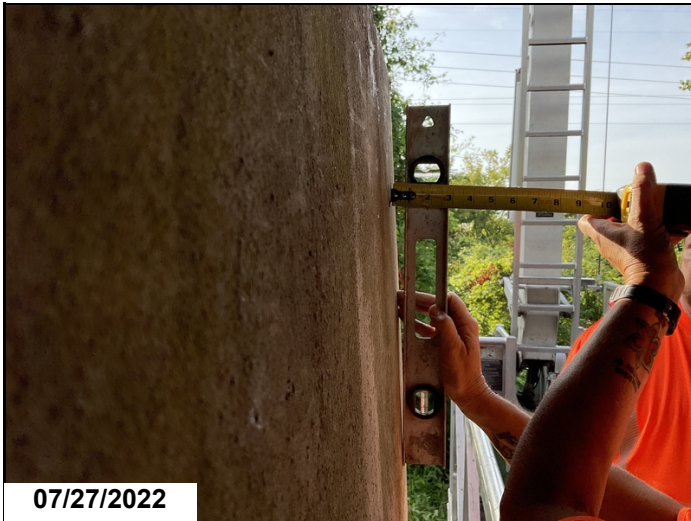
Pile Bents

Bents 1 - 7 are rotated 1/4" to 3/4" ahead in 18"
Bent 2.

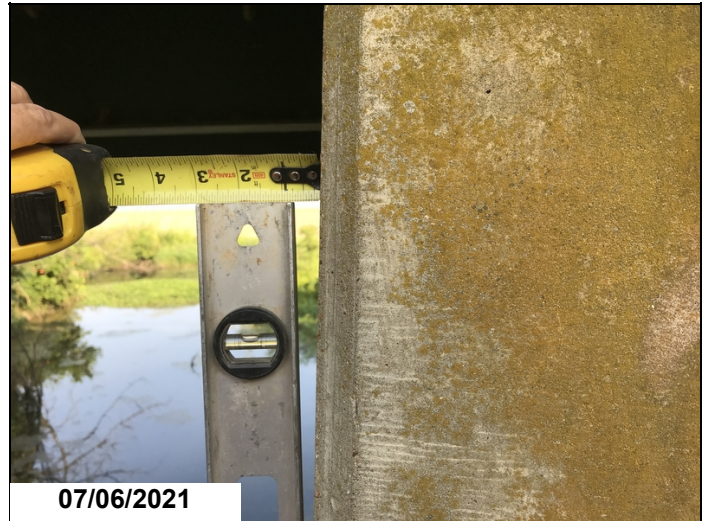
Pile Bents

Bents 1 - 7 are rotated 1/4" to 3/4" ahead in 18"
Bent 2.

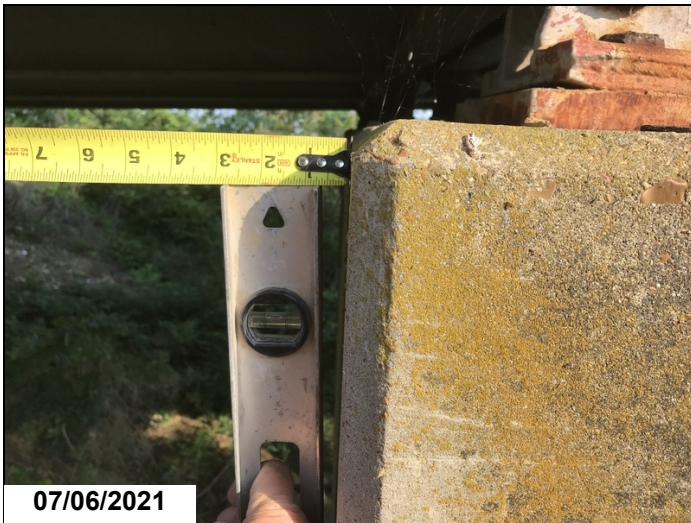
Pile Bents

Bents 1 - 7 are rotated 1/4" to 3/4" ahead in 18"
Bent 1.

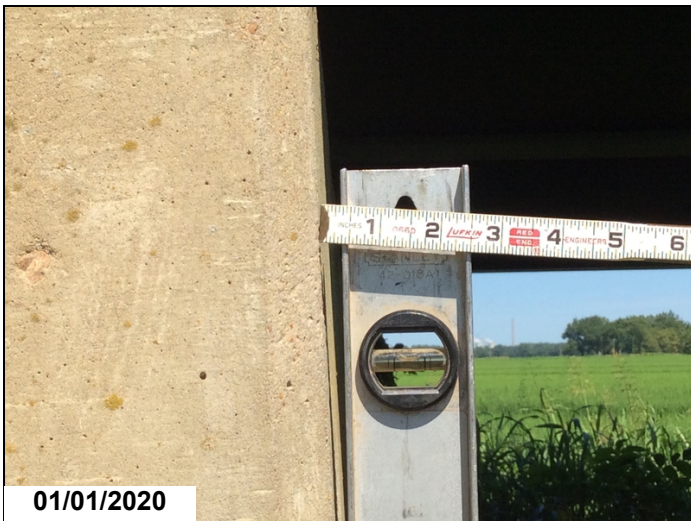
Typical out of plumb Bent.

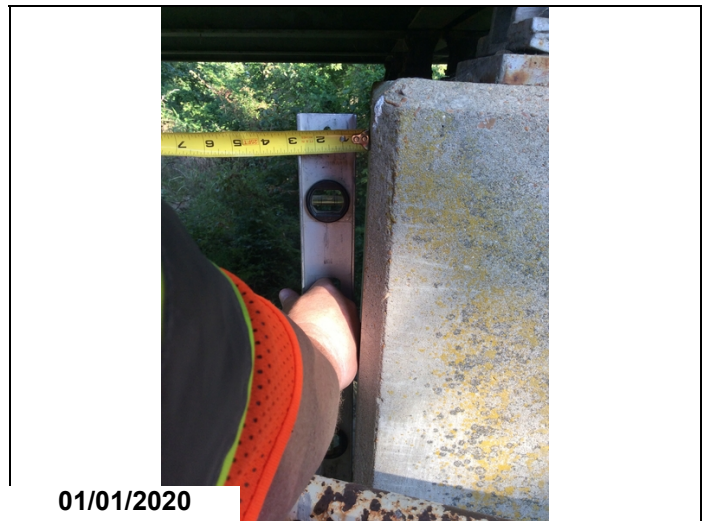
Bent 1 is rotated ahead 1/2" in 18".
