## Bridge 01884 Inspection Report

Asset #01884(Other Special Recurring)

SH 367/Jackson Co. over WHITE RIVER RELIEF

Team Lead: Floyd Haley Inspection Date: 06/23/2025

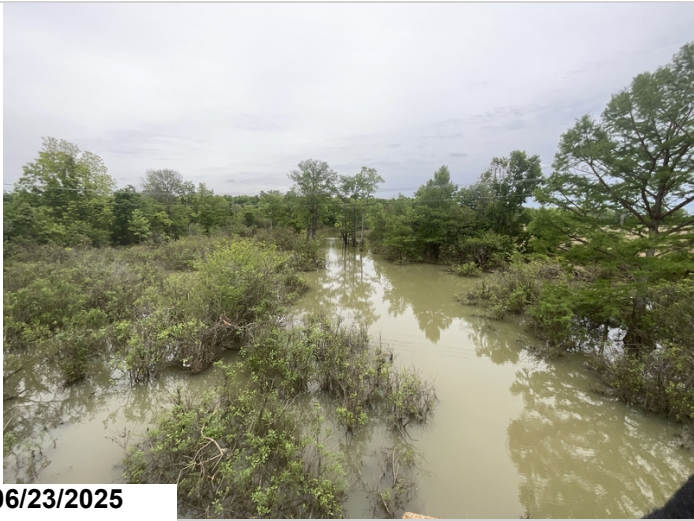
Left side channel view.

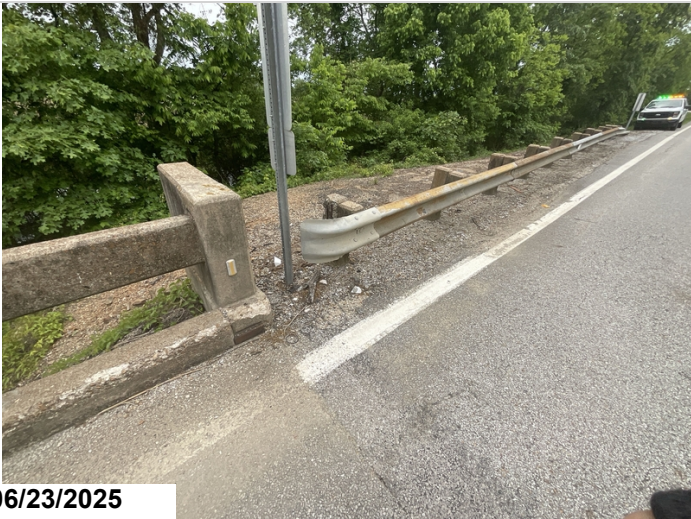
The transitions are not attached to the bridge.

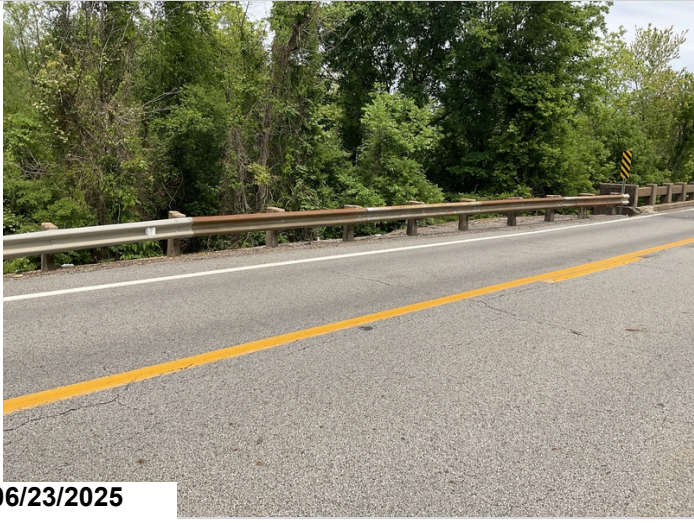
The transitions are not attached to the bridge.

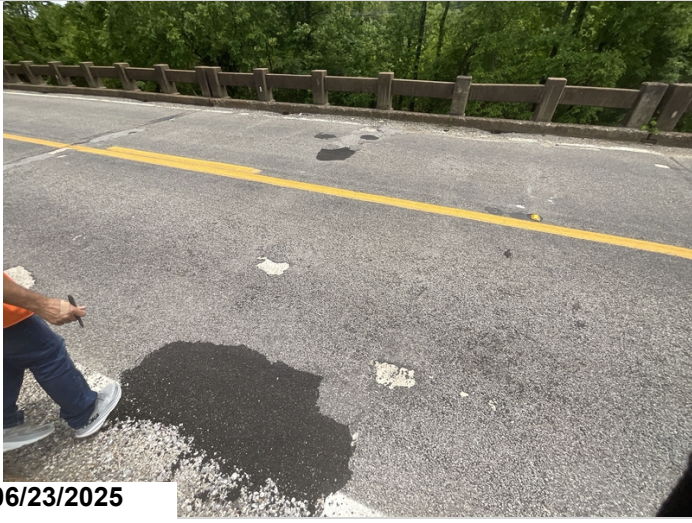
Span 1: Spalls with corroded rebar exposed. 2SF CS3

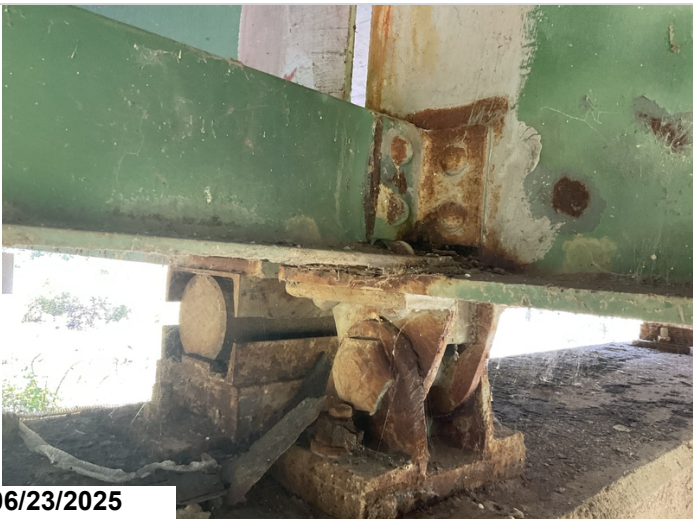
Superstructure is in Poor condition with areas of rust, many having section loss & holes to webs below paving haunches & rust to flanges of girders throughout. There are many areas of peeling paint to girders. As a result, a rating of 4.

Span 8: EOS: Girder 4: Heavy section loss with 3/4" x 1 1/2" hole in web below haunch. 1LF CS4

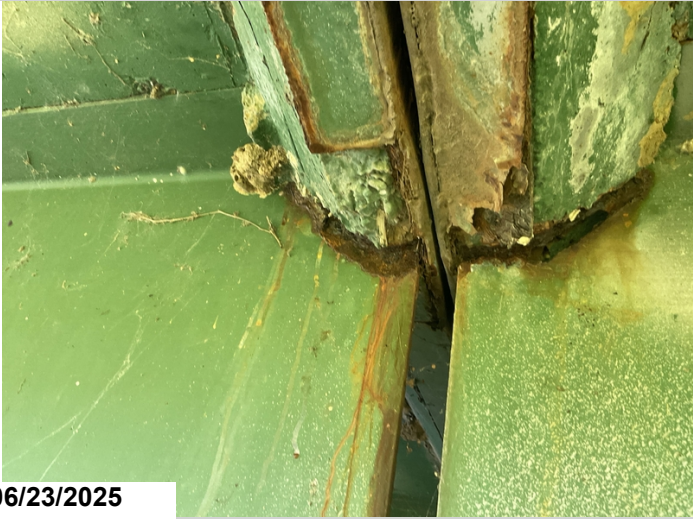
Span 4: EOS: Girder 4: Heavy section loss with 1/2" x 2" hole in web below haunch. 1LF CS4

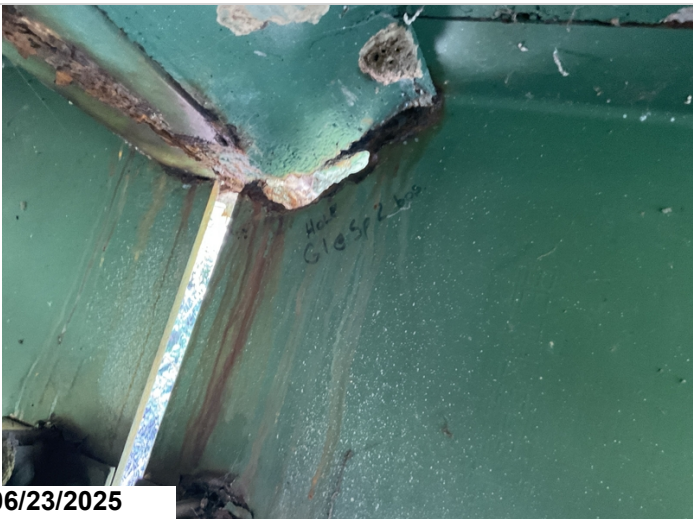
Typical area of minor section loss at the haunches.

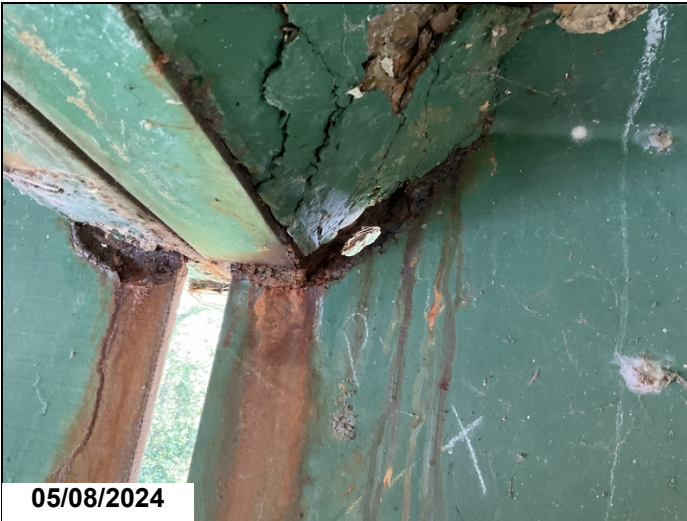
Span 2, Bent 2, Girder 4: 0.5" X 1" Hole in the Web in the Haunch area.

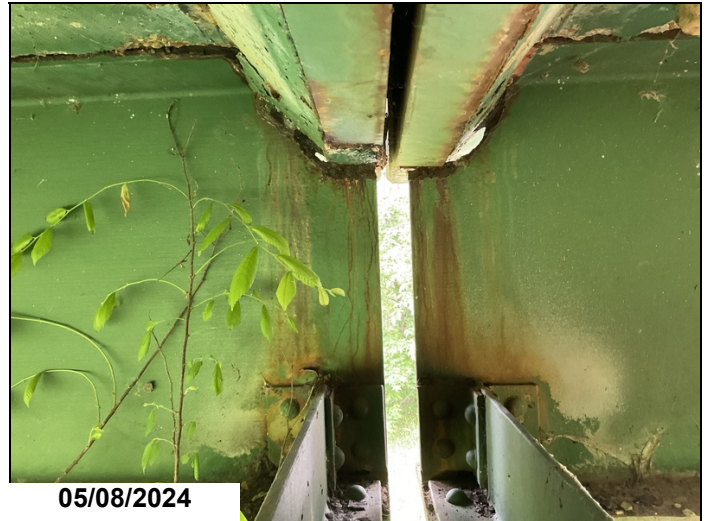
Span 11, Bent 11, Girder 4: 1" X 6" Hole in the Web in the Haunch area.

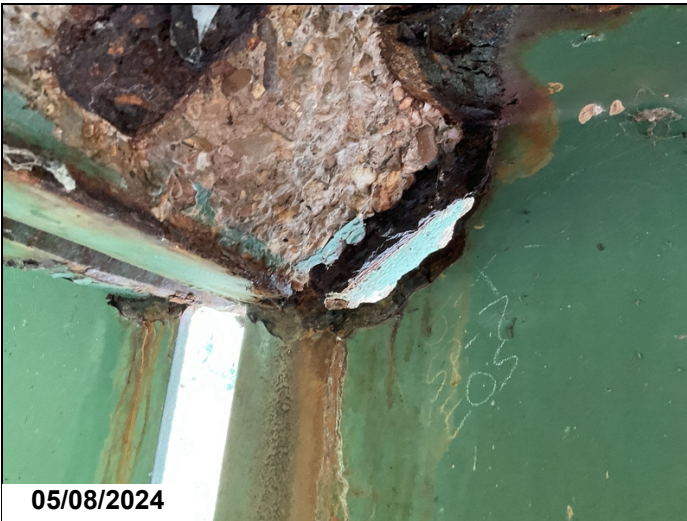
Span 7, Bent 7, Girder 4: 1.25" X 5" Hole in the Web in the Haunch area.

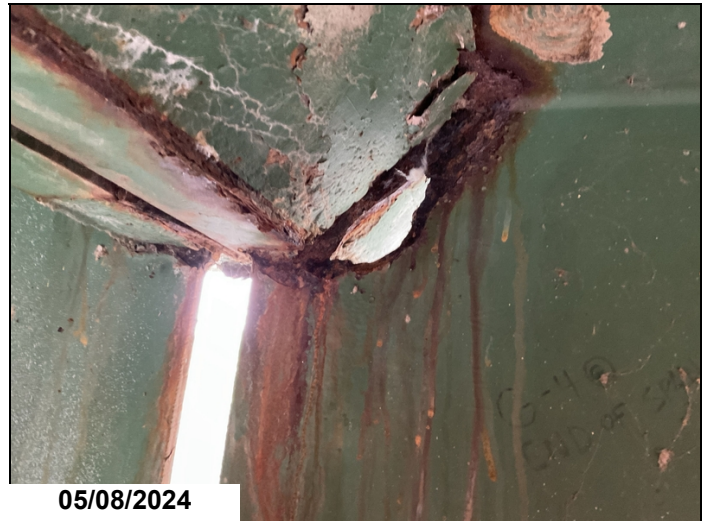
Span 5, Bent 5, Girder 4: 2" X 4" Hole in the Web in the Haunch area.

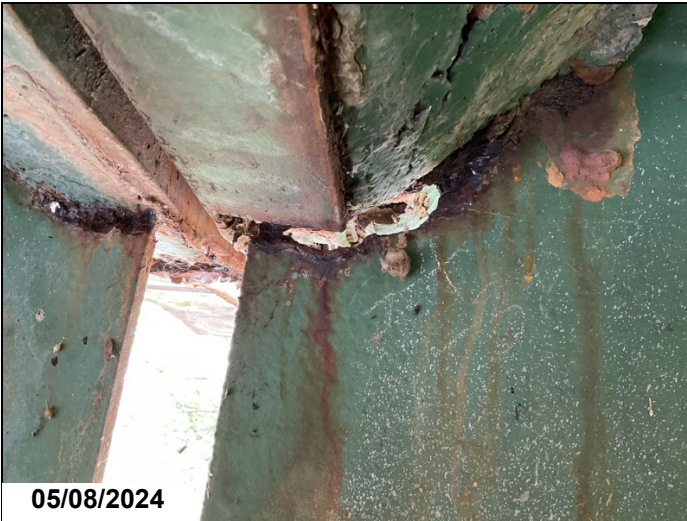
Span 3, Bent 3, Girder 4: 1" X 4" Hole in the Web in the Haunch area.

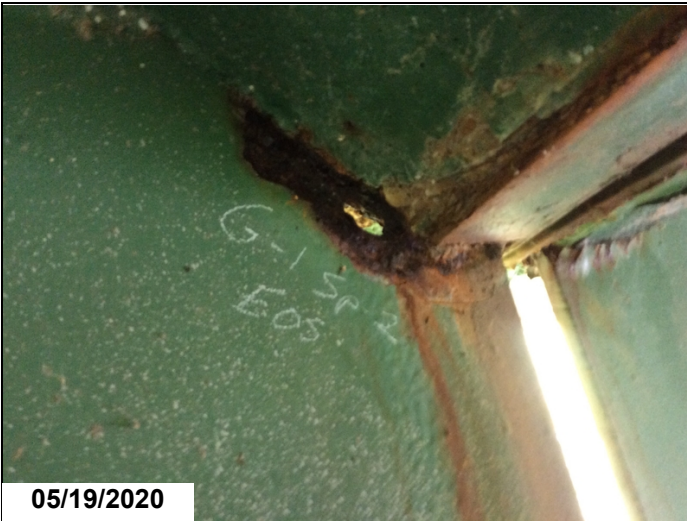
Hole in web @ paving haunch @ Girder 1 end of Span 2.

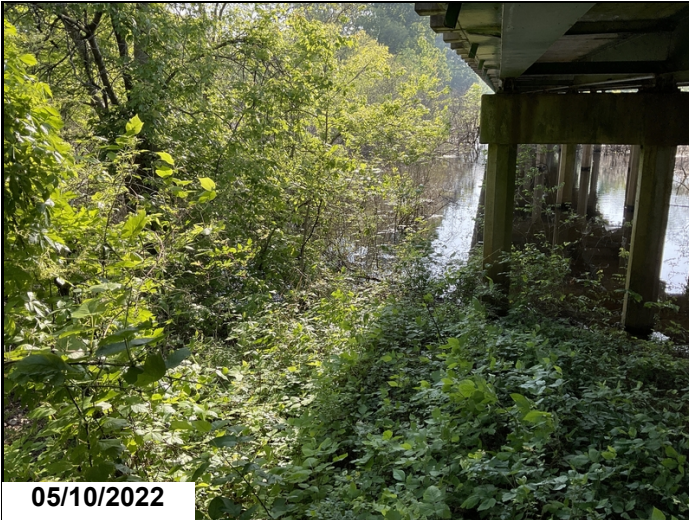
Heavy vegetation on Lt. & Rt. sides @ Spans 1-9.

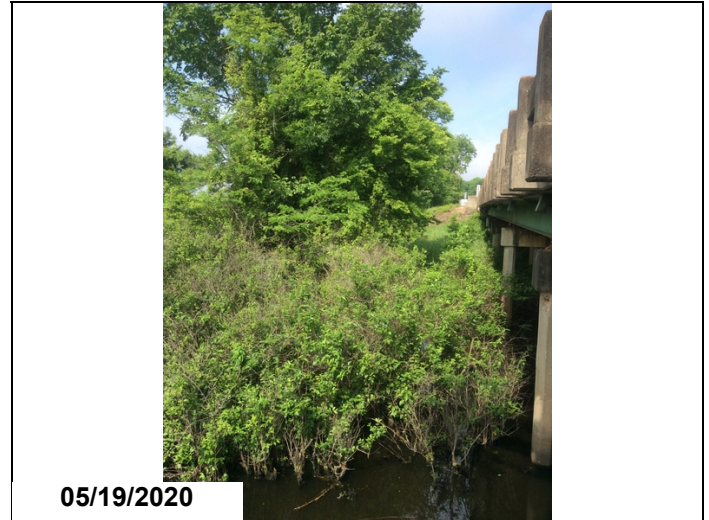
Heavy vegetation on Lt. & Rt. sides @ Spans 1-9.

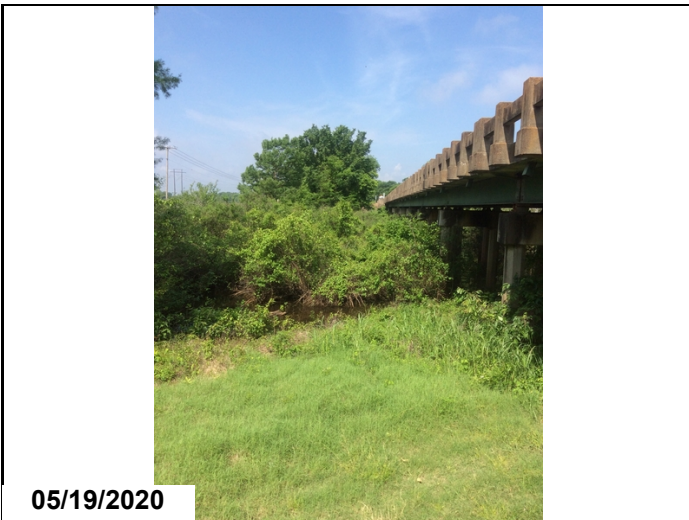
Spans 3 - 8 has heavy vegetation and trees growing along Left & Right sides of bridge.  
(Looking back)

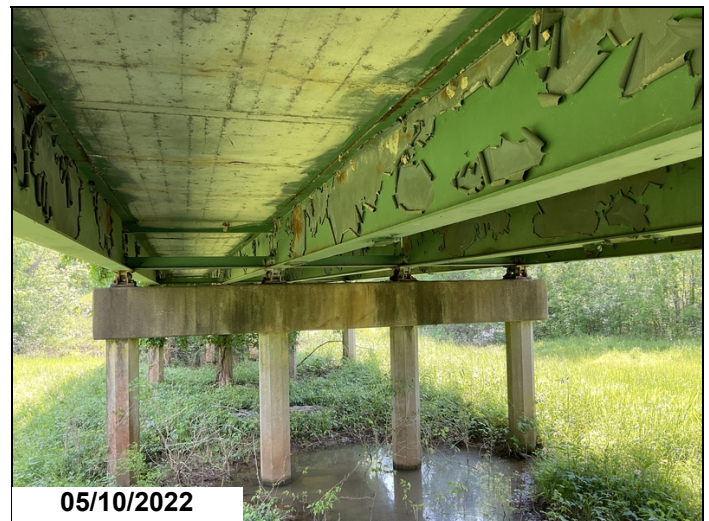
Typical Paint peeling to girders 1-4 @ span 26.
