Bridge 01885 Inspection Report

Route:367 Section:21 Log:6.399

Arnold Road ID:34x367x21xA, Arnold Log mile:6.387

District 05, 67 - Jackson County

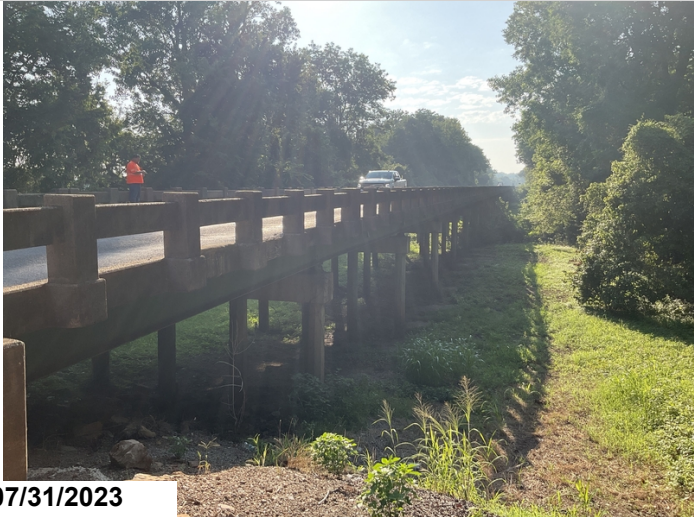
Elevation with the log mile running to the right.

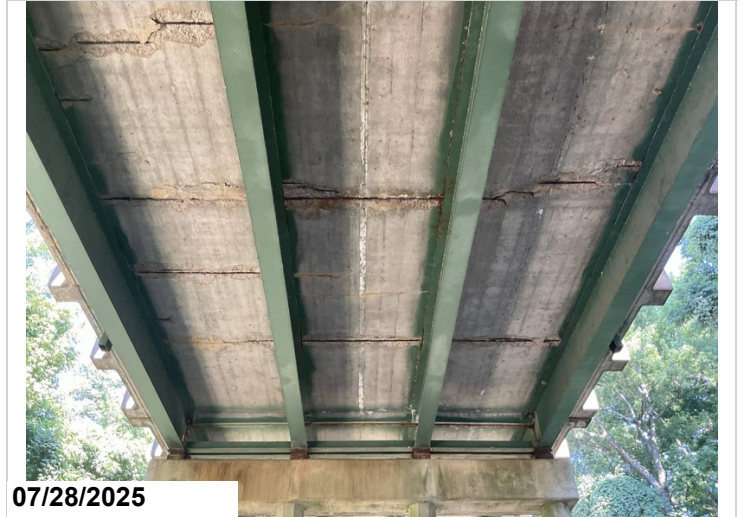
Typical undersurface.

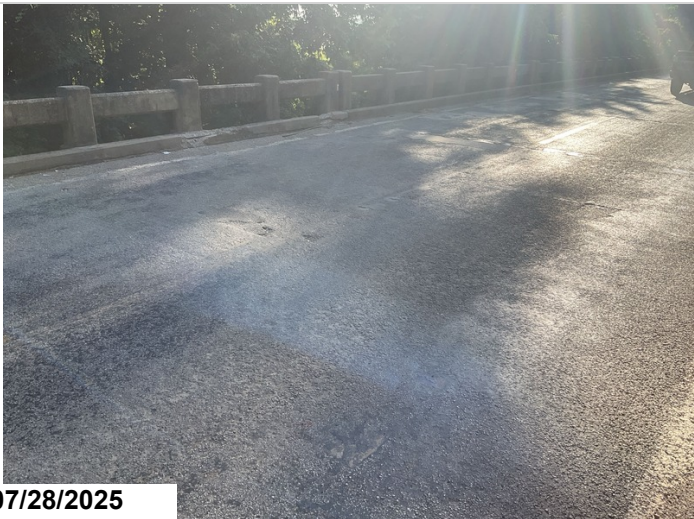
Typical deck

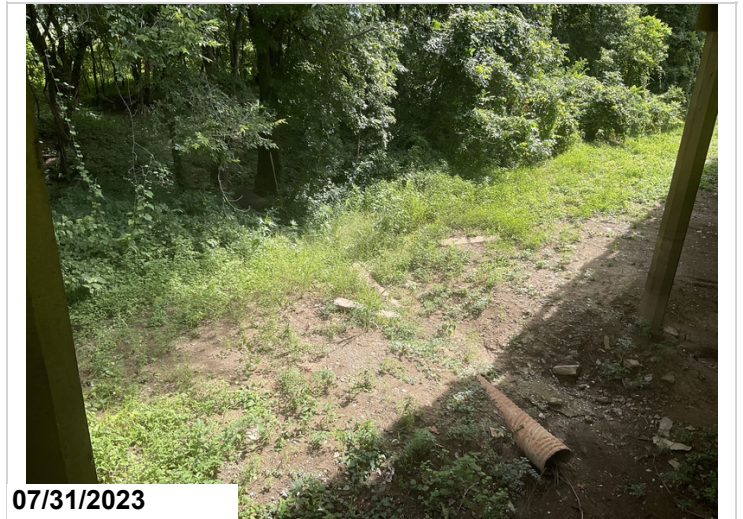
Channel 2, left side view.

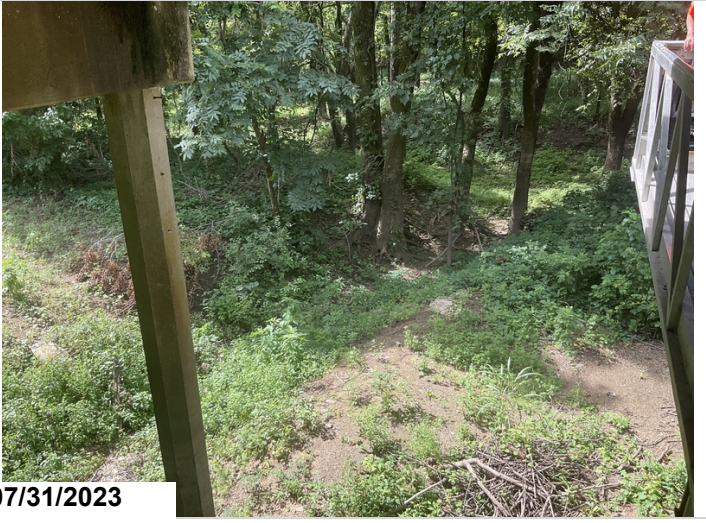
Channel 2, right side view.

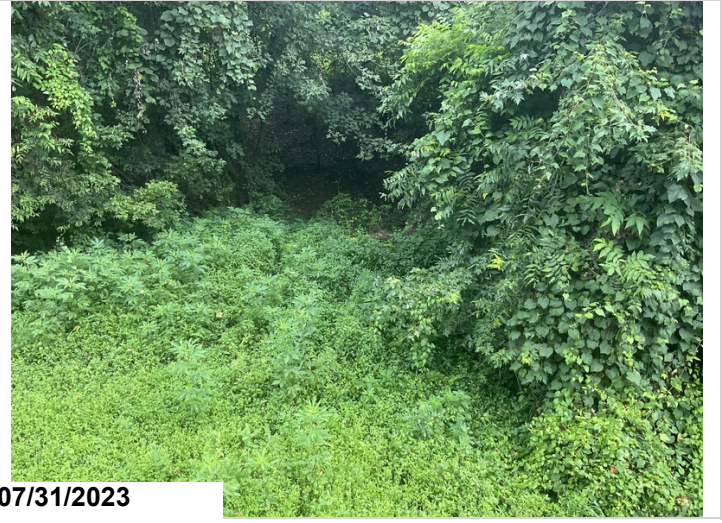
Channel 1, left side view.

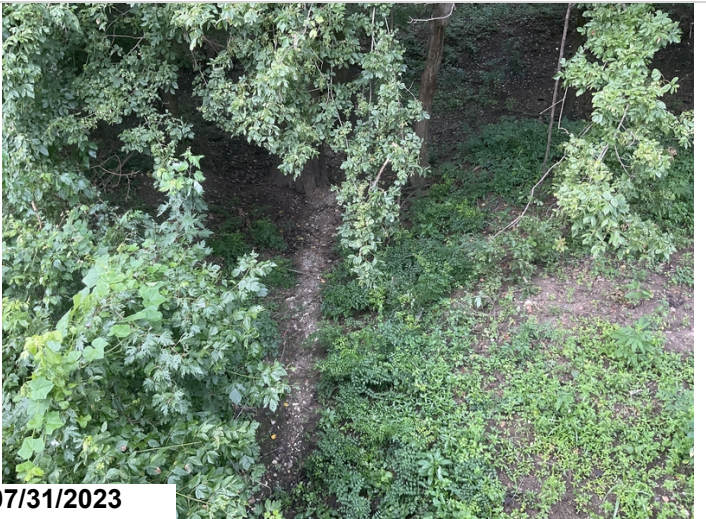
Channel 1, right side view.

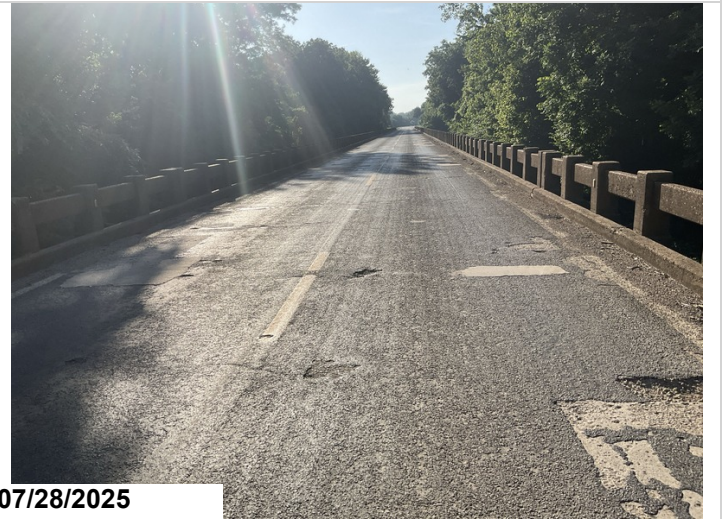
Roadway with Log Mile running Southwest to Northeast.

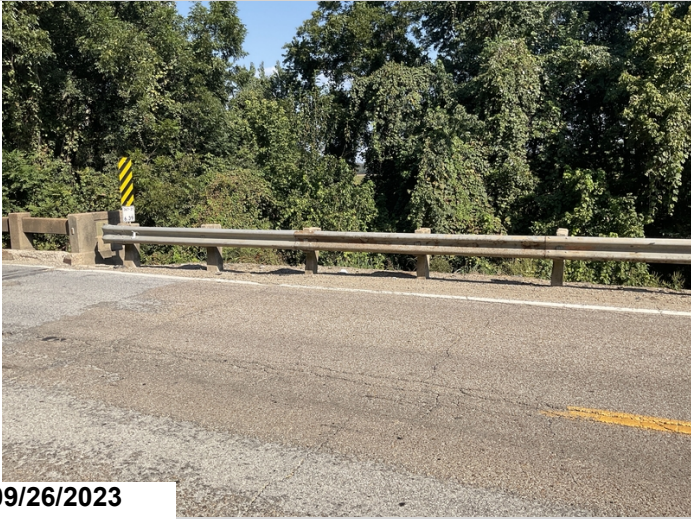
Transitions do not tie into bridge railings.
End of bridge, right side, collision damage.

The transitions do not connect to the bridge.

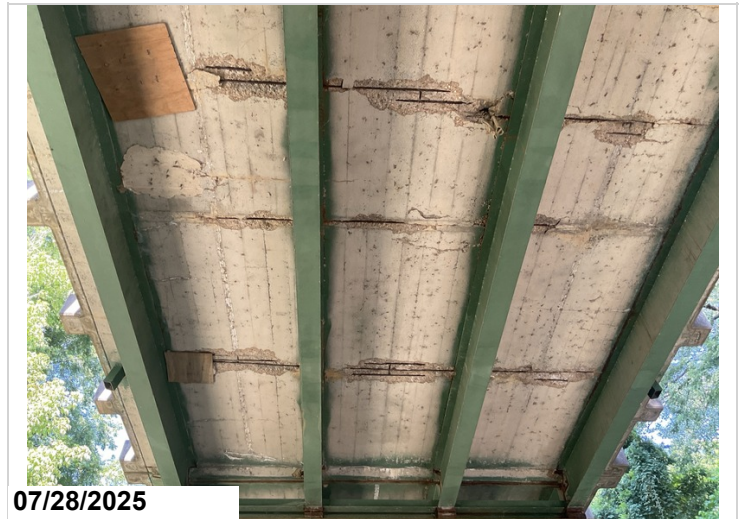
Typical undersurface with exposed rebar and efflorescence.

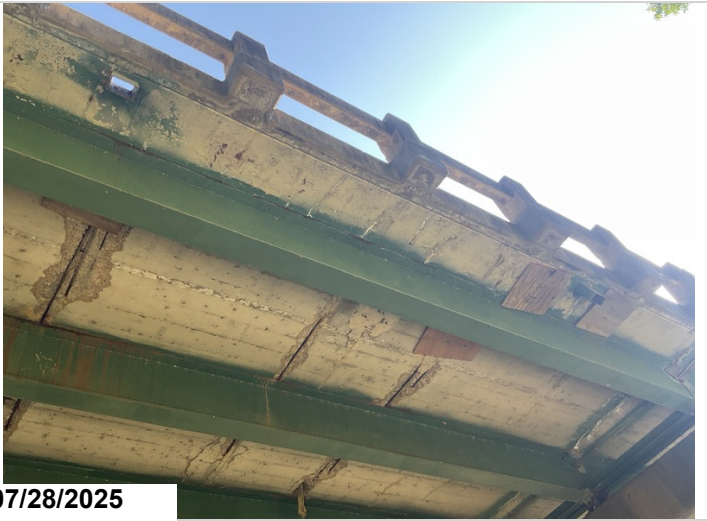
Typical overhangs with efflorescence and exposed rebar.

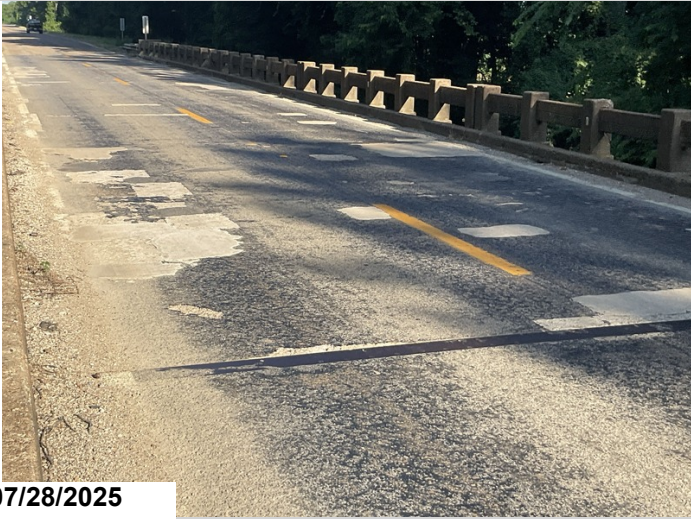
Span 5: has widespread patches and scattered spalls.
139SF CS2 | 17SF CS3

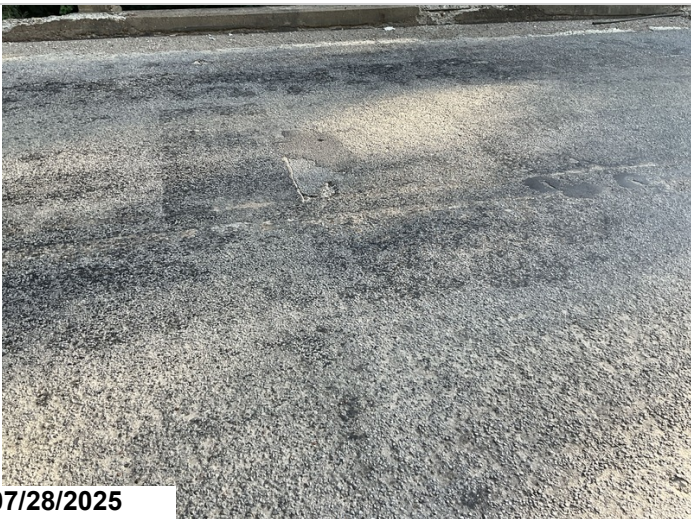
Typical unsound patch.

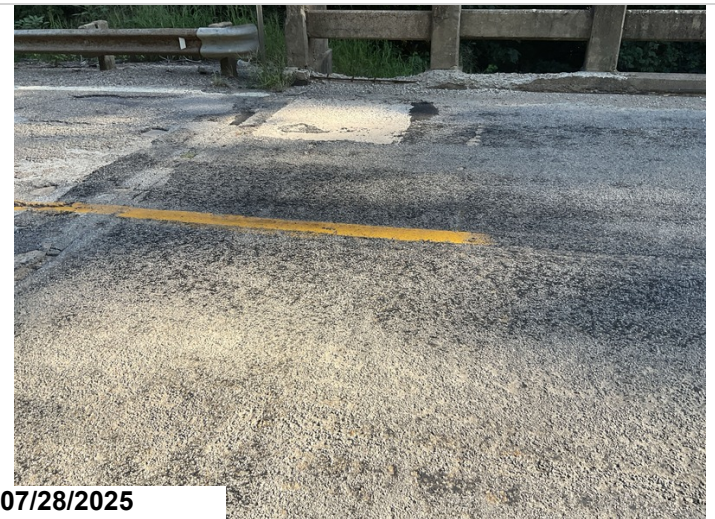
Typical patched areas of the driving surface.

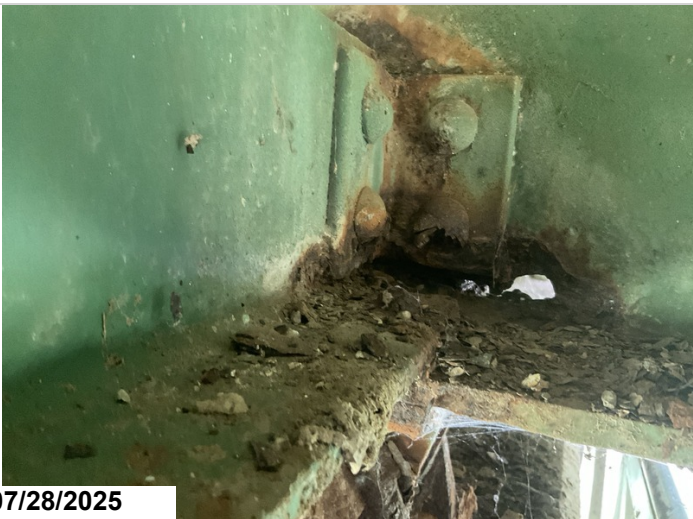
07/28/2025

Span 9, bent 9, girder 3: has section loss at the haunch and diaphragm areas with a 1" x 4" hole in the web at the haunch and a 3/4" x 5" hole in the web at the diaphragm. 1LF CS4

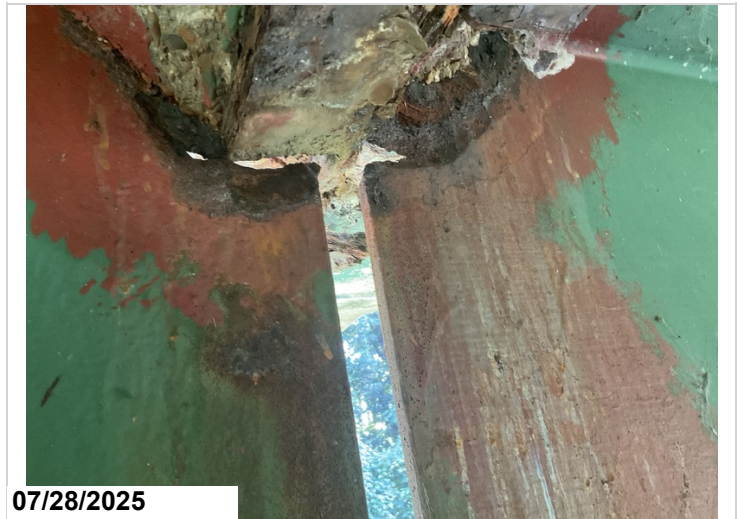
07/28/2025

Span 7, bent 7, girder 1: has section loss at the haunch with a 1/2" x 3" hole in the web. 1LF CS4

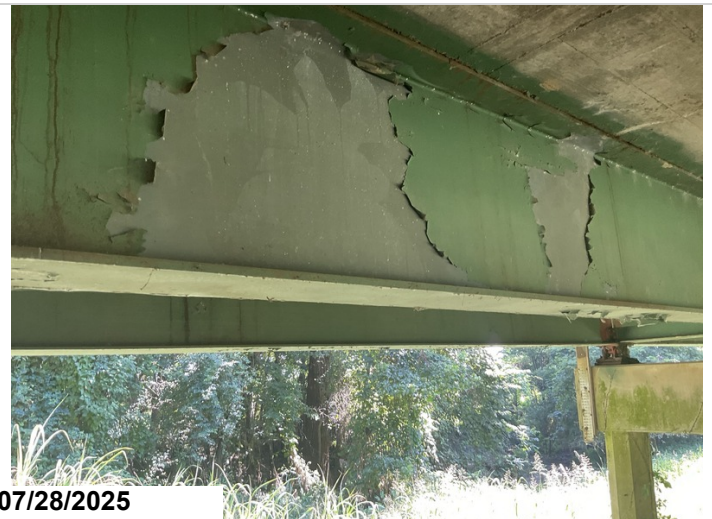
07/28/2025

The girders have areas of peeling paint throughout. 1040SF
CS3

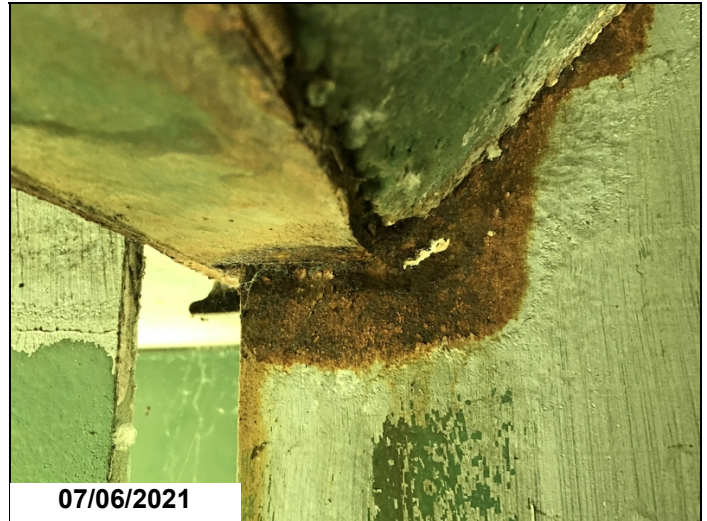
Severe section loss to Girder 3 & 4 with hole in web
below haunch @ Bent 21.
Girder 3. - 2021

2025 - Span 21, bent 21, girder 3: has section loss at the
haunch with a 1/2" x 1 - 1/2" hole in the web. 1LF CS4

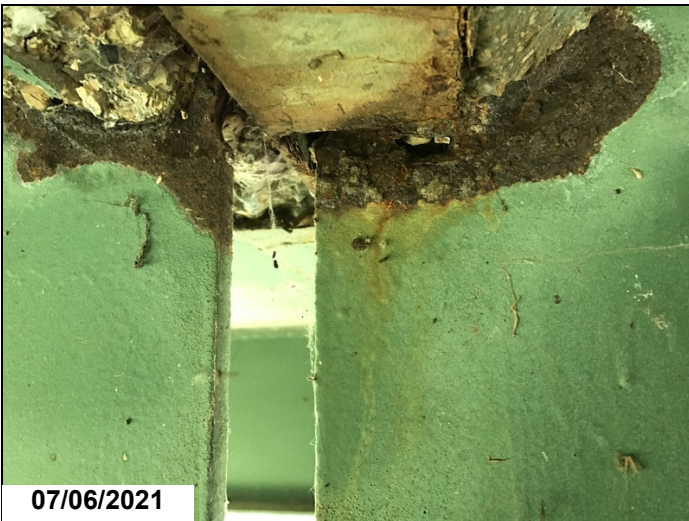
Severe section loss to Girders 2 & 3 with holes in web
below haunch @ Bent 17 & 19.
Bent 19, girder 2, 3, & 4. - 2021

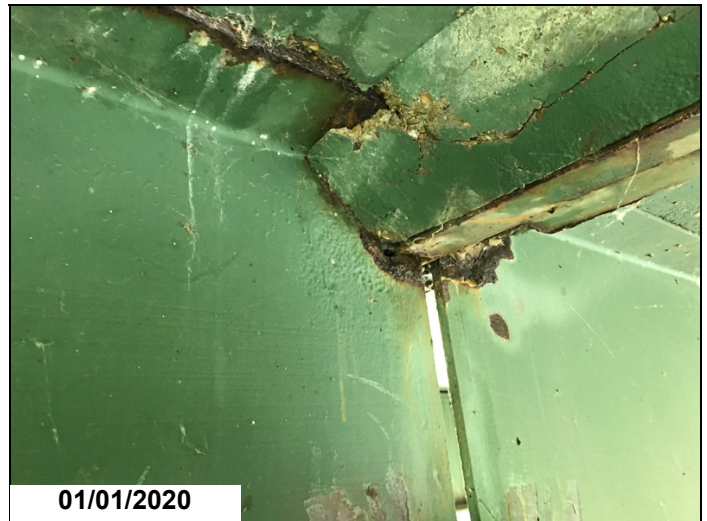
Small hole @ end of Girder 2 @ haunch area @ Bent 19.
- 2020

2025 - Span 19, bent 19, girder 2: has section loss at the
haunch with a 1" x 4" hole in the web. 1LF CS4

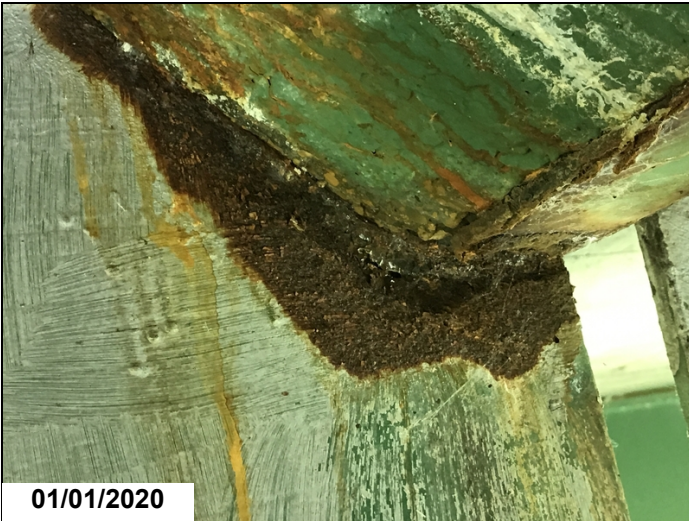
Severe section loss to end of Girder 3 with hole in web below haunch @ Bent 21. - 2020

2025 - Span 21, bent 21, girder 3: has section loss at the haunch with a 1/2" x 1 - 1/2" hole in the web. 1LF CS4

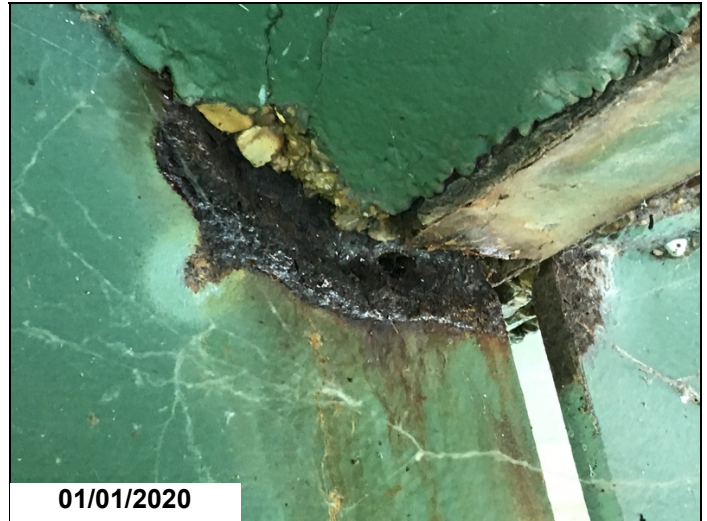
Small hole @ end of Girder 3 @ haunch area @ Bent 19. - 2020

2025 - Span 19, bent 19, girder 3: has section loss at the haunch with a 3/4" x 2" hole in the web. 1LF CS4

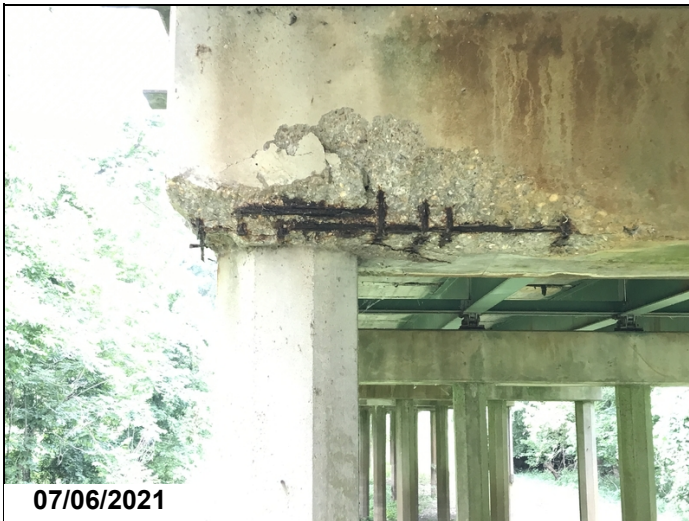
Cracks, delaminated areas & spalls with rebar exposed to caps at Bents 3, 12, 14, 15, 16 - 24.
Ahead side of bent 22 @ pile 4.

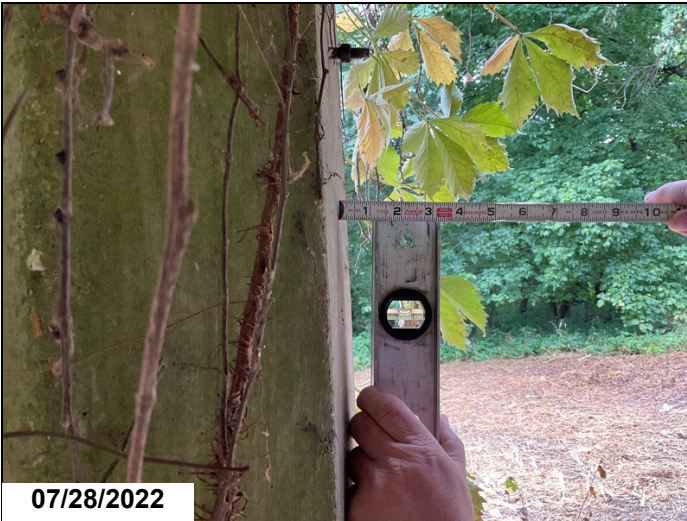
Bent 1, pile 1 is out of plumb

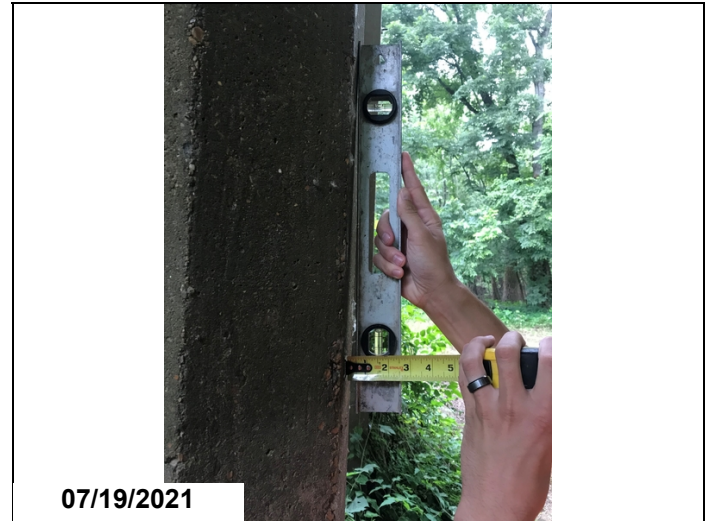
Bent 25, pile 3 is out of plumb.

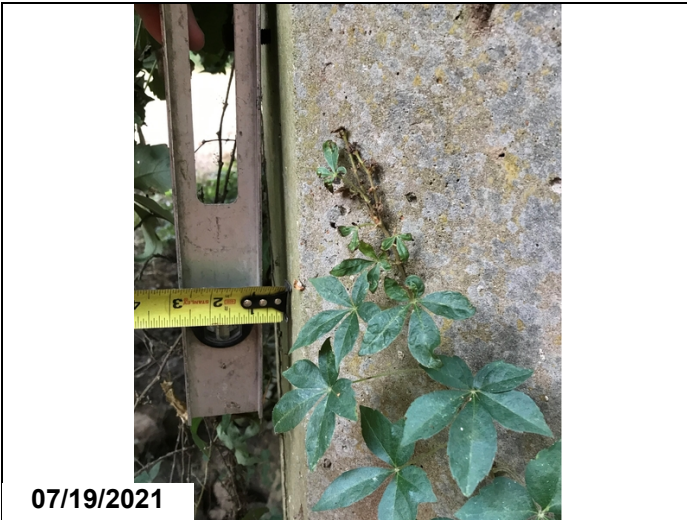
Bent 1, pile 1 is out of plumb

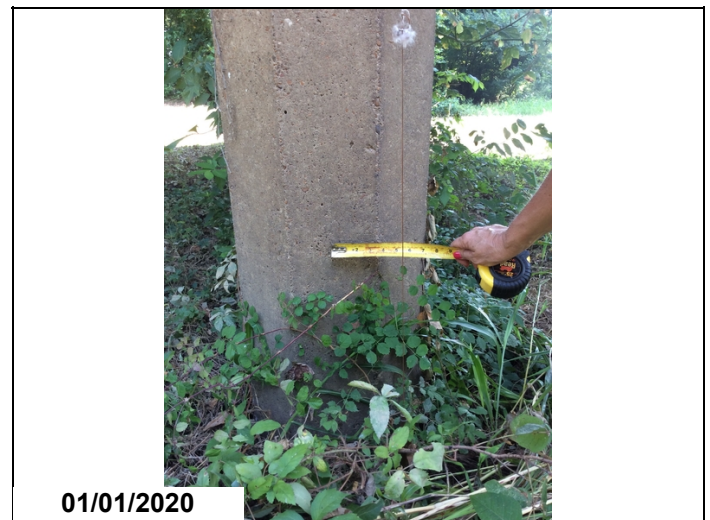
Bent 2 out of plumb.

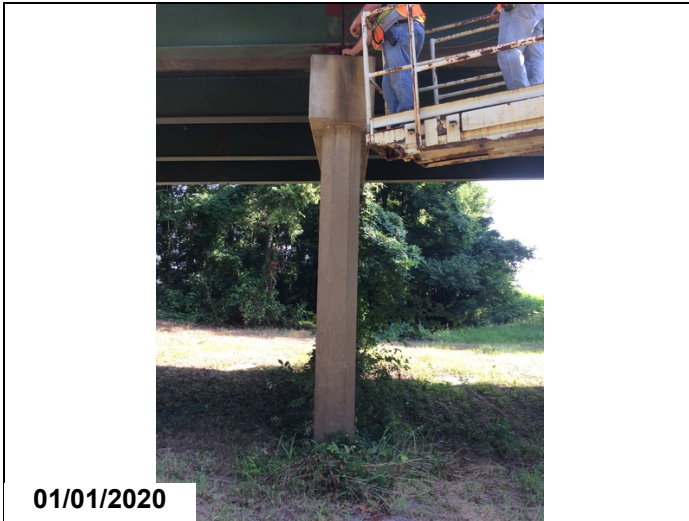
Bent 2 out of plumb.

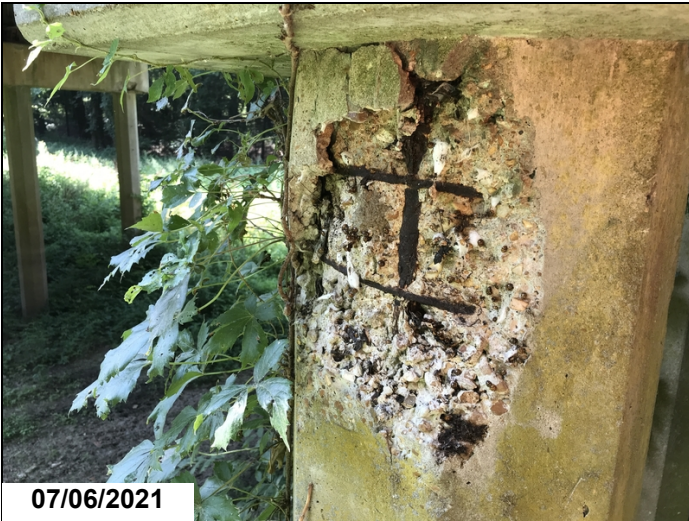
Cracks, delaminated areas & spalls with rebar exposed to
Piles at Bents 1, 2, 6 - 12, 14, 15, 17, 19 - 21, 23.
Pile 1 @ bent 2.

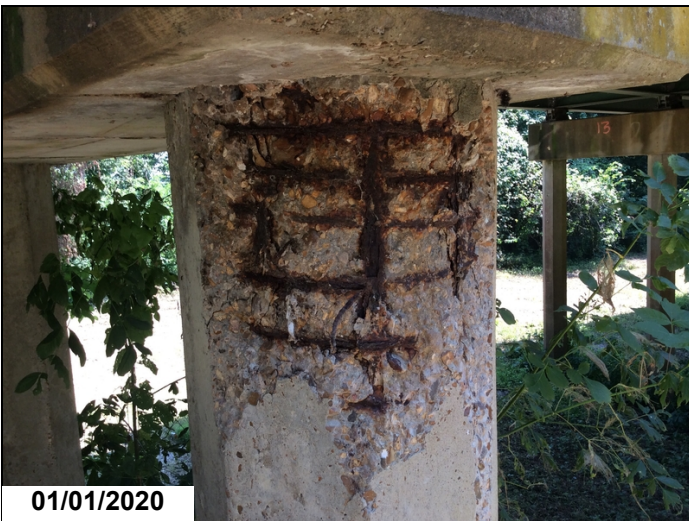
Pile 4 at Bent 12 spalled at top with 6' of exposed rebar
with 100% section loss.

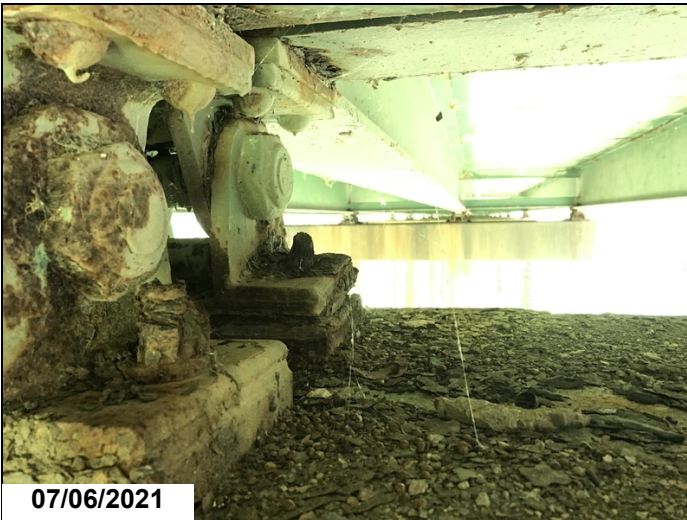
All bearings have heavy rust and section loss with flaking and pack rust.
Bearings are missing anchor bolts and/or nuts at:
Bent 1, girder 3: has anchor bolt nut missing on the back side.
Bent 5, girder 2: has anchor bolt nut missing on the ahead side.
Bent 6, girders 3 & 4: have anchor bolt and nuts missing on the ahead side.
Bent 7, girders 3 & 4: have anchor bolts and nuts missing on the ahead side.
Bent 8, girder 3: has 2 anchor bolt nuts missing on the ahead side..
Bent 11, girder 2: has 1 anchor bolt nut & 2 anchor bolts missing on the ahead side.
Bent 19, girder 4: has 1 anchor bolt nut missing on the ahead side.
Bent 20, girder 4: has 2 anchor bolts & nuts missing on the ahead side.
Bent 21, girder 3: has anchor bolt & nut missing on the ahead side.

Bent 19 - Girder 3 & 4 has 1 anchor bolt nut missing on ahd. side.

Type of Work: Bearing Repair/Replacement

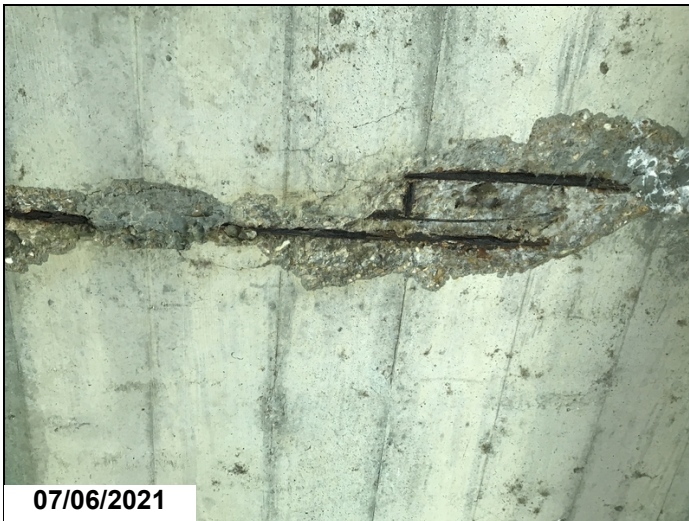
The undersurface has heavy spalling with exposed rebar, as well as efflorescence and rust-stained cracks throughout.

07/06/2021
Spalls with rebar exposed to deck below & to left & right overhang at all spans.
Span 5, between girders 3 & 4.

Type of Work: Deck Repair

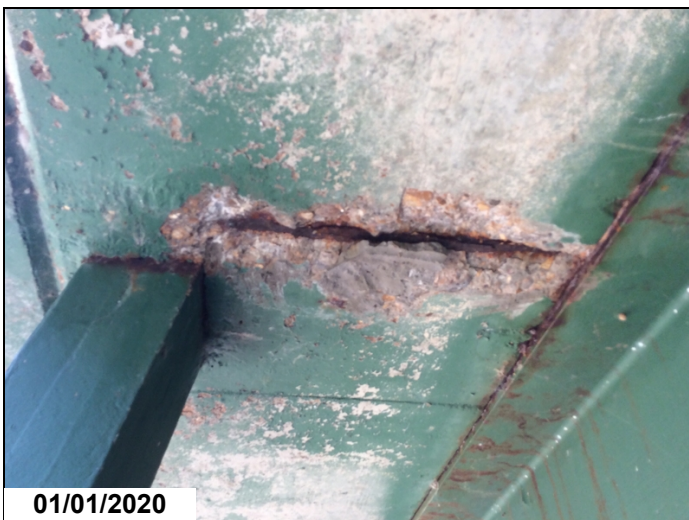
01/01/2020
Typical spall with exposed rebar to overhangs.
