Asset #01381(Routine, NSTM)

US67 Sec4 Lm 0.01 over LITTLE MISSOURI RIVER

Team Lead: John Parks Inspection Date: 01/24/2023

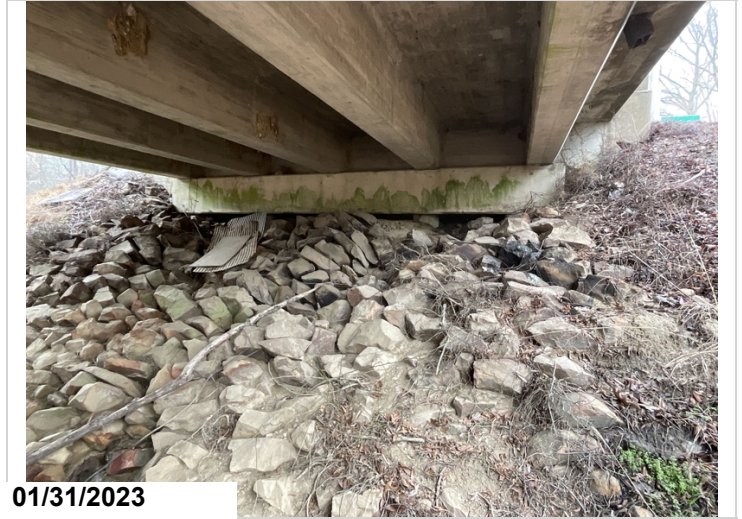
Bent 28 abutment, embankment has settled below the cap.

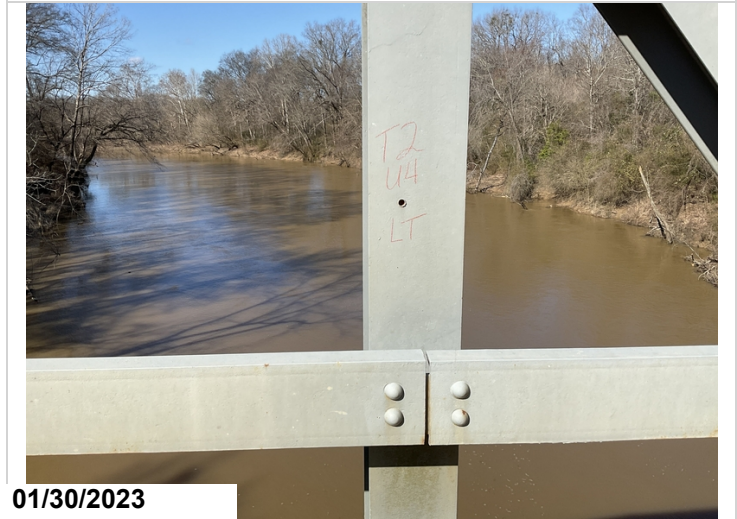
Bullet Hole in upright

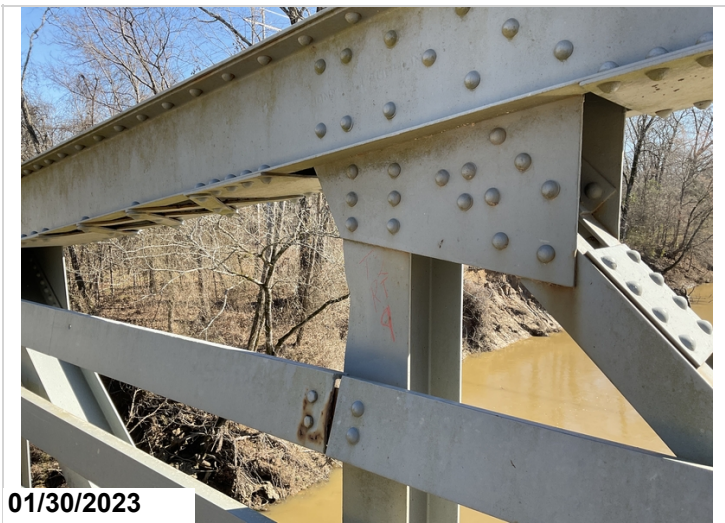
Traffic impact.

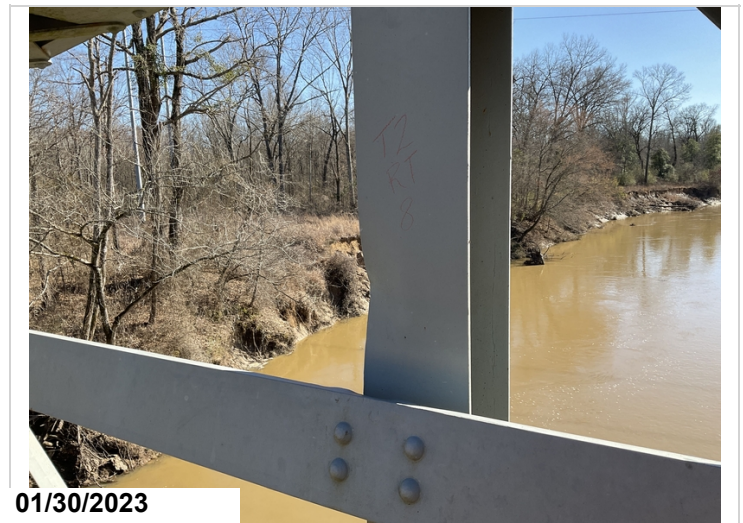
Traffic impact.

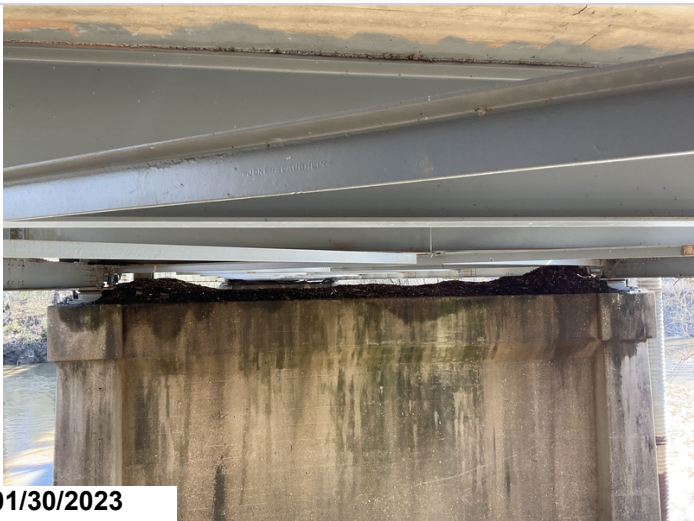
Top of caps full of debris.

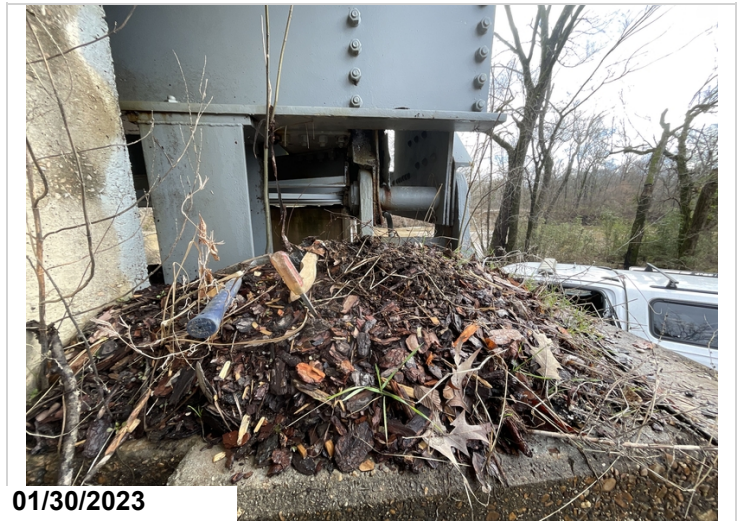
Bent 11, debris built up around the bearings.

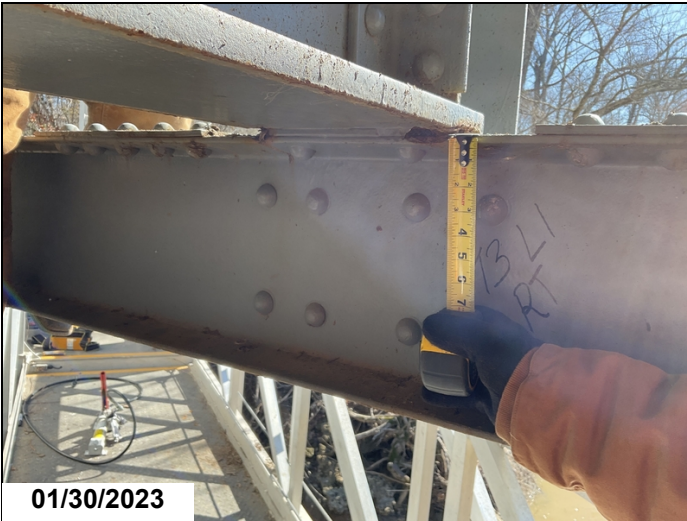
T3 L1 Rt. Inside C-channel of lower chord. Pitting to bottom flange & web upto 1/4" deep.

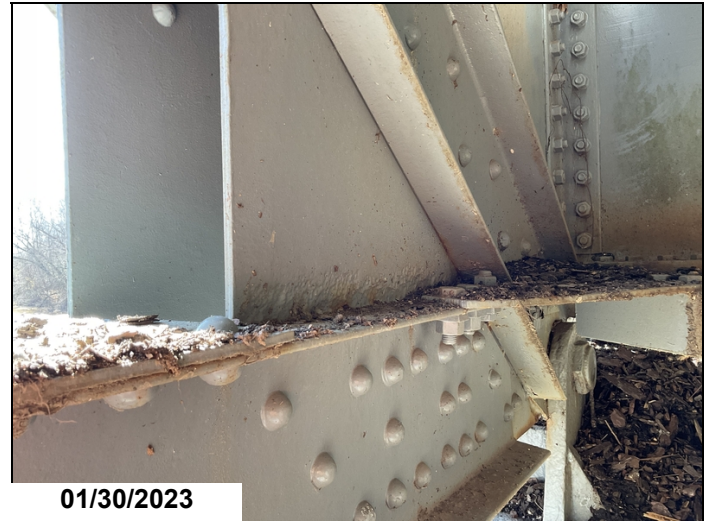
T3, L0, RT, gusset plates have 1/8" pitting, LT IS SIMILAR.

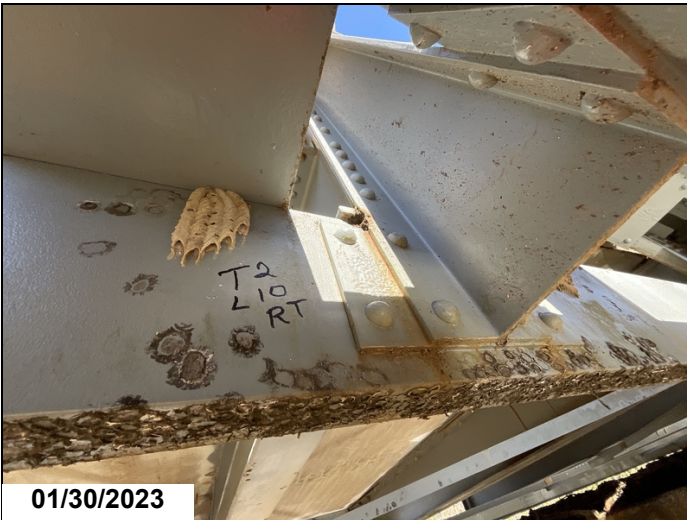
T2 L10 Rt. Inside C-channel of lower chord. Top flange & web, pitting upto 1/4" deep.

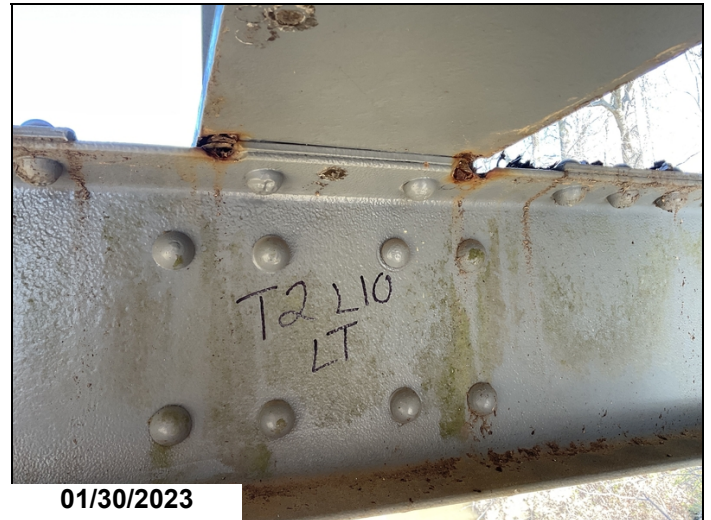
T2 L10 Lt. Inside C-channel of lower chord. Pitting to bottom flange & web upto 1/4" deep.

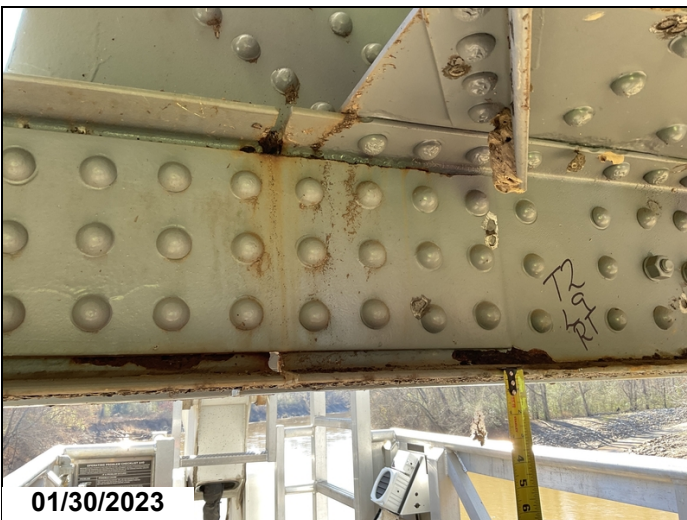
T2 L9 Rt. Inside C-channel of lower chord. Pitting to bottom flange & web upto 1/4" deep.

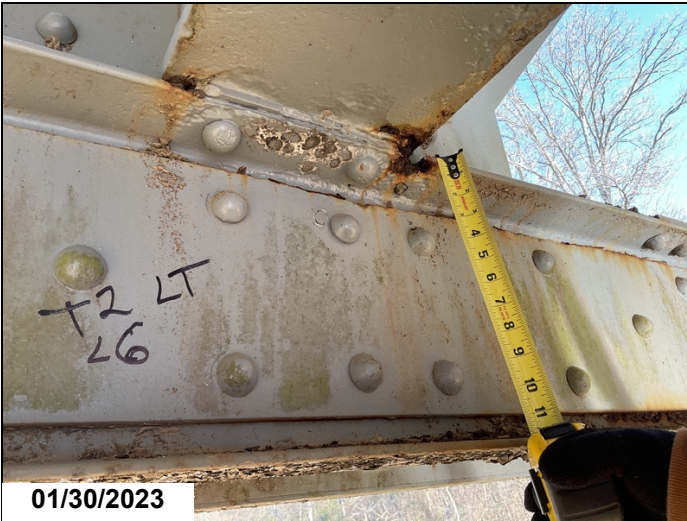
01/30/2023
T2 L6 Lt. Inside C-channel of lower chord. Top flange 1/2" hole in the outside of the top flange.

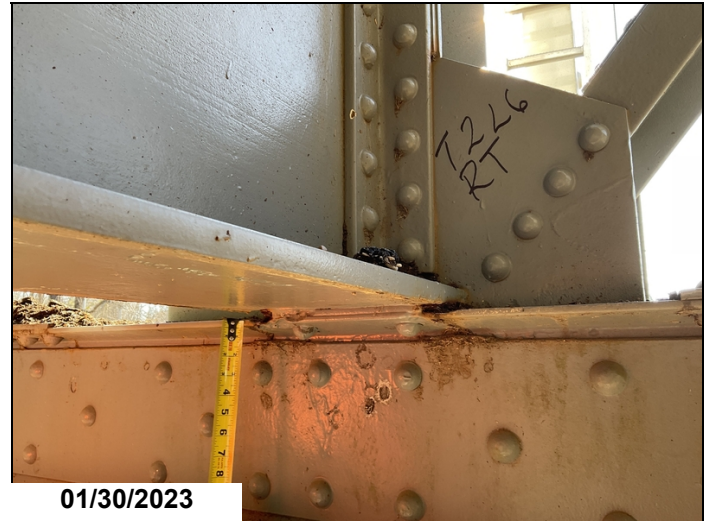
01/30/2023
T2 L6 Rt. Inside C-channel of lower chord. Top flange pitting upto 1/4".

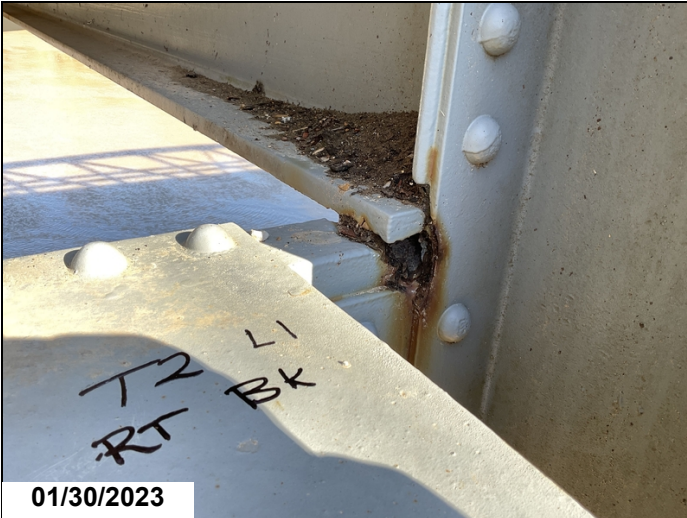
01/30/2023
T2 L1 Rt. Inside C-channel of lower chord. Pitting to top flange & web 3/8" deep.

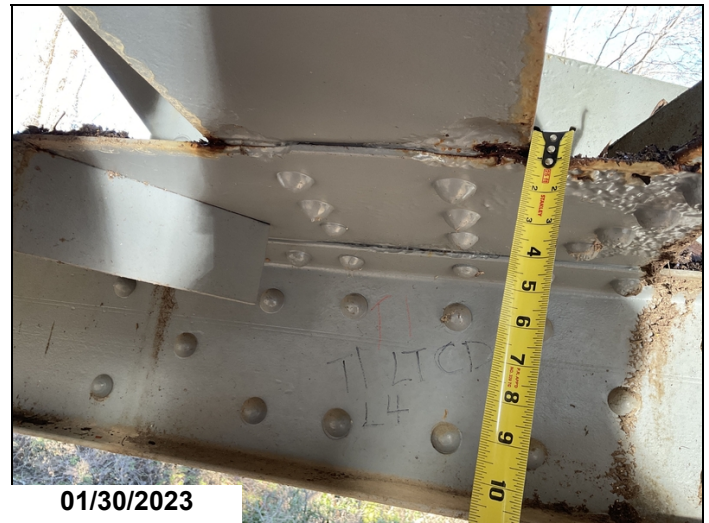
T1 L4 Lt. 3/8" section loss lower flange of floor beam.

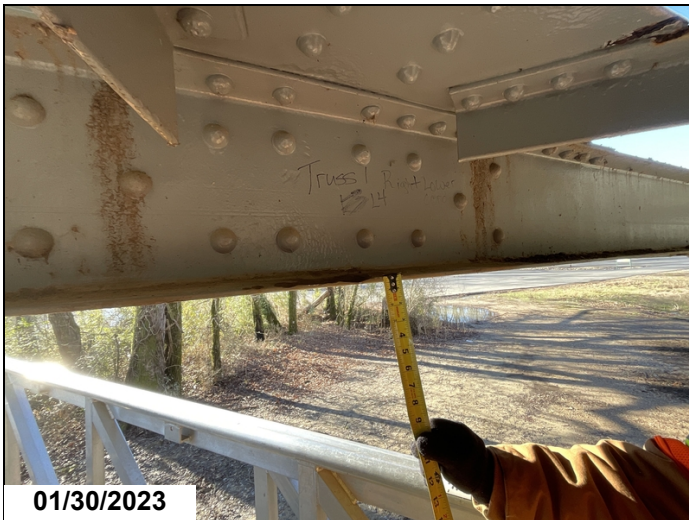
T1 L4 Rt. Inside C-channel of lower chord. Bottom flange of inside cord down to knife edge.

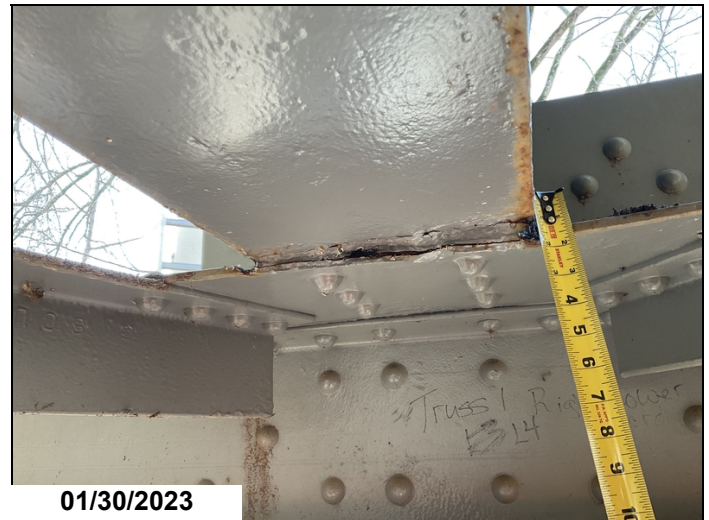
T1 L4 Rt. 3/8" section loss lower flange of floor beam.

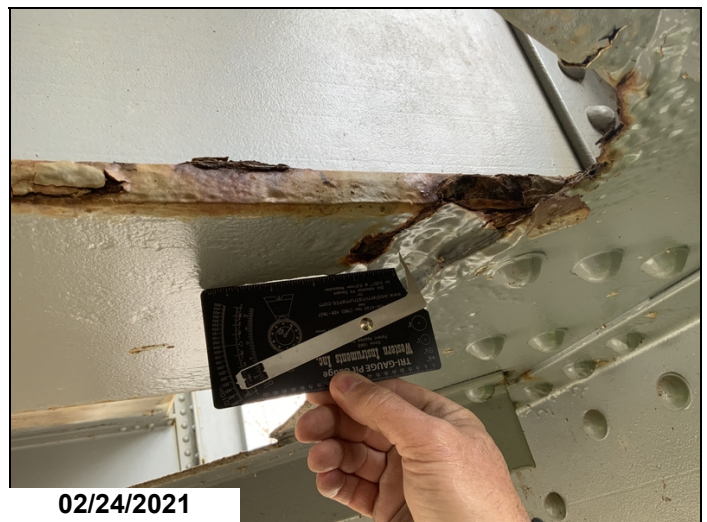
Right side truss 1, fb 6, 3/8 in section loss, in bottom flange

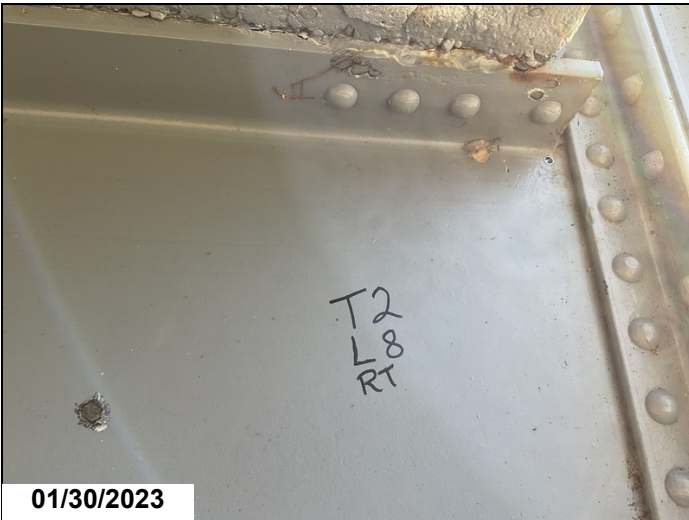
T2 L8 Rt. Crack repaired, hole drilled & arrester installed.

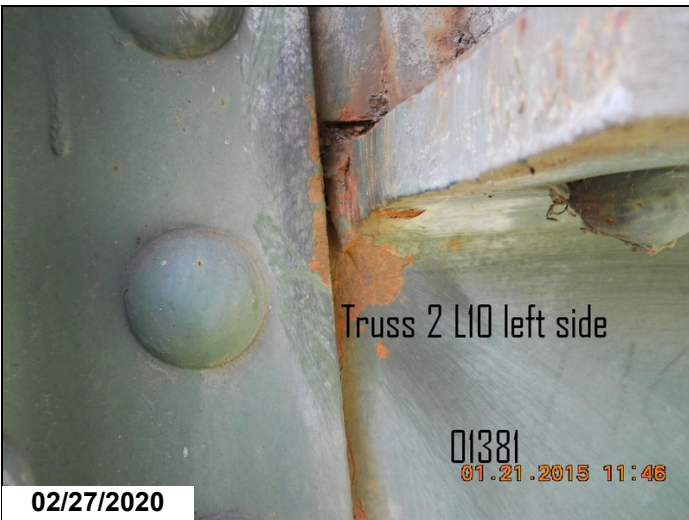
Truss 2, L10 Lt. crack in web of FB.

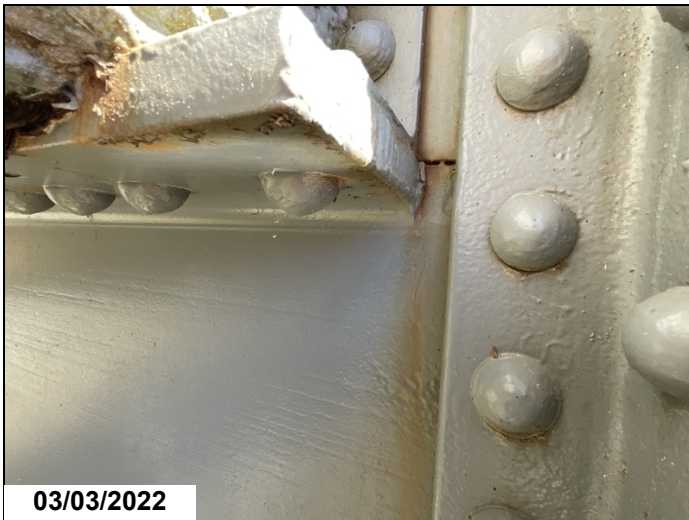
Truss 2 at L9 crack in FB

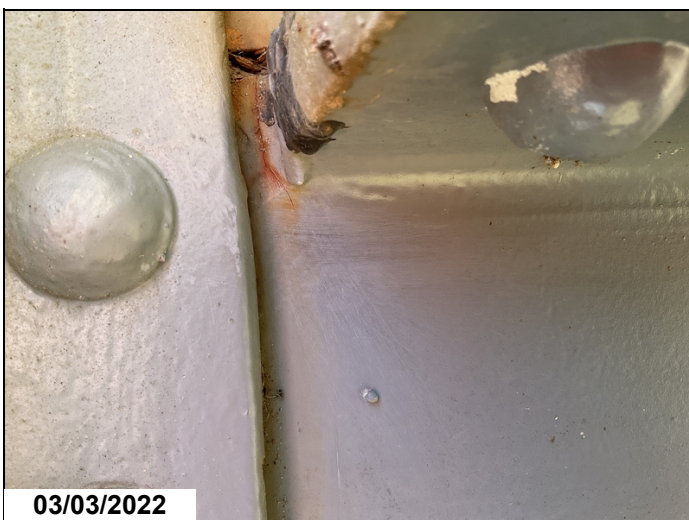
Truss 3 at L1 crack in FB

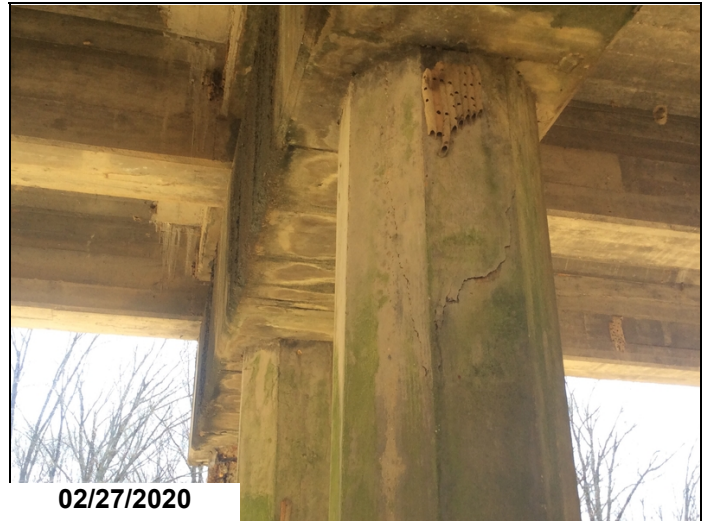
Bent 3, Pile 3 has 1 1/2' of delamination @ top of pile & bottom of cap.

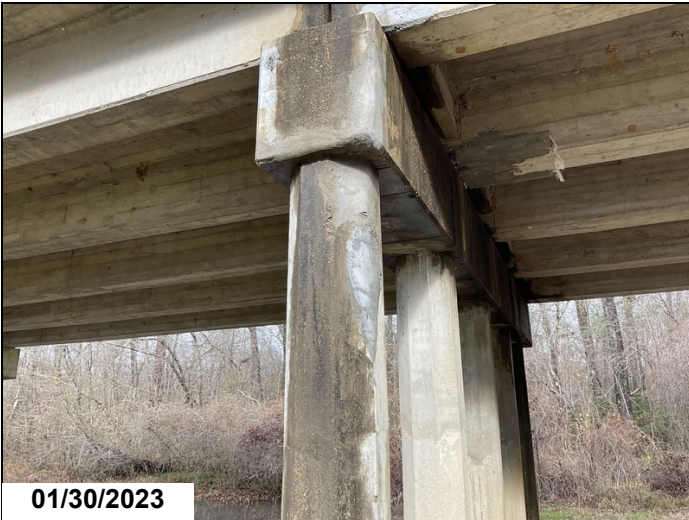
Bent 5, pile 5 has been repaired.

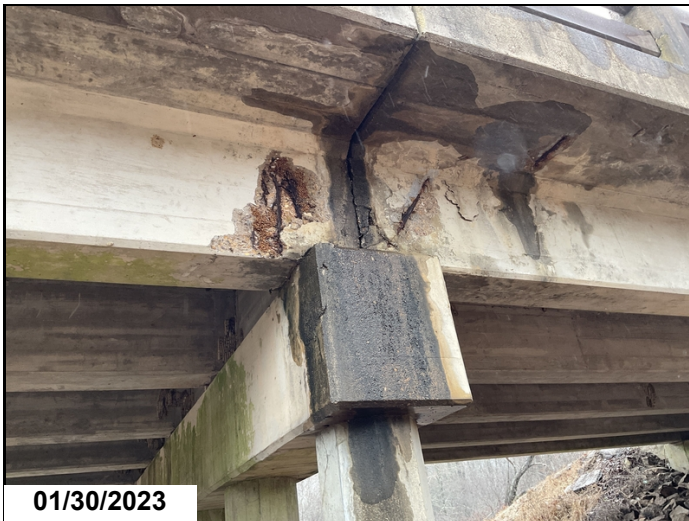
| ELEMENTS | DESCRIPTION | UNITS | TOTAL | CS1 | CS2 | CS3 | CS4 |
|---|---|---|---|---|---|---|---|
| (110) The R.C. Girders have spalls, spalls with exposed rebar, and cracks in the following locations. Span 5 @ Bent 5, Girder 1 has a small delam & crack 2' long horizontal crack that is 0.025". Span 6 @ Bent 7, spall with exposed rebar. Span 7, @ Bent 7, Girders 1, 2, 3, & 5 have spalls with exposed rebar. Span 9 @ Bent 9, Girder 1 has 2' long horizontal crack 0.025, Girder 3- 5 have small spalls with exposed rebar. Span 14, girder 4 & 5 have spalls with exposed rebar. Span 15 @ Bent 5, Girder 5, spall with exposed rebar. Span 19, Girders 1, 2, & 5 have spalls with exposed rebar. Span 24, @ Bent 24, Girders 2- 4 have spalls with exposed rebar. Span 26 & 27, @ Bent 27, Girder 5, exposed rebar. | | | | | | | |

Span 26 & 27, Girder 5, exposed rebar.

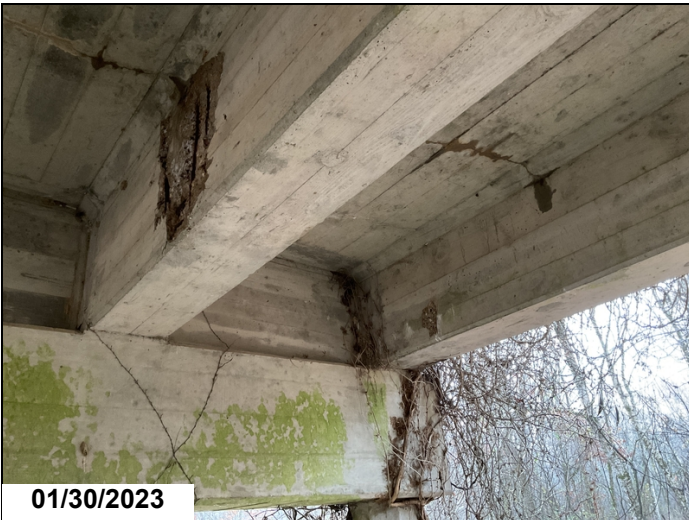
Span 15 @ Bent 5, Girder 5, spall with exposed rebar.

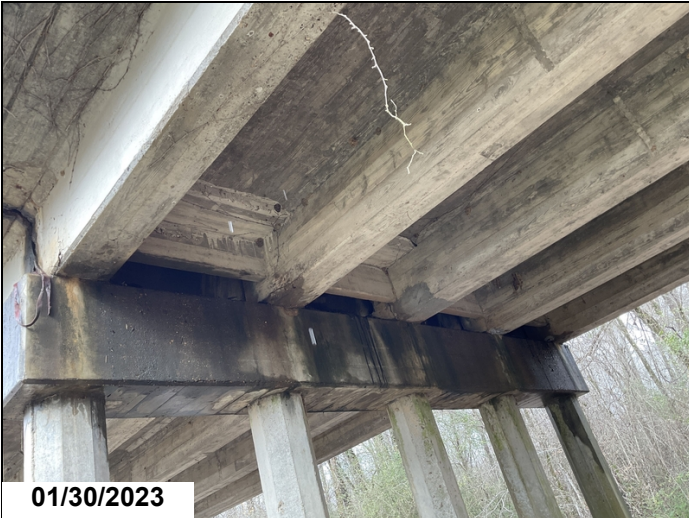
Span 9 @ Bent 9, Girder 1 has 2' long horizontal crack 0.025, Girder 3- 5 have small spalls with exposed rebar.

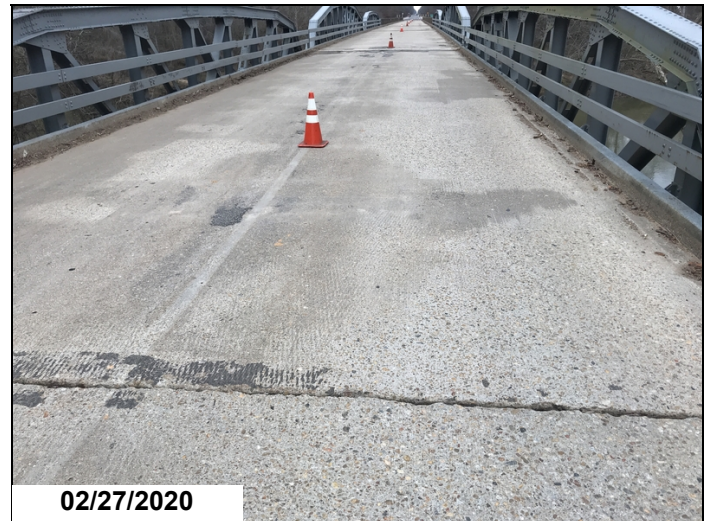
Truss #1 deck, joint is rough.

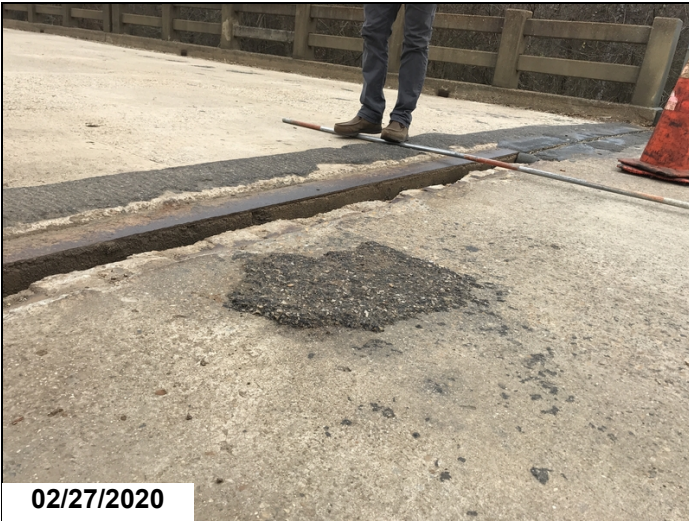
Joint between T3 & approach span 14, the gap is 4" & there is about a 2" drop from approach span to T3. Road iron on T3 Lt. from C/L Lt. The road iron is missing on truss 3 EB lane and there is a bump of asphalt remaining on the approach span thus making it look as if the truss span is lower than the approach span. Joint between T2 & T3 Lt. side looking from Rt. to Lt., gap is 3 1/2" wide between road iron, sliding plate is missing thus making the joint rough to traffic.

Joint between T3 & approach span, the gap is 4" & there is about a 2" drop from approach span to T3. Road iron on T3 Lt. from C/L Lt.

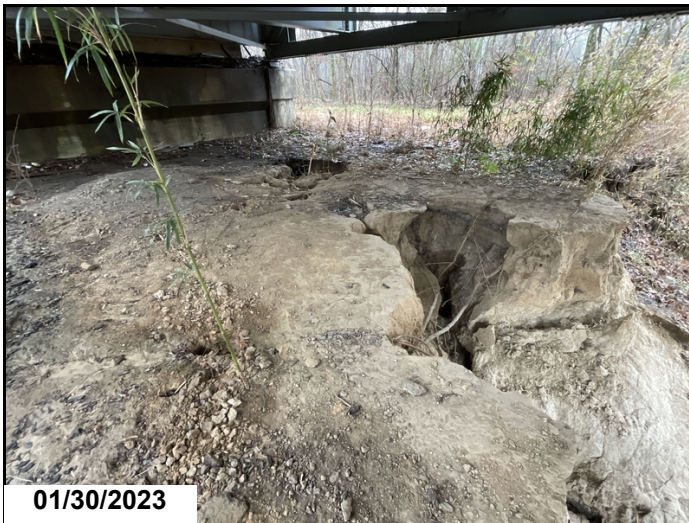
Span 13, scour action is eroding the embankment towards Bent 14.

Erosion below span 13

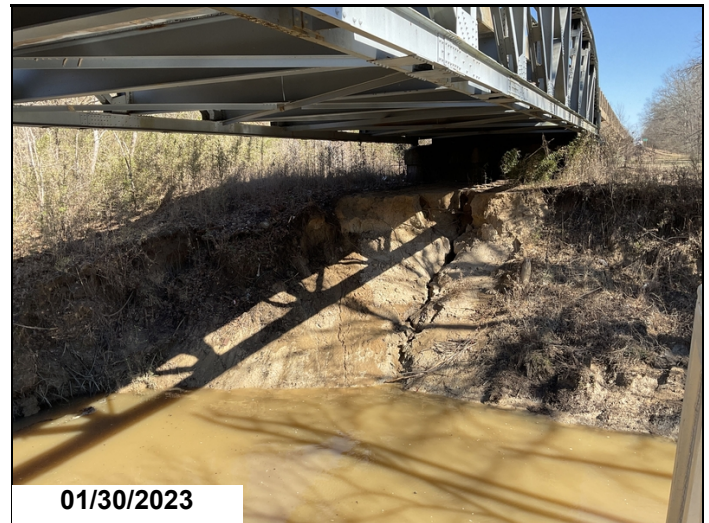
Span 13, Erosion of embankment towards Bent 14.

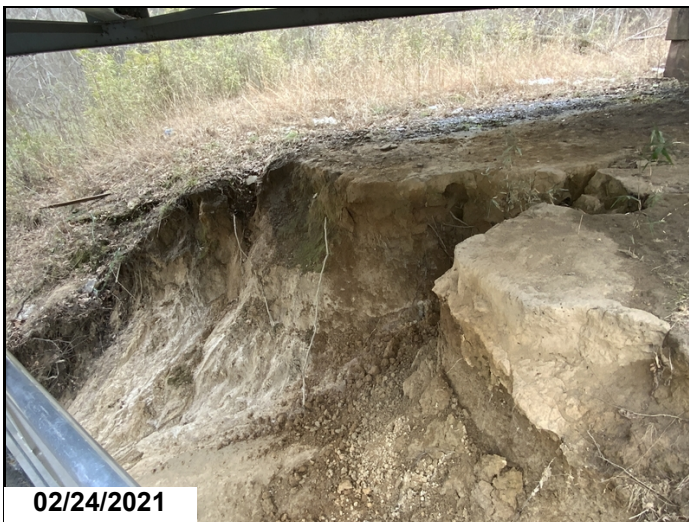
Bank erosion under truss 3

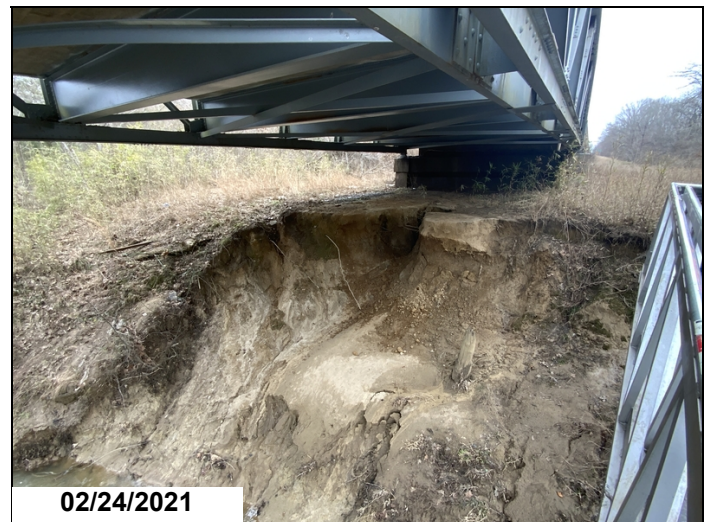
Bank erosion span 13

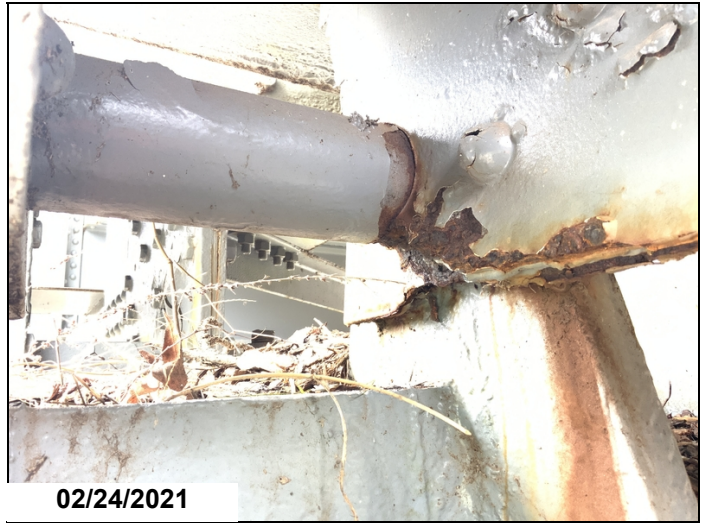
Truss 3, right side L0 at the pin inside gusset plate has pack rust that has pushed the inside plate out 3/4 inch and has section loss around top of pin.

Truss 3 right side, RL0 at pin connection plate with section loss

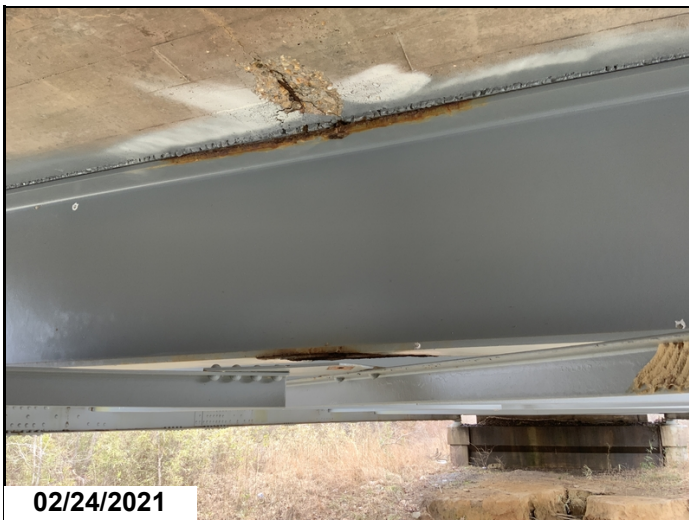
Truss 3, Floor beam 2 cross bracing has built up pack rust that has caused bracing to detach from bottom of floor beam and broke the hanger bolts.

Truss 3 fb 2, cross bracing connection bolts missing

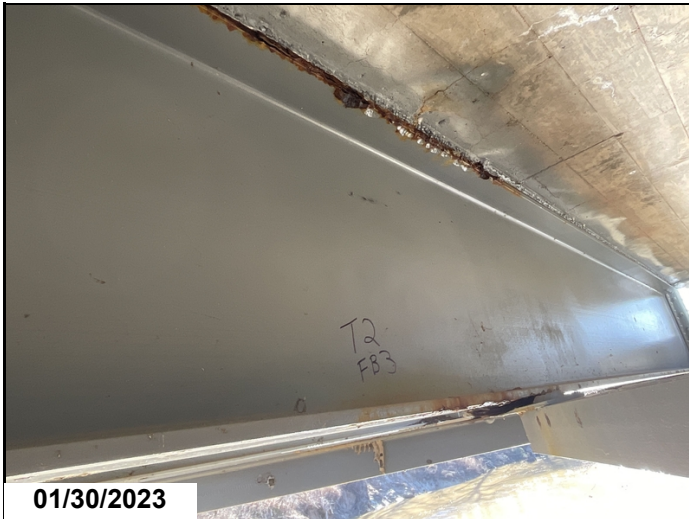
T2 FB 3. Flanges have pitting up to 1/4" deep.

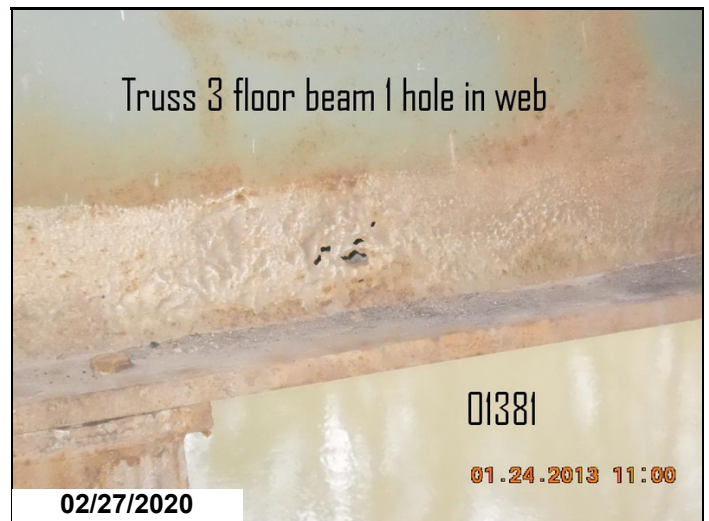
Floor beams have section loss in the lower web due to corrosion.
Truss 1, FB 1, corrosion along the flanges.
Truss 3 -- small holes in floor beam 3' left of L0 Rt.

Truss 3, hole in FB.

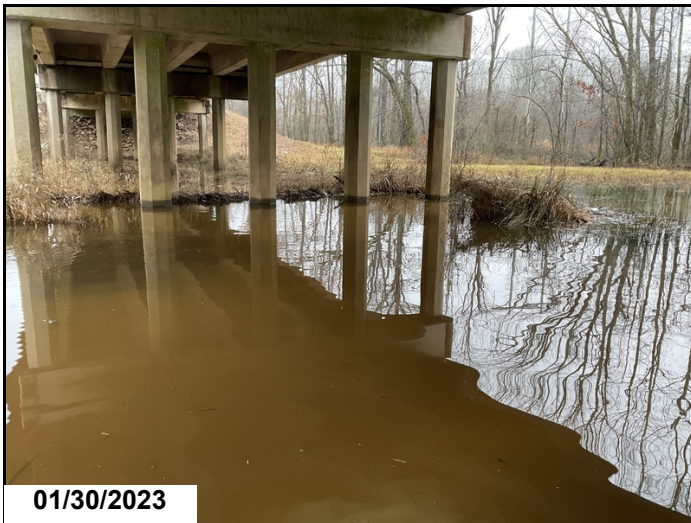
There is a small beaver dam being built under Span 25.

Span 25, beaver dam.

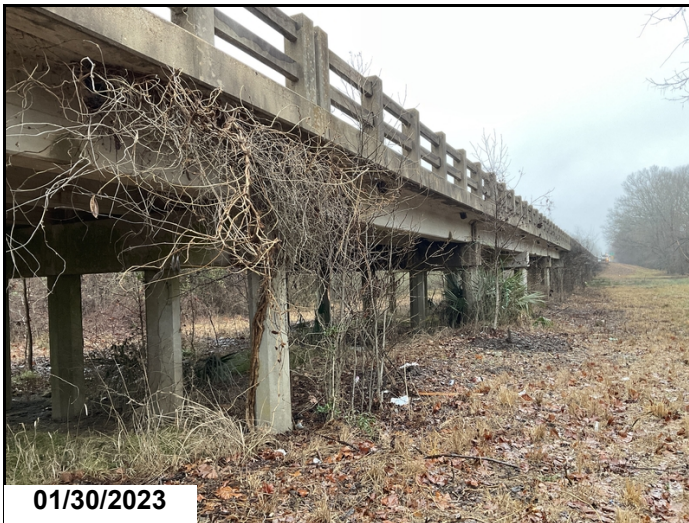
Spans 14 - 22, vines are growing on the bridge and trees are growing against the bridge.

Span 14 - 22, vines & vegetation

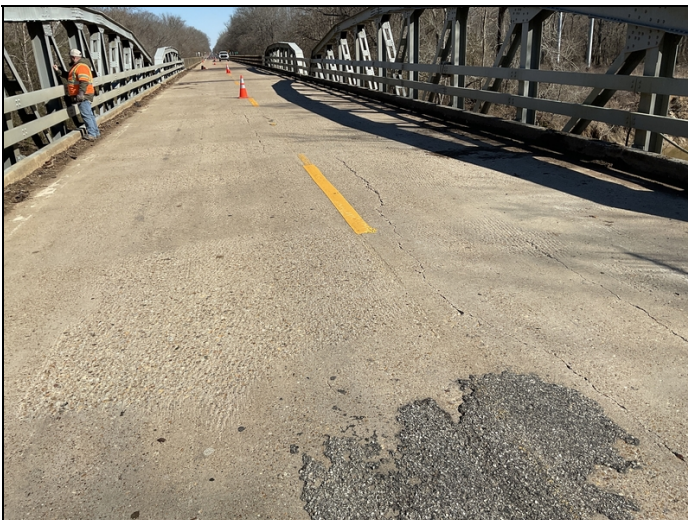
Deck cracks span 12

A-54 - Sealable Deck Cracks (Yes)

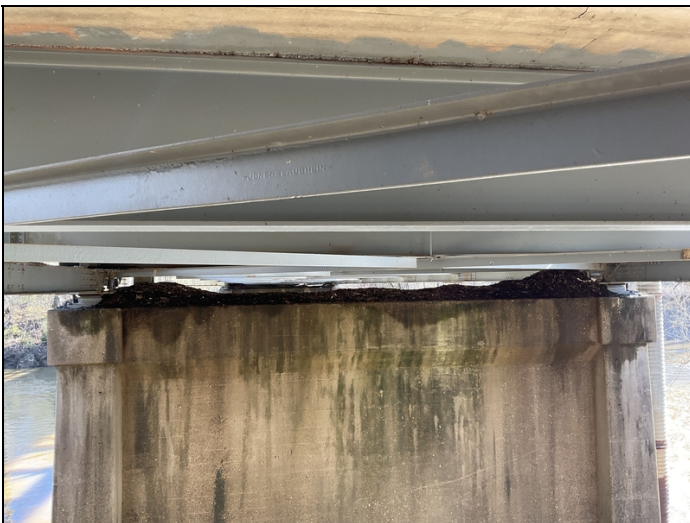
Top of caps full of debris.

A-58 - Cap Cleaning/Flushing Needed (Yes)

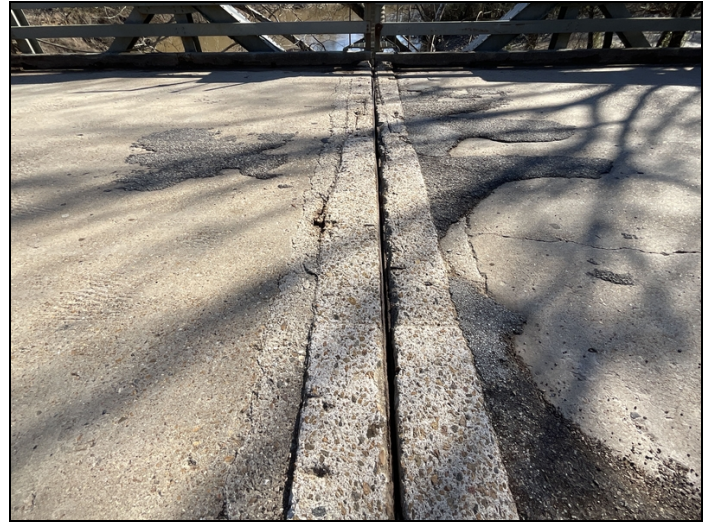
Bent 12, joint.

A-59 - Joint Repair Needed (Yes)

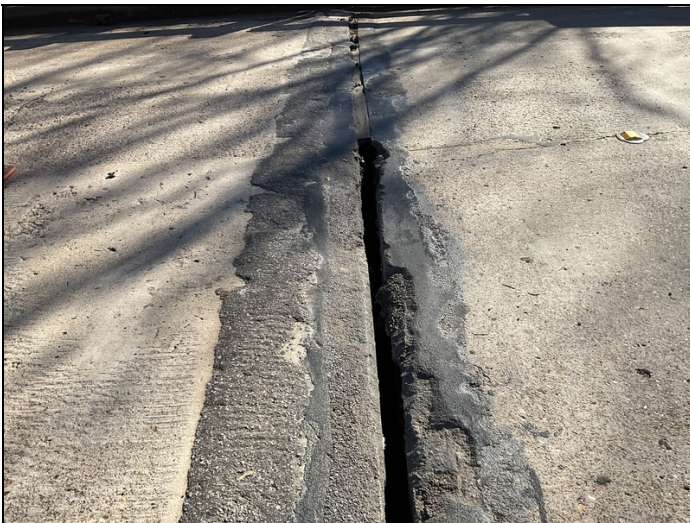
Joint bent 14
