Asset #00356(Routine, Underwater type 2)
State Highway 22 over Six Mile Creek-Logan Co.

Location: 0.5 MI E JCT SH 23

Team Lead: Bob McEntyre, Inspection Date: 08/24/2022

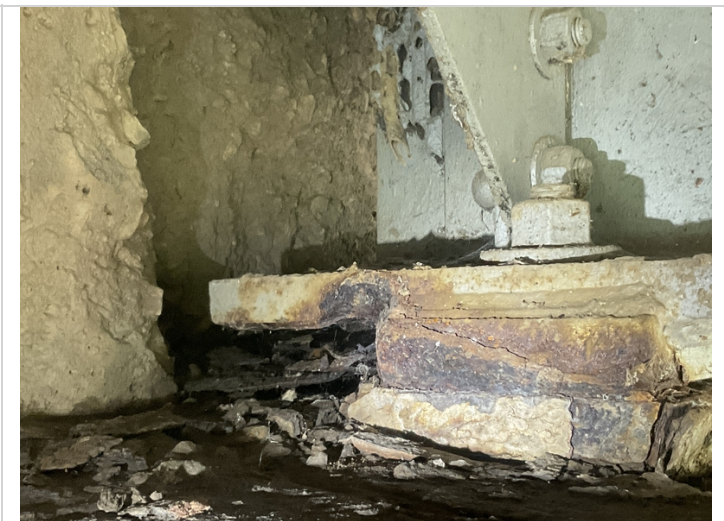
Span # 3, beams # 2 and # 3 have approximately 1/4" section loss to the bottom flange behind the bearing device.

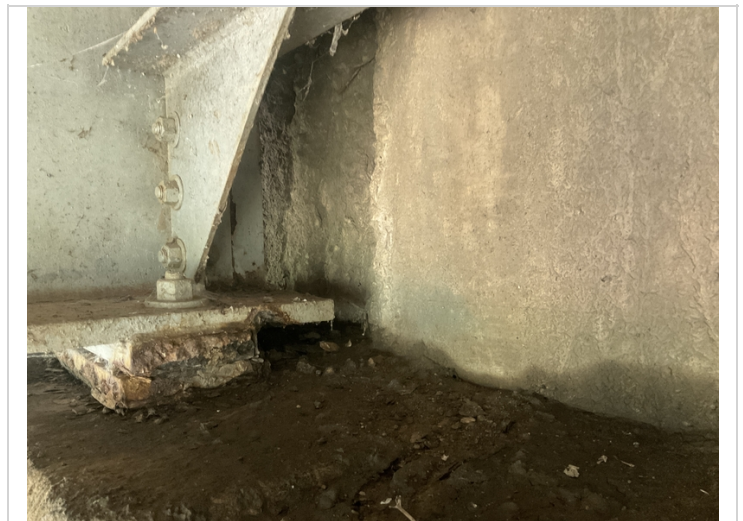
Abutment 2 backwall chipped out to provide additional expansion room

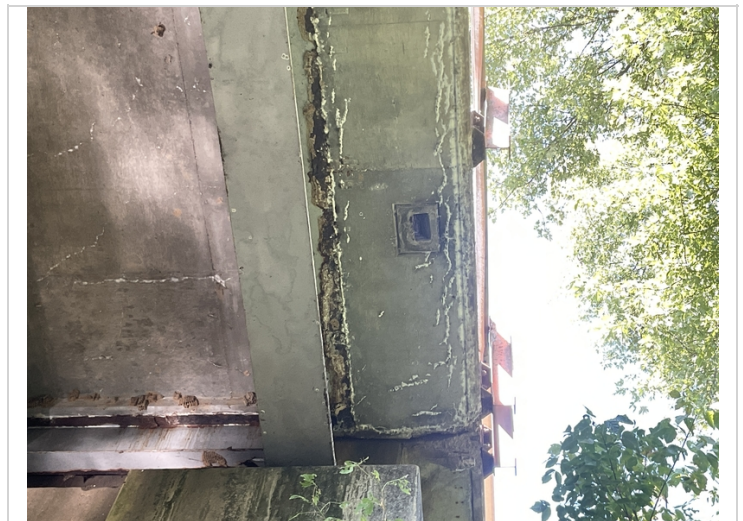
Span 3, right side-Mapcracking with efflorescence in deck overhang

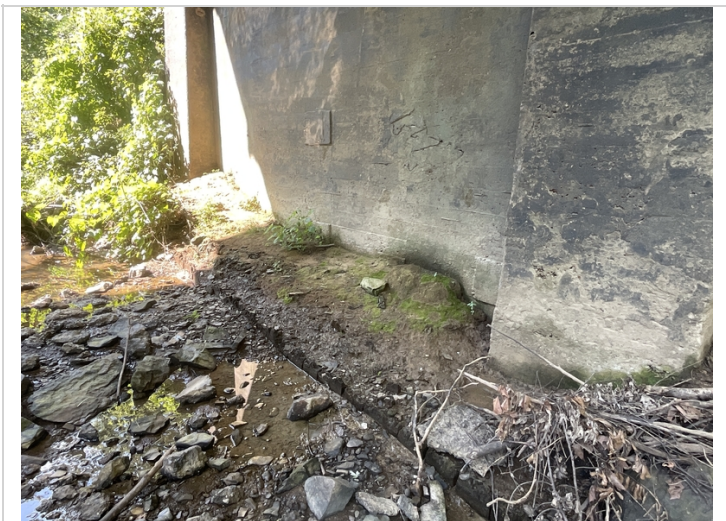
Bent 3 footings have cover

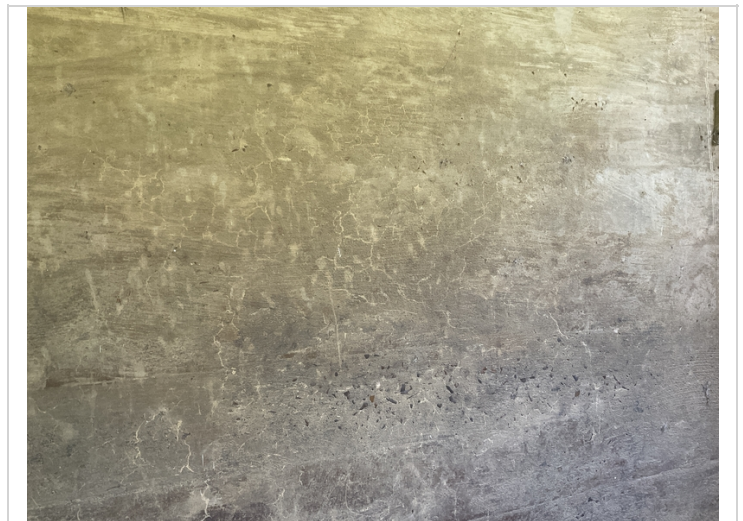
Bent 3 web wall-Superficial mapcracking

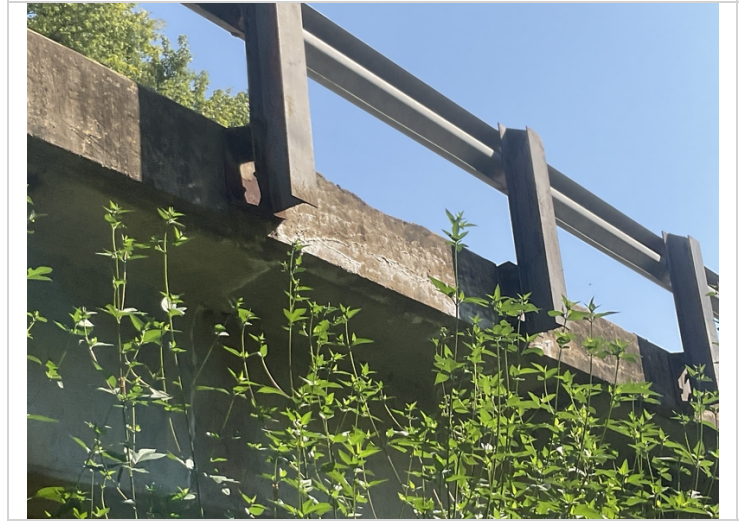
Span 2, right side-Mapcracking with efflorescence

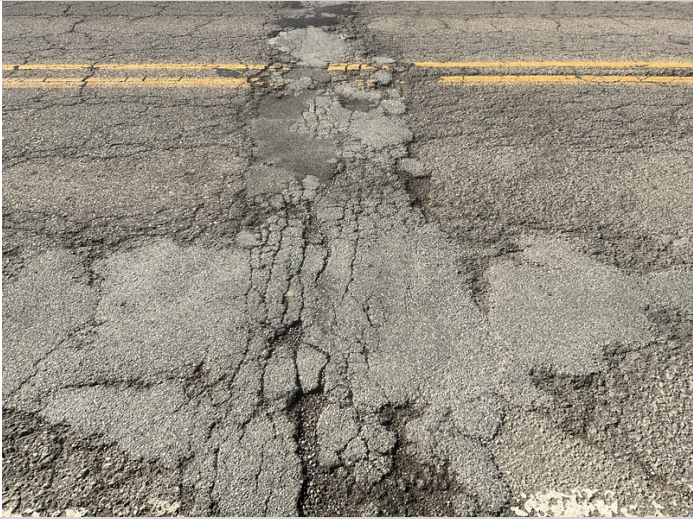
(12) -The flare board sign on the left side of abutment # 2 is twisted away from the roadway.							
Span # 3 - Concrete deck with an asphalt wearing:							
-Asphalt wearing surface has map cracking throughout with potholes over the mid-span joint and in the left driving lane.							
-Large areas of concrete deterioration in the curbs with exposed reinforcing steel.							
-The curbs have concrete deterioration that exposes approximately 74' of reinforcing steel and approximately 32' of concrete deterioration that does not currently have exposed reinforcing steel.							
Deck Undersurface:							
-Map cracking with light efflorescence is visible on the undersurface in span # 3, bays # 1 & 3.							
-Span # 3, bay # 3 adjacent to bent # 3 has a shallow concrete delamination that appears to have been caused by shallow placed reinforcing steel.							
(510-12) The driving surface of the deck has heavy map cracking throughout with potholes forming. The asphalt is breaking apart over bent # 3.

Asphalt breaking apart over bent 3

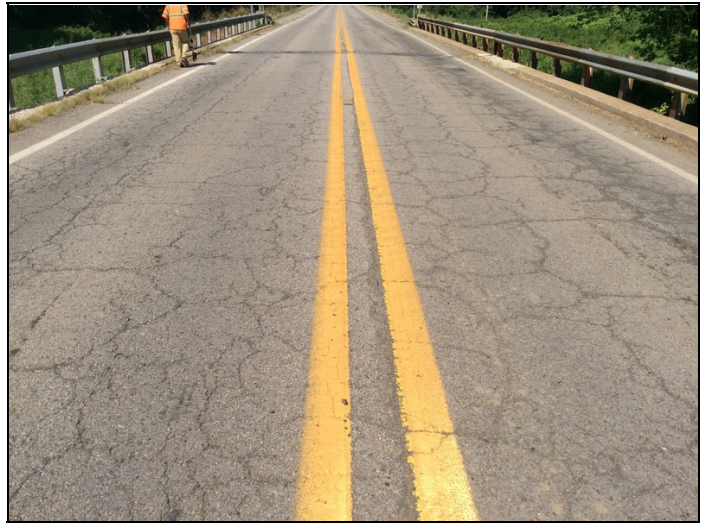
Bent # 3 asphalt breaking apart over the bent.
