Bridge 03356 Inspection Report

Route:109 Section:03 Log:4.939

National Bridge Inventory Data Sheet

Team Lead: Rhett Franks, Inspection Date: 04/08/2025

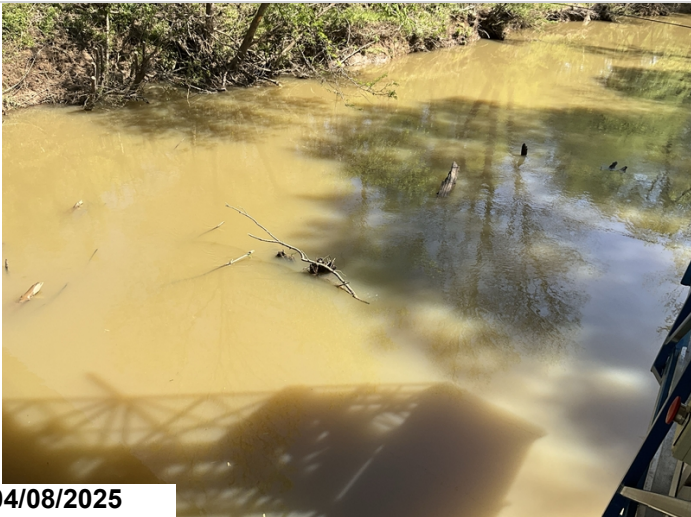
Overall, the channel is in satisfactory condition on fair alignment in a forked channel with banks beginning to slump with large trees in the channel at span 4, up and down stream sides. The banks are well vegetated with small trees, drift and Johnson grass that could use a trim/removal.

Large trees under structure.

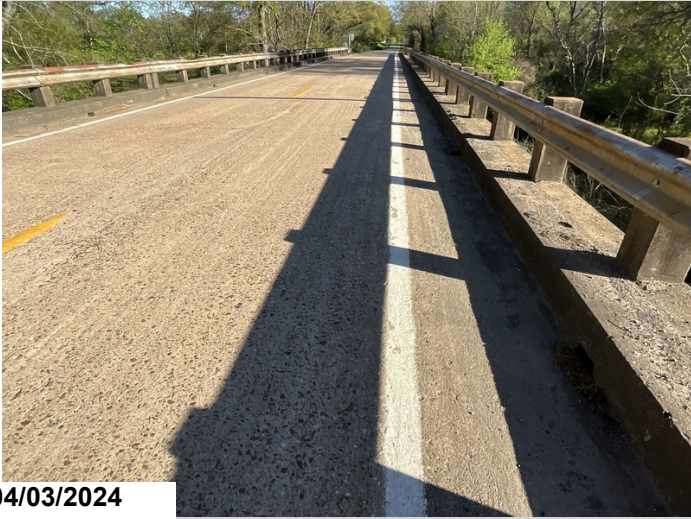
Dirt and debris in gutters

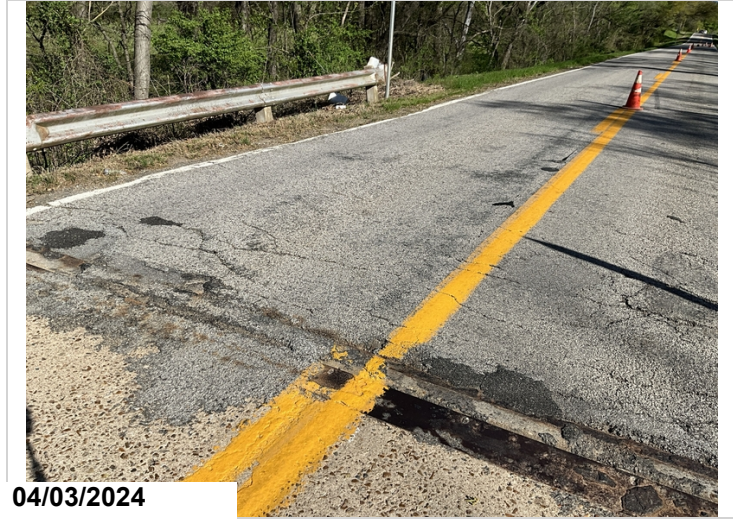
Joints need to be cleaned.

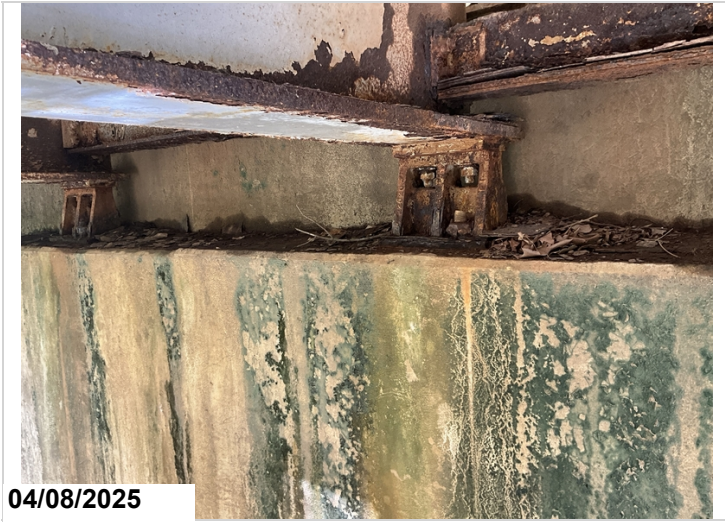
Typical debris on caps

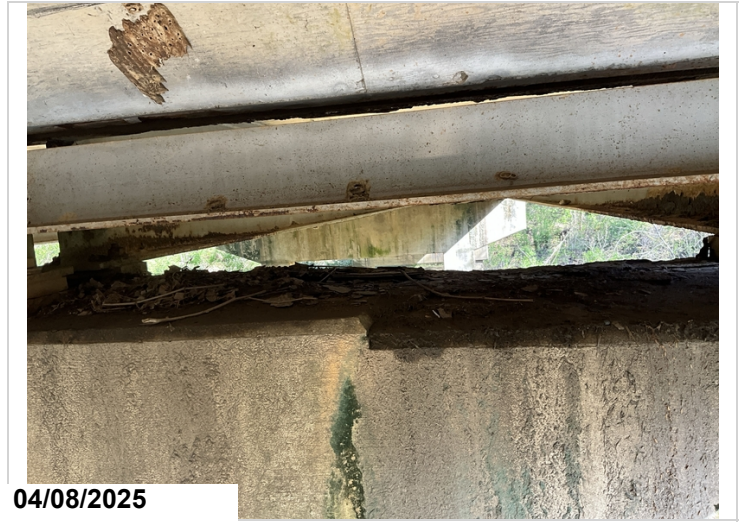
Typical dirt and debris on caps.

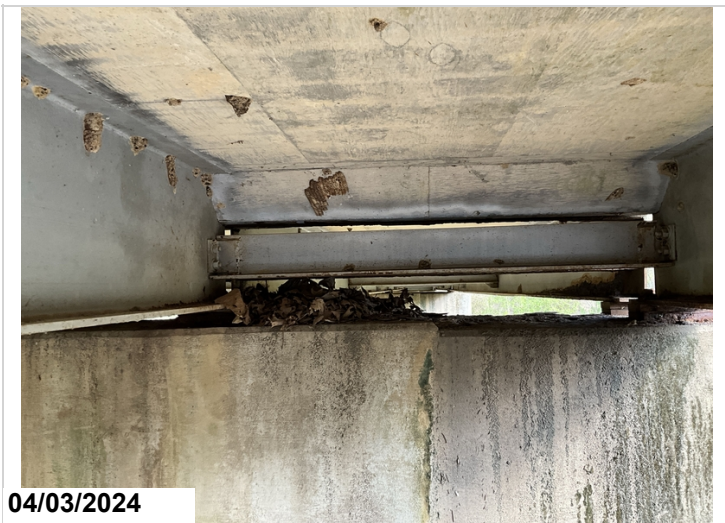
Caps have debris built up on top of them.

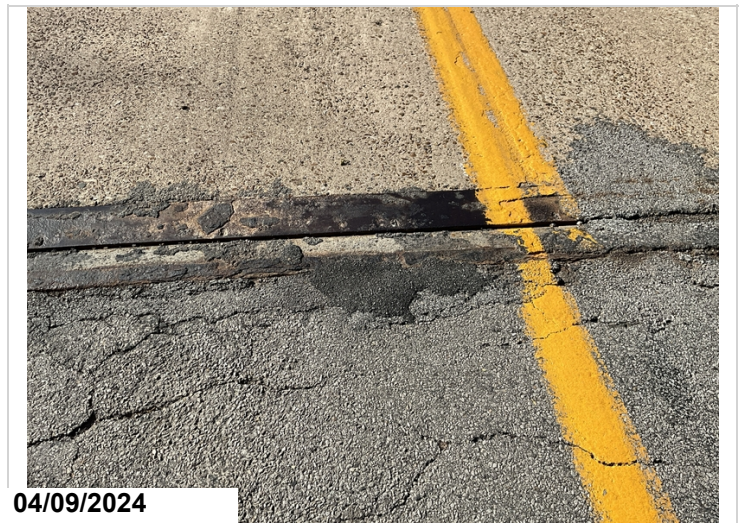
Typical debris impact in joints.

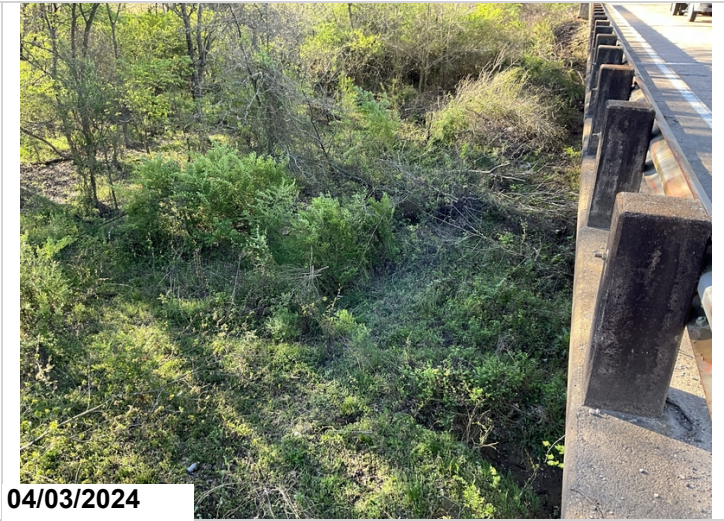
Typical brush right side

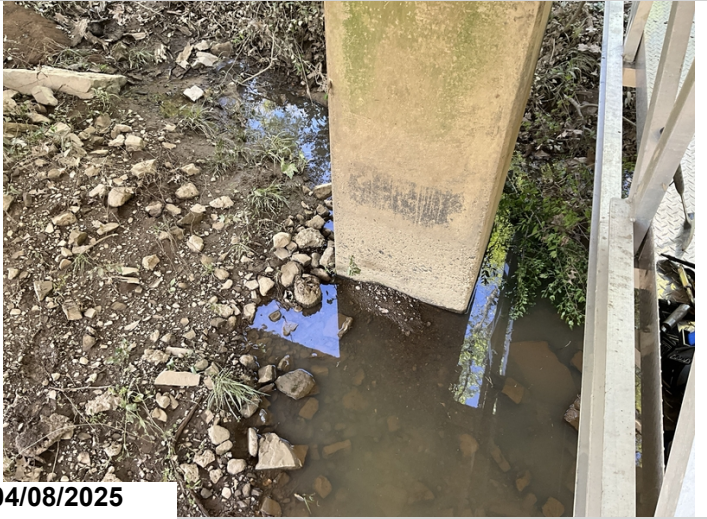
Span 3 Bent 3 Typical abrasion on all columns. CS2 1 EA

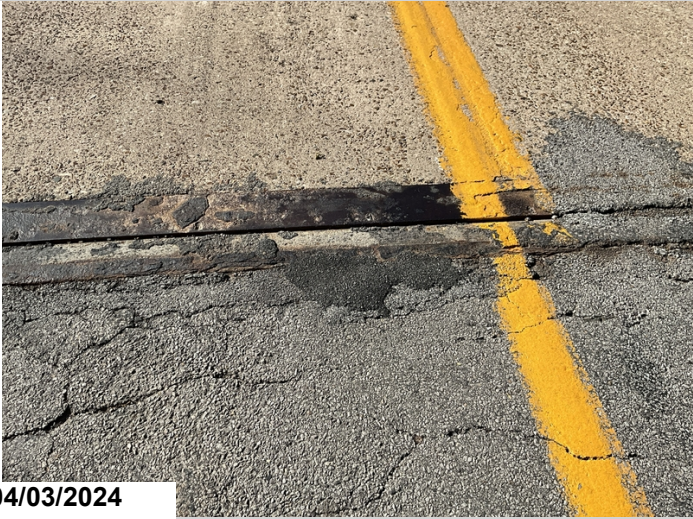
All joints have debris impaction. CS2 full length

Typical debris impact in joints.

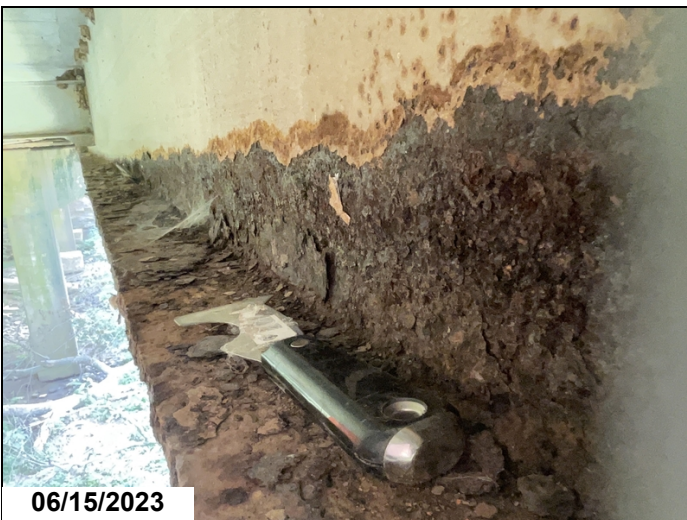
Span # 3, beam # 1 at bent # 4-Section loss to bottom flange.

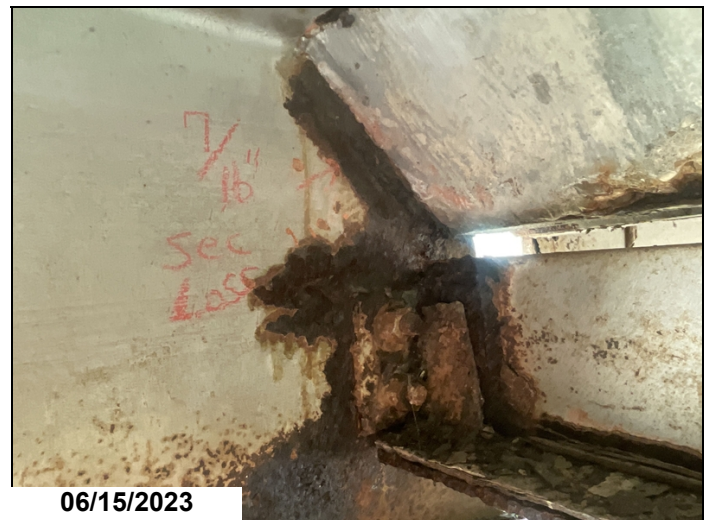
Span # 3, beam # 1 at bent # 4-Section loss to web at expansion dam and diaphragm connection.

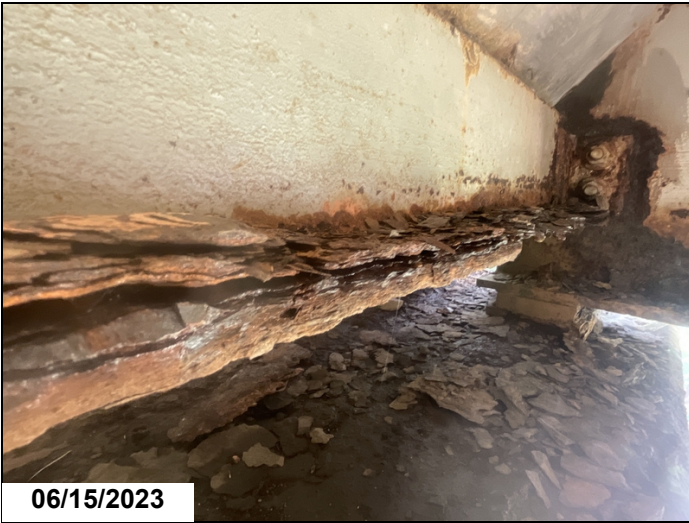
Span # 2, bay # 1-Section loss to diaphragm.

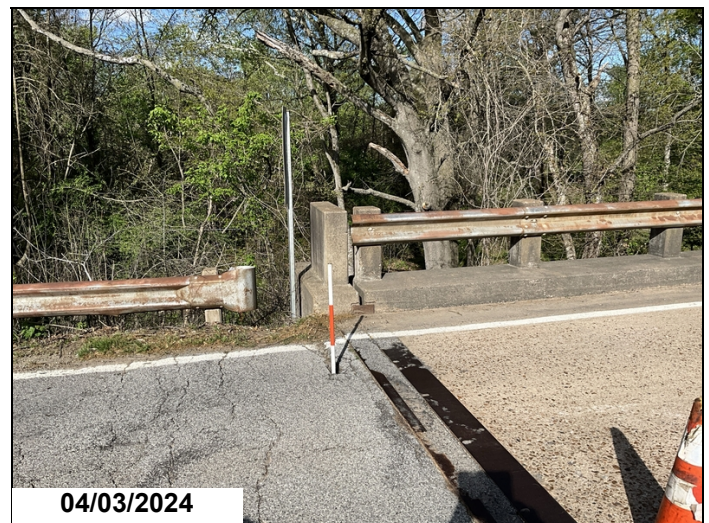
Abutment 1, approach, left lane, has settled. 2ft

4/8/2025 State maintenance forces have repaired the void in the approach roadway since last inspection.

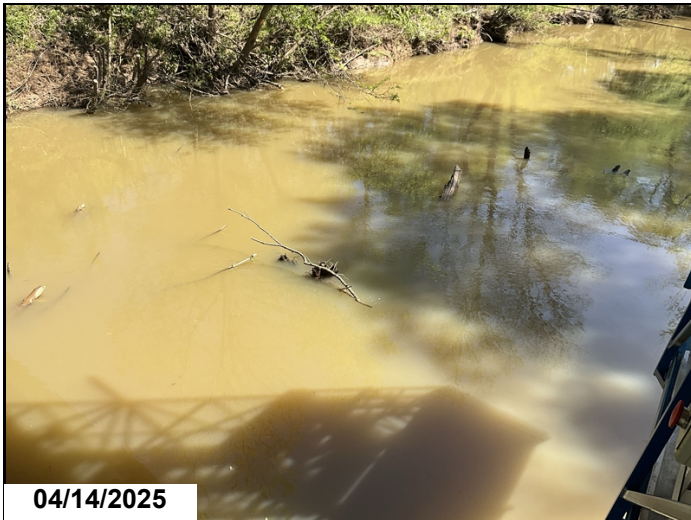
The channel has a tree under span 4 promoting additional drift accumulation.

Large trees under structure.

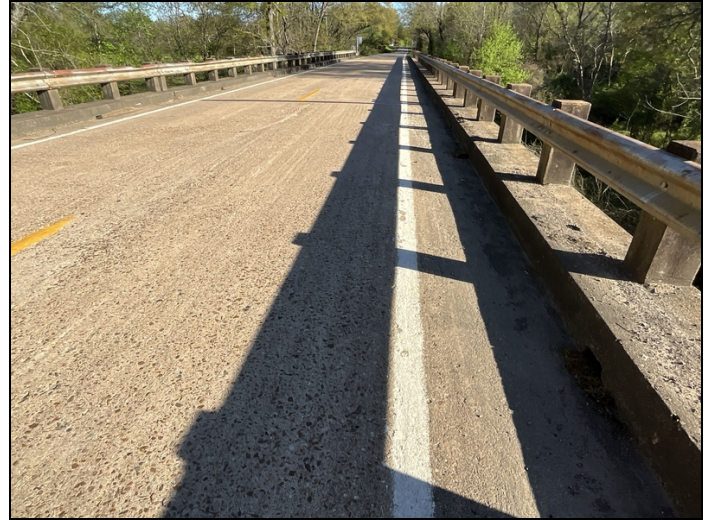
Dirt and debris in gutters

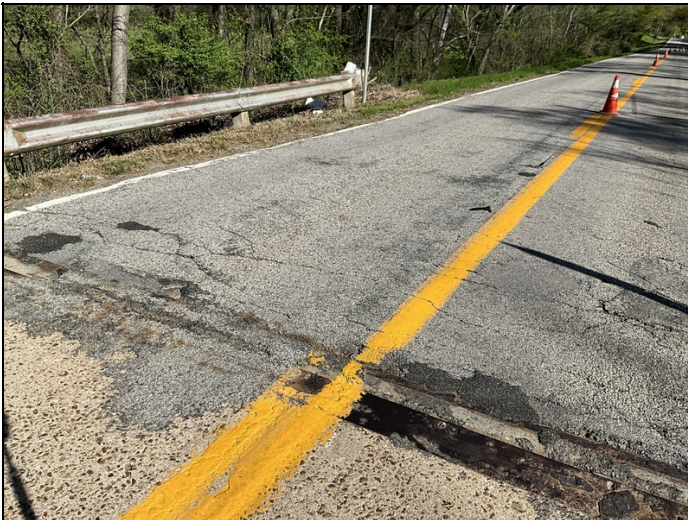
A-56 - Joint Cleaning/Flushing Needed (Yes)
Joints have debris impaction.

Joints need to be cleaned.

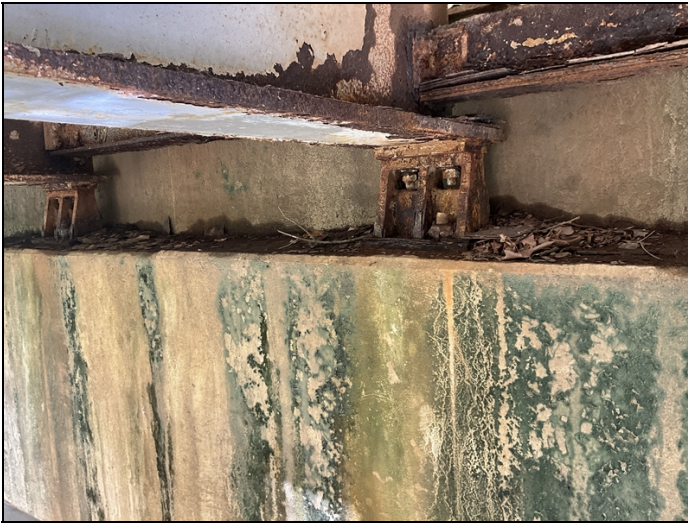
Typical debris on caps

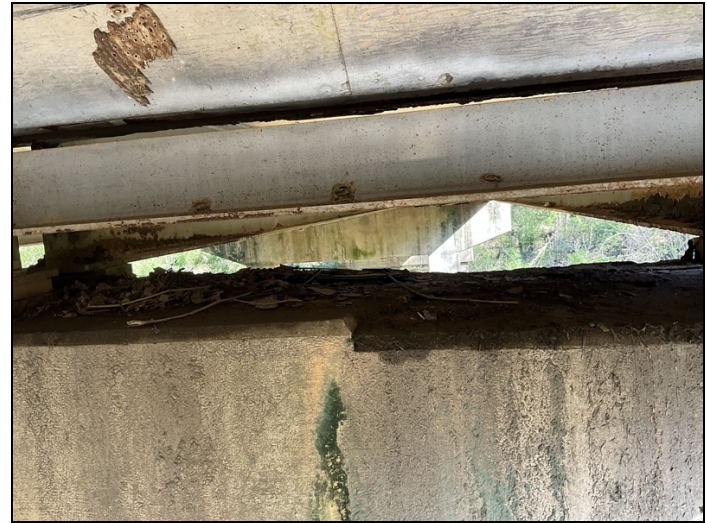
Typical dirt and debris on caps.

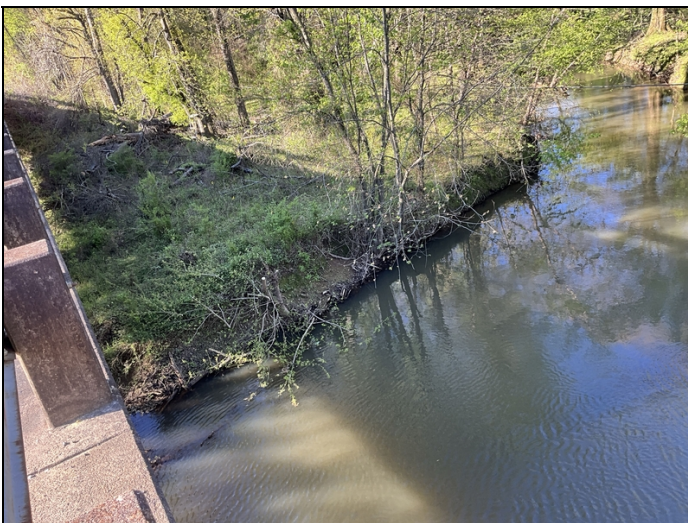
Typical trees and brush left side

A-64 - Vegetation Removal Requested (Yes)

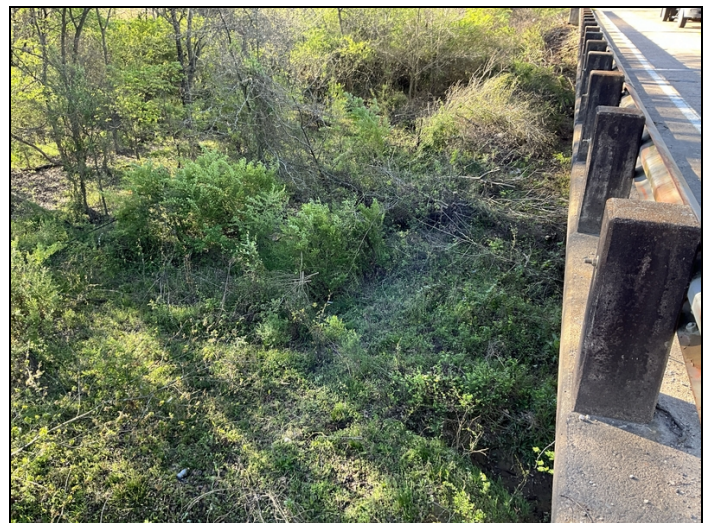
Typical brush right side
