Bridge #06059(Routine)

US 62/412 Marion over WHITE RIVER

Team Lead: Benjamin Smith Inspection Date: June 17, 2020

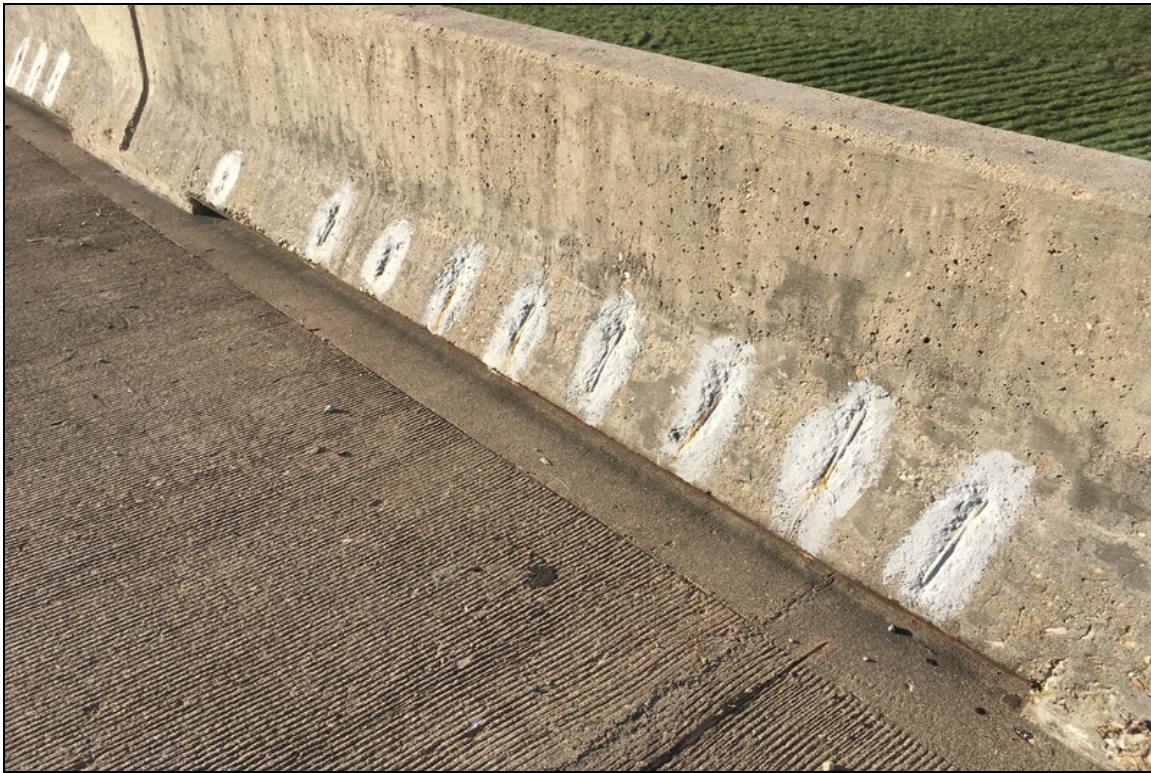
ELEM	DESCRIPTION	UNITS	TOTAL	CS1	CS2	CS3	CS4
	<p>The total quantity of the bridge railing includes the concrete approach railing. The railing has shallow exposed rebar through out the vertical face, these areas have been painted, but the rust is beginning to show through.</p> <p>Left side parapet wall- has 135' of vertical hairline cracks. The cracking is mostly at the corners of the drain areas, more cracking exists but is not quantified due to exposed rebar in the same footage. the left side has 812' of exposed rebar at numerous locations throughout the parapet wall.</p> <p>Right side parapet wall- has 141' of vertical hairline cracks. The cracking is mostly at the corners of the drain areas, more cracking exists but is not quantified due to exposed rebar in the same footage. The right wall also has 793' of shallow exposed rebar at numerous locations throughout the parapet wall.</p>

Exposed rebar in the concrete parapet walls.

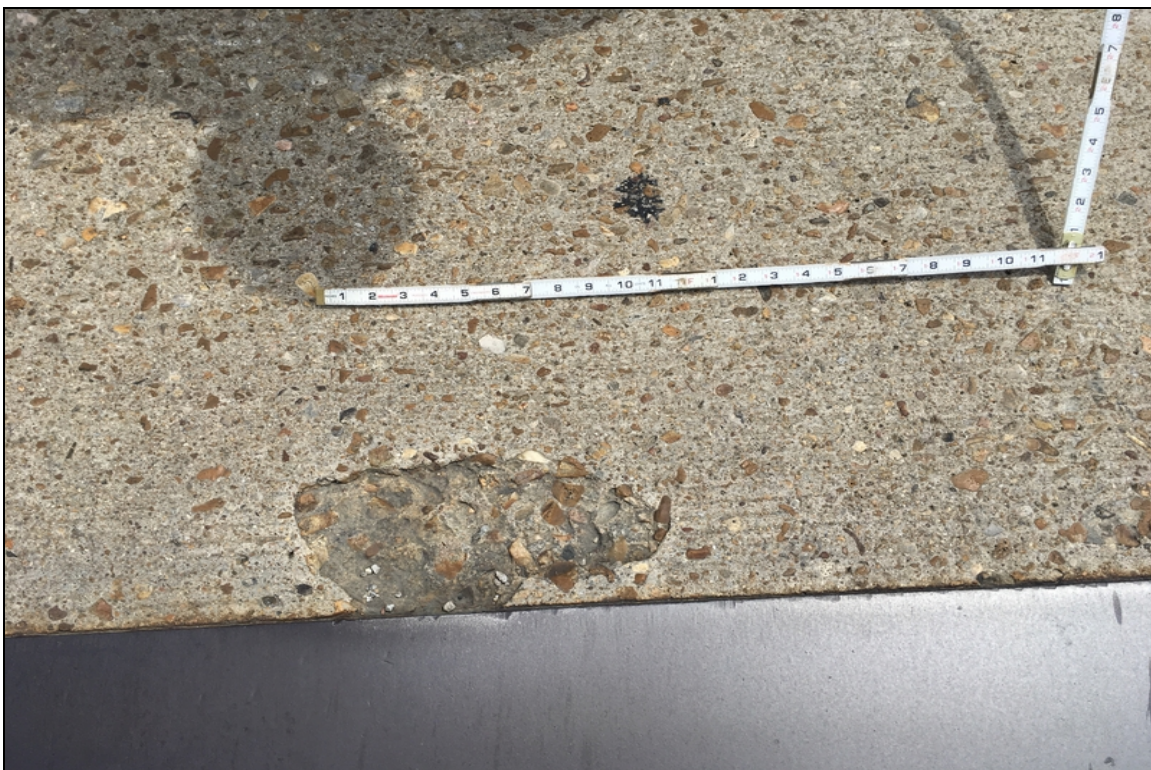
Delamination in the left driving lane at the beginning of span #4.

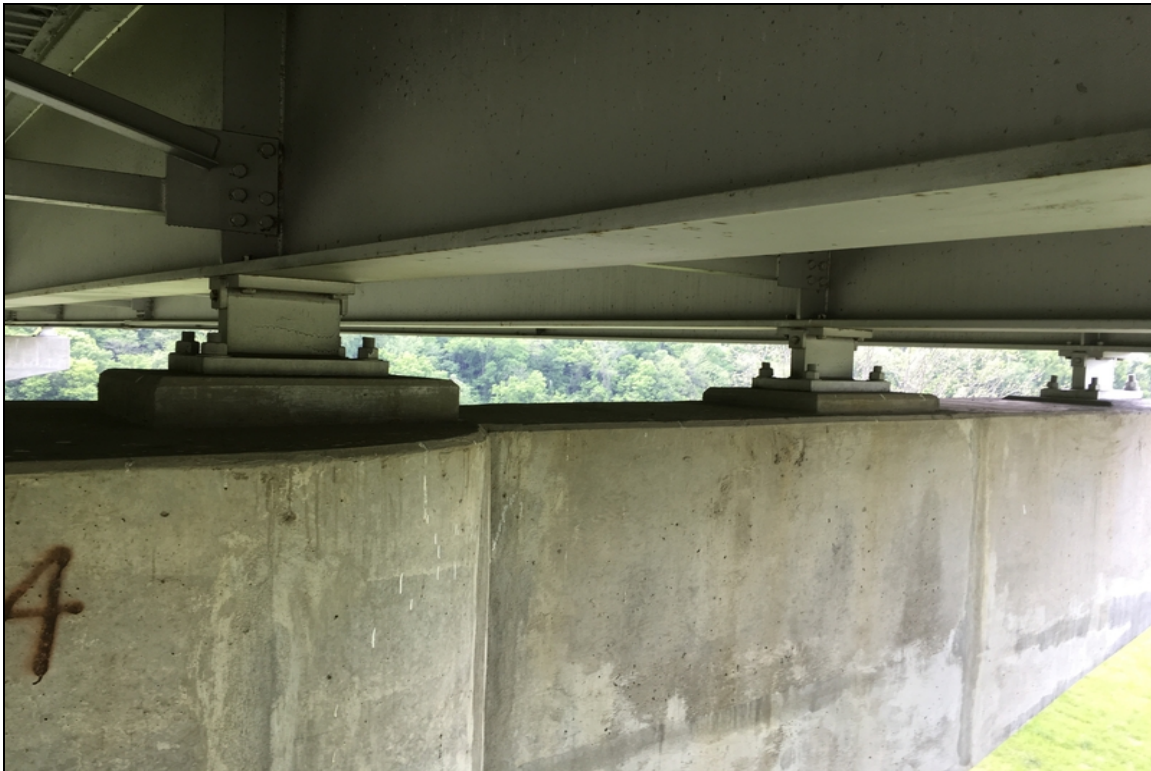
Fixed bearing condition at pier #4. Typical of all 6 at this location.

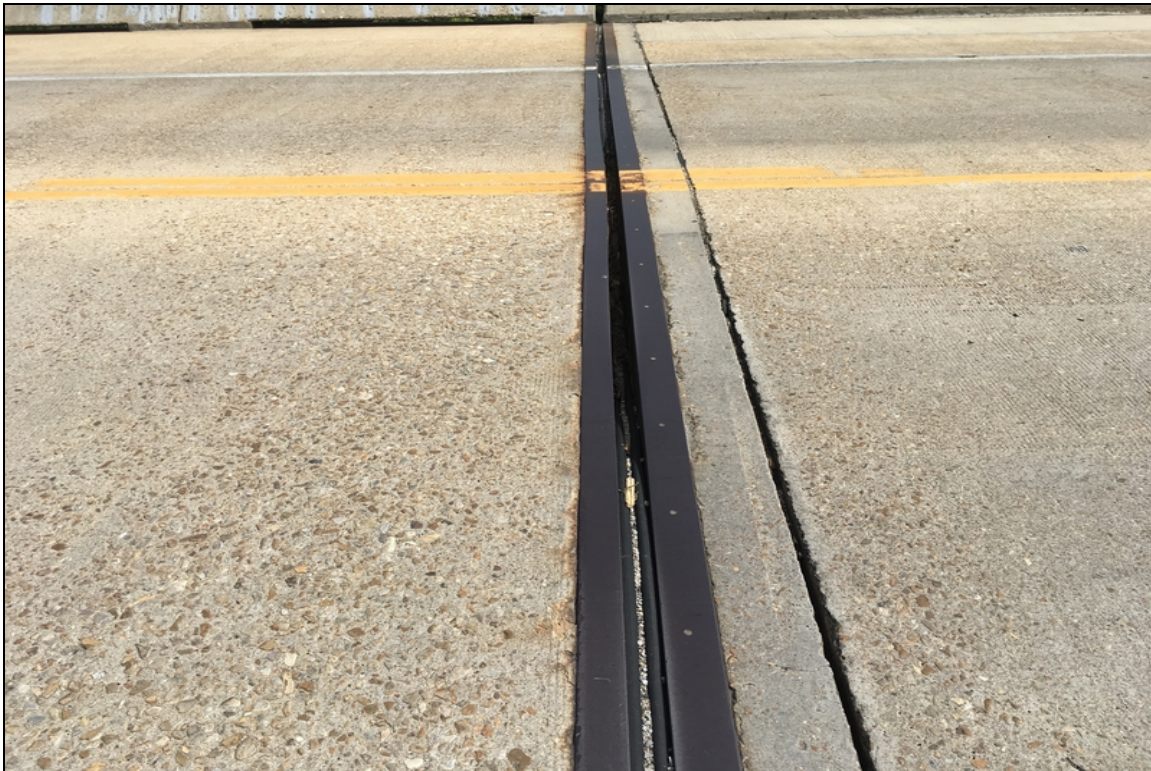
General view of the abutment #2 compression seal.

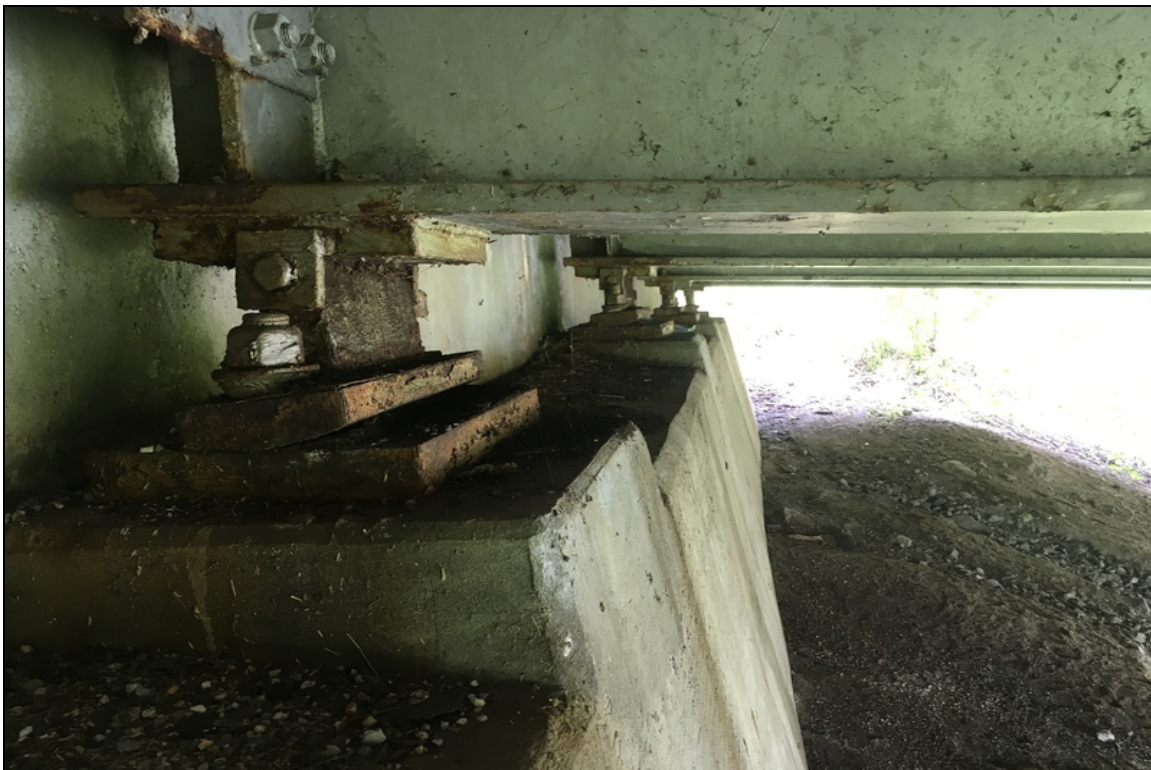
ELEM	DESCRIPTION	UNITS	TOTAL	CS1	CS2	CS3	CS4
311	Movable Bearing	EA	48	0	30	18	0
1000	Corrosion	EA	48	0	30	18	0
(311)							
<p>Inspection temperature was 72 degrees.</p> <p>Abutment #1 moveable bearings- all 6 have corrosion with pack rust at the rocker area.</p> <p>Pier #3 moveable bearings- Both anchor bolts are missing on the left side of beam #5 over pier #3, the horizontal sole plate bolt is also missing. The 8 interior bearings have minor corrosion. The 4 exterior bearings have corrosion with rust in the rocker areas.</p> <p>Pier #6 moveable bearings- all 12 have minor corrosion with no section loss. The interior horizontal sole plate bolt is missing on beam 6 on the span 7 side.</p> <p>Pier #9 moveable bearings- the 8 interior bearings have minor corrosion. The 4 exterior bearings have heavier corrosion with minor pack rust. Beam 6 has a horizontal sole plate bolt missing on the interior and exterior span 9 side. The sole plates are welded to the bottom flange a this location. They are bolted at the other locations.</p> <p>Abutment #2 moveable bearings- bearings 2-5 have corrosion with pack rust at the rocker area. Bearings #1 ,6 have very little corrosion. Bearings #3,4 are tilted toward the back wall the other bearings are not. Bearing #3 right anchor bolt is not fully tightened.</p>

Bearings #3,4 at abutment #2. Showing tilt at 80 degrees F. The other bearings are not tilted.

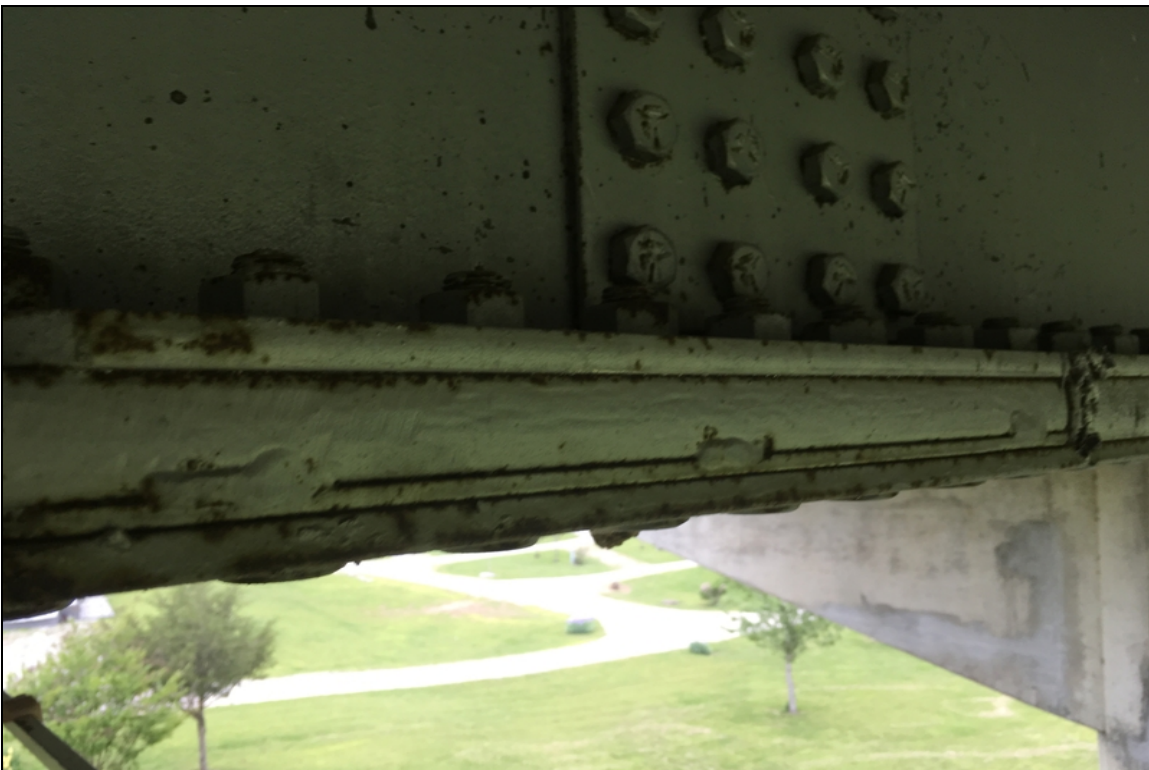
Tack welds on the spacer plates of the splice panels. Typical of all locations.

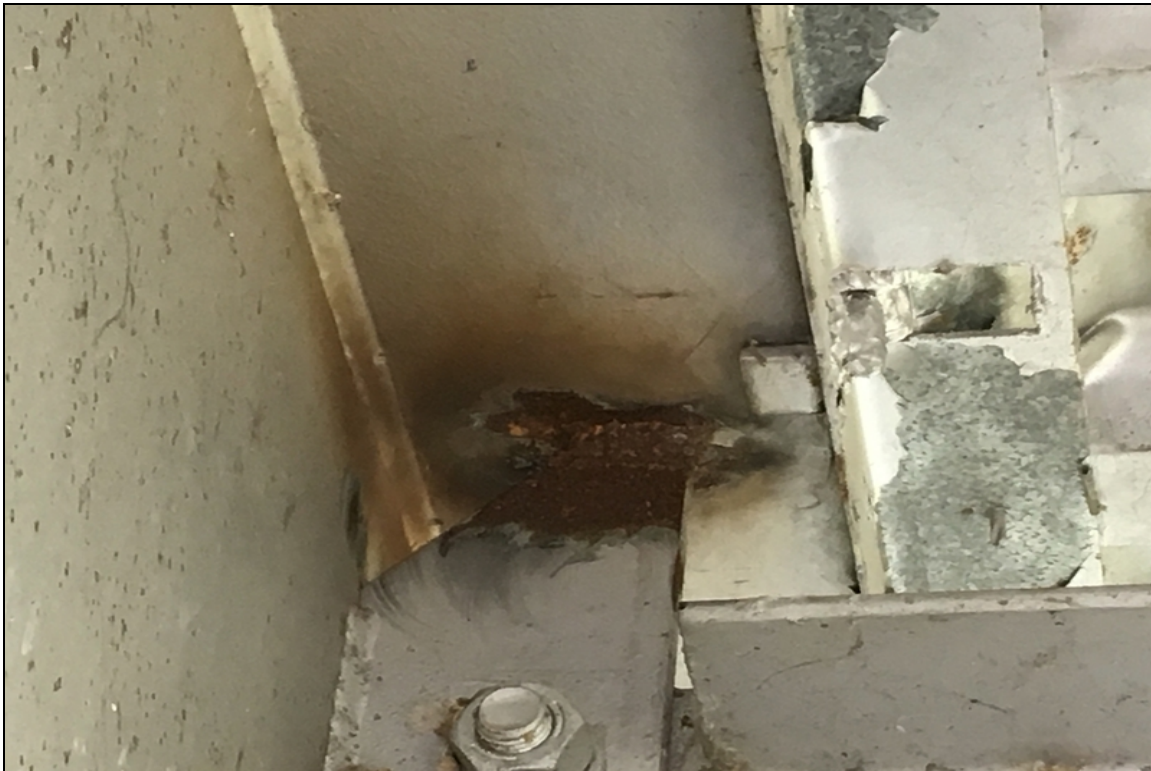
Re welded upper diaphragm connection on girder #6 of span #6 near mid span.

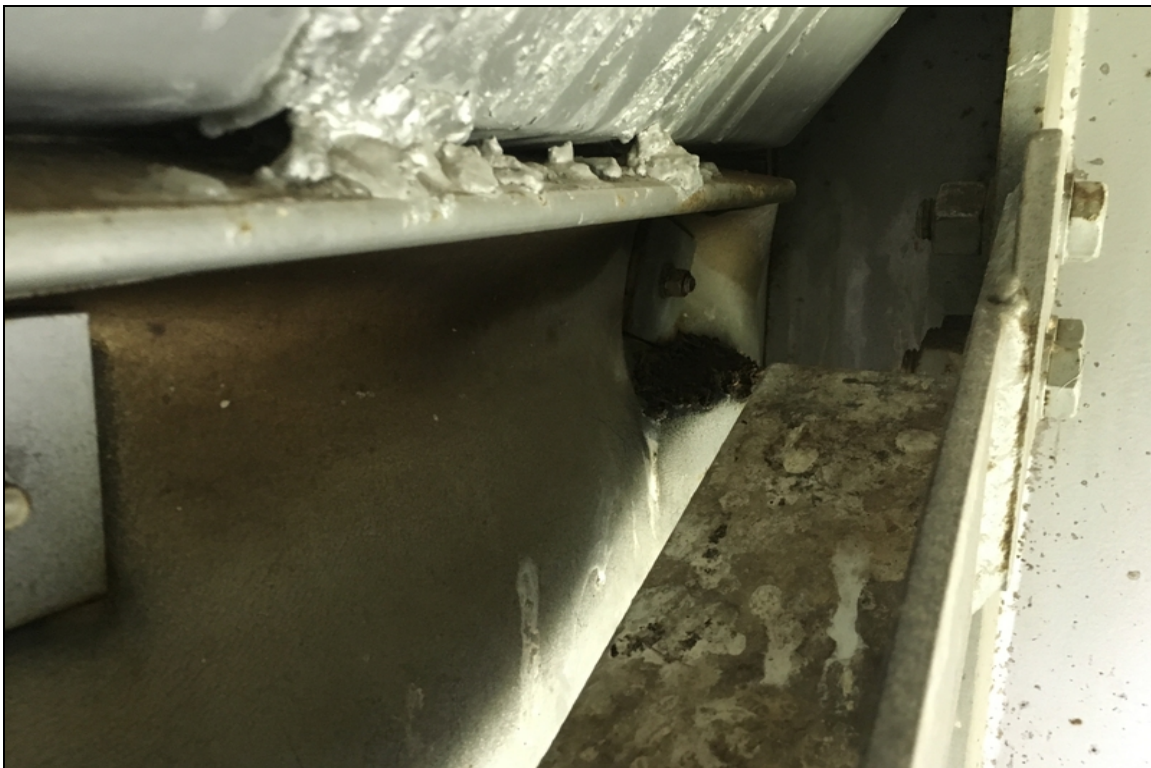
(303)							
Pier #3 assembly joint- is completely full of debris. The trough has tears at the connections and large horizontal rips in the trough.							
Pier #6 assembly joint- is completely full of debris. The trough has tears at the connections.							
Pier #9 assembly joint- is half full of debris. No tearing was noted at the connections.

Torn location on the neoprene trough in bay #2 over pier #3.

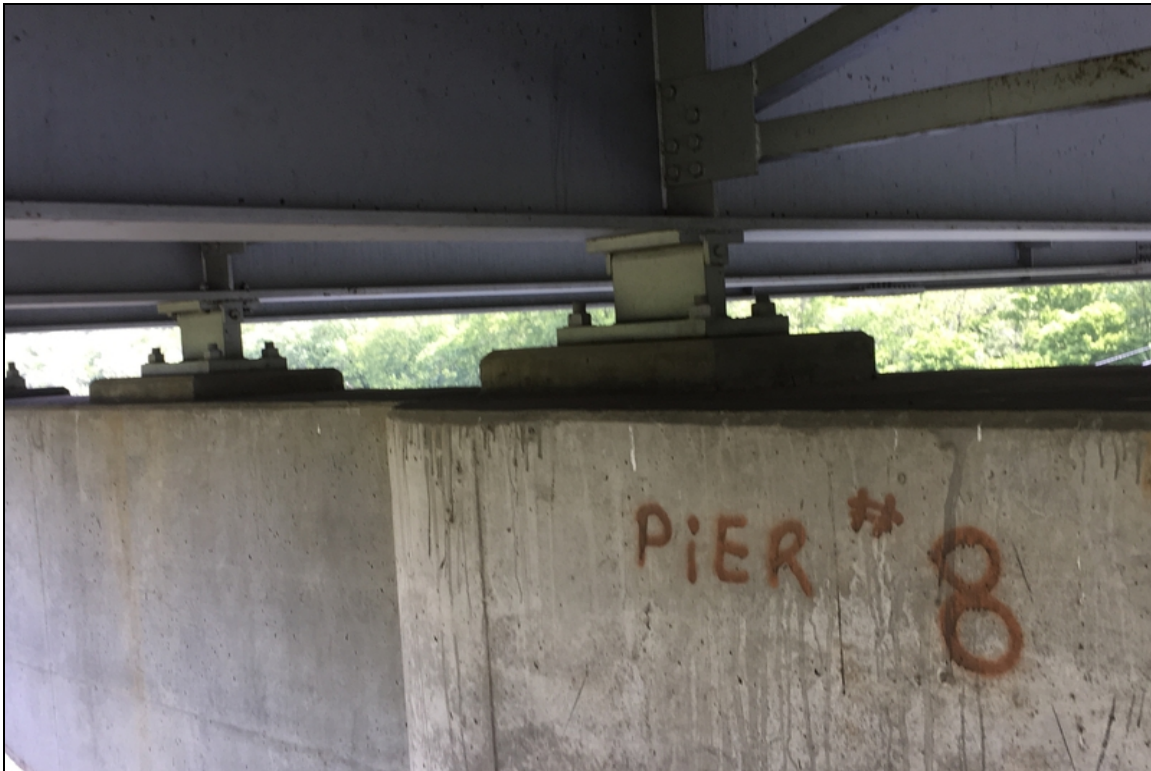
Fixed bearing condition at pier #8. Typical of all 6 at this location.

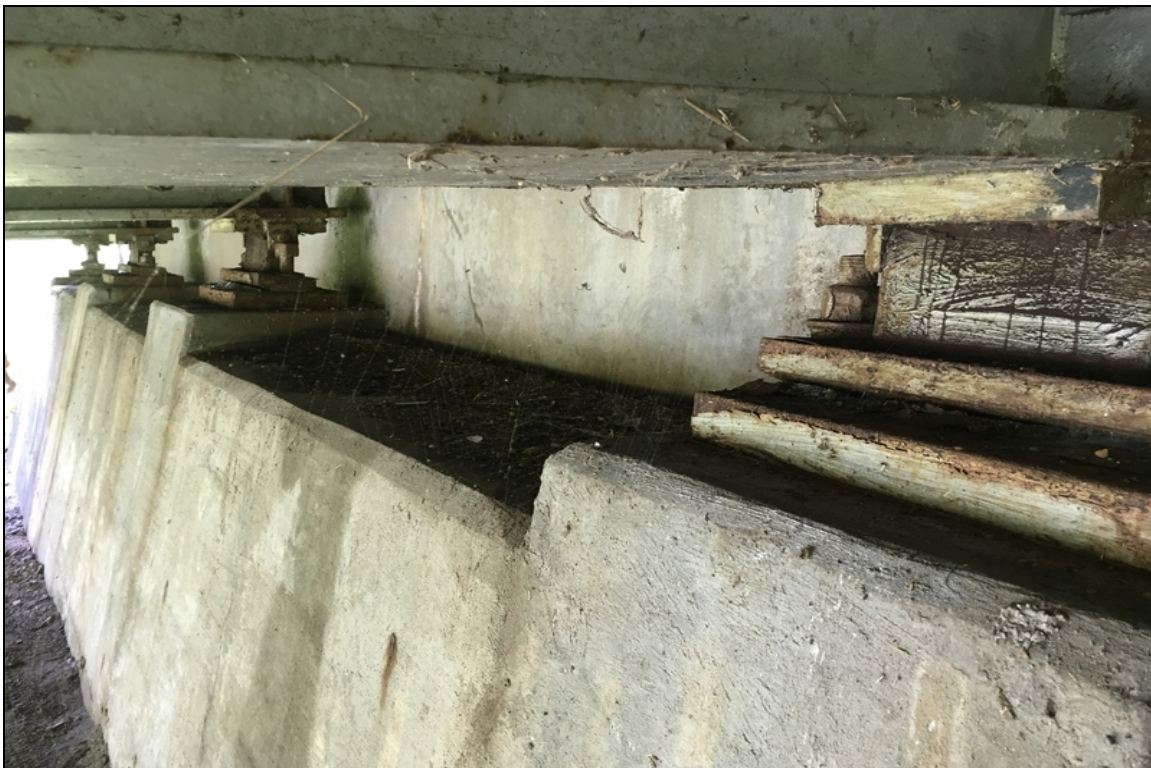
Bearing condition at abutment #2. Typical of all 6 rocker bearings at this location.

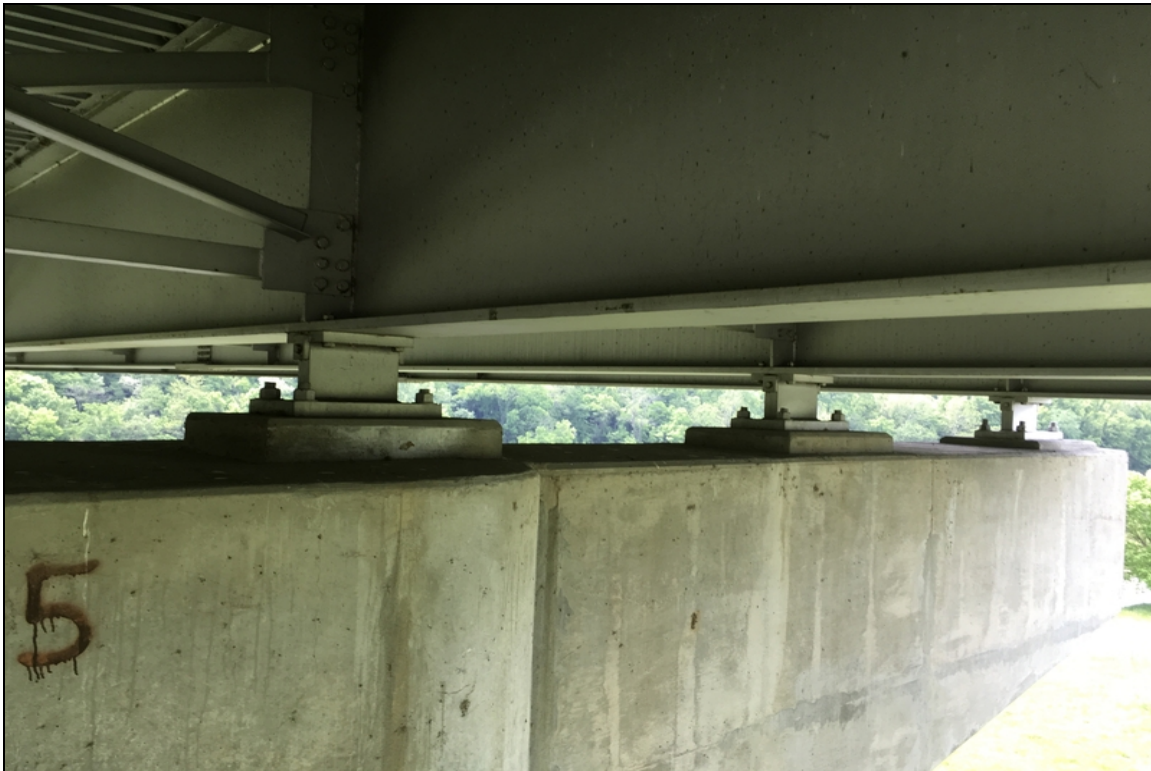
Fixed bearing condition at pier #5. Typical of all 6 at this location.

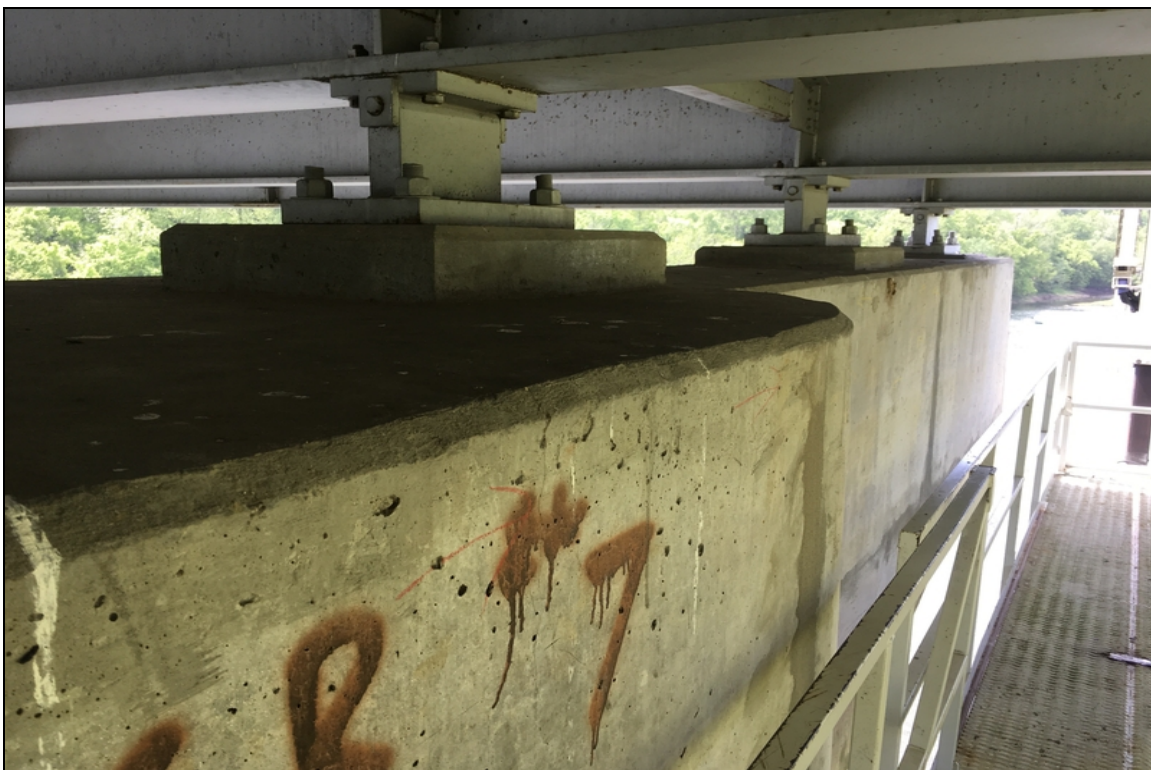
Fixed bearing condition at pier #7. Typical of all 6 at this location.

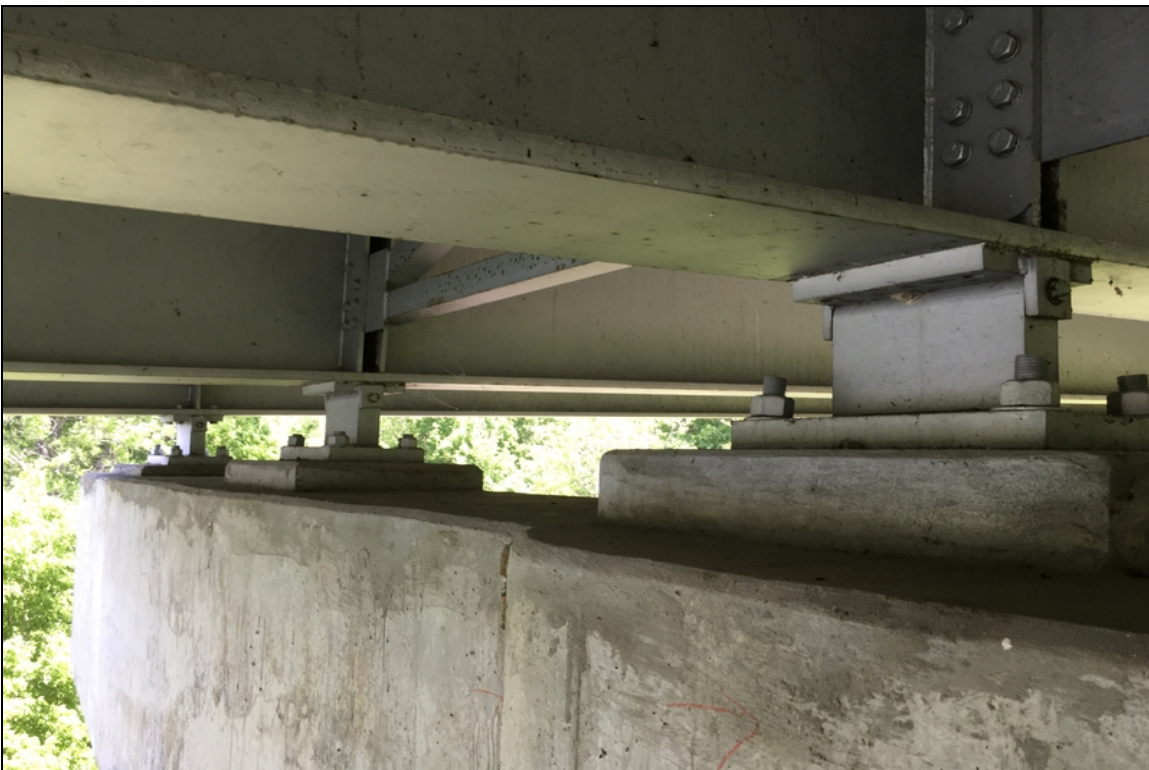
Fixed bearing condition at pier #11. Typical of all 6 at this location.

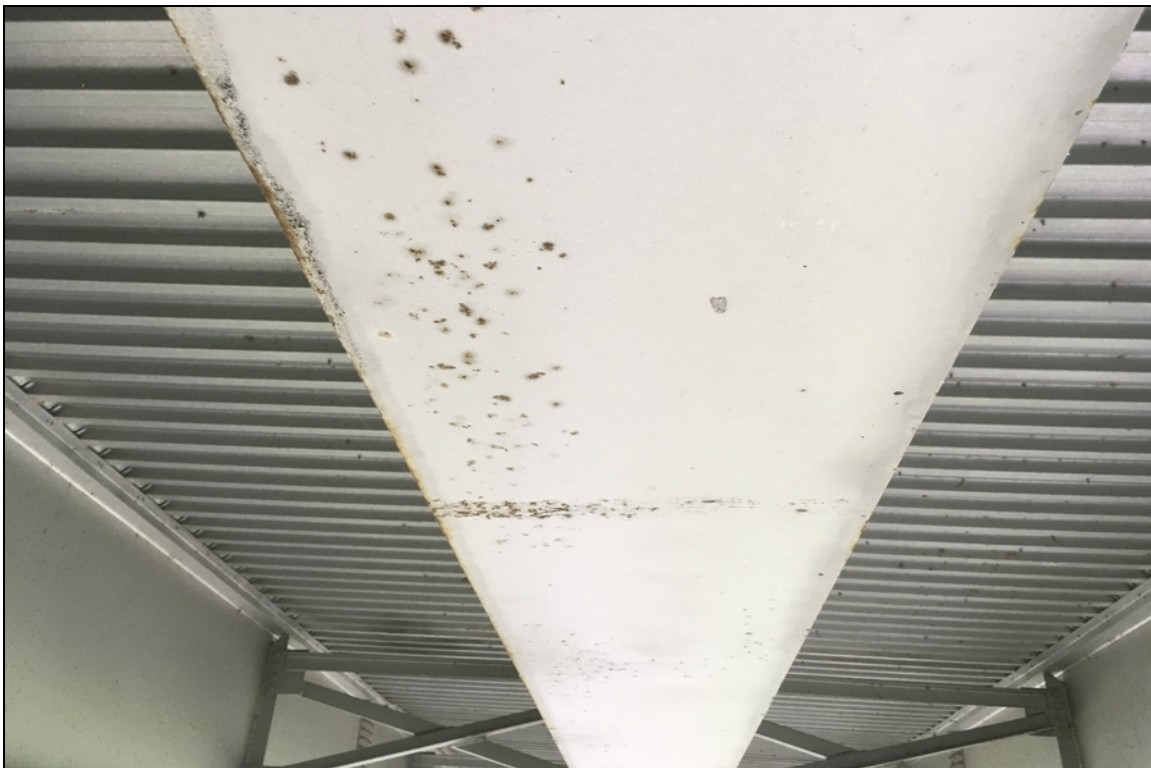
Typical paint condition of the bottom flanges of all beams.

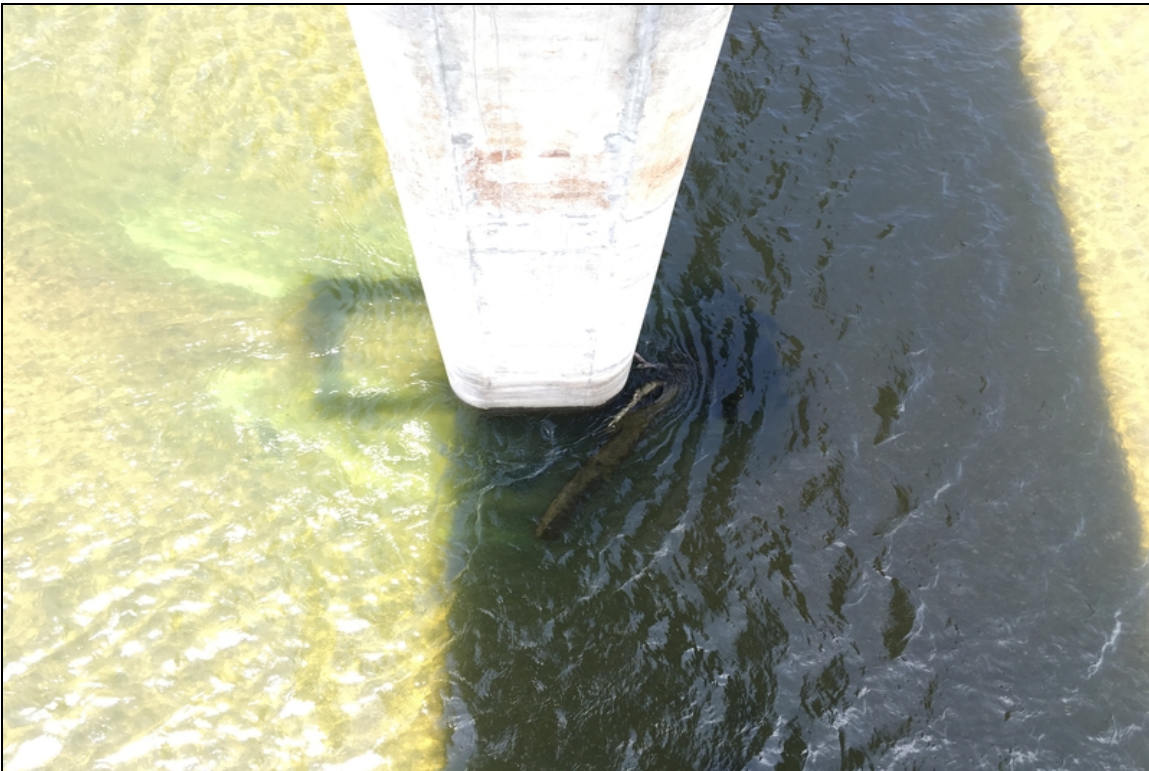
Minor drift accumulation on pier #8.

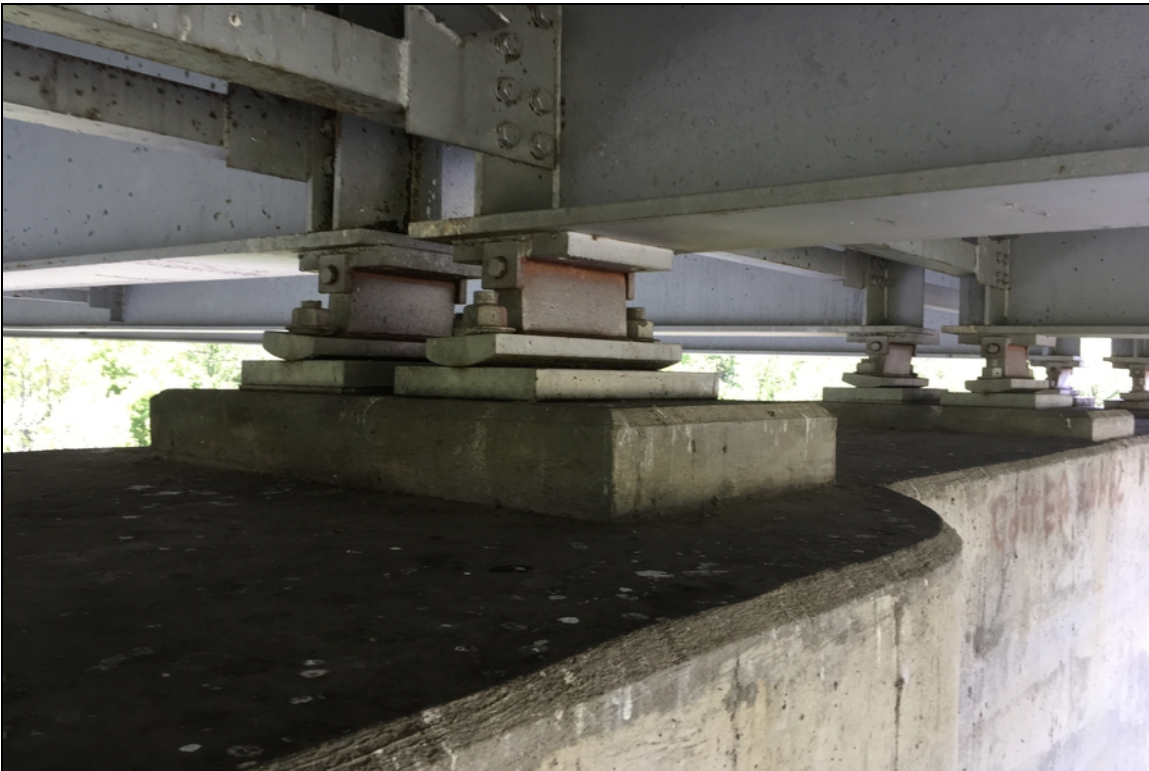
Moveable bearing condition at pier #9. Typical of the 8 interior bearings.

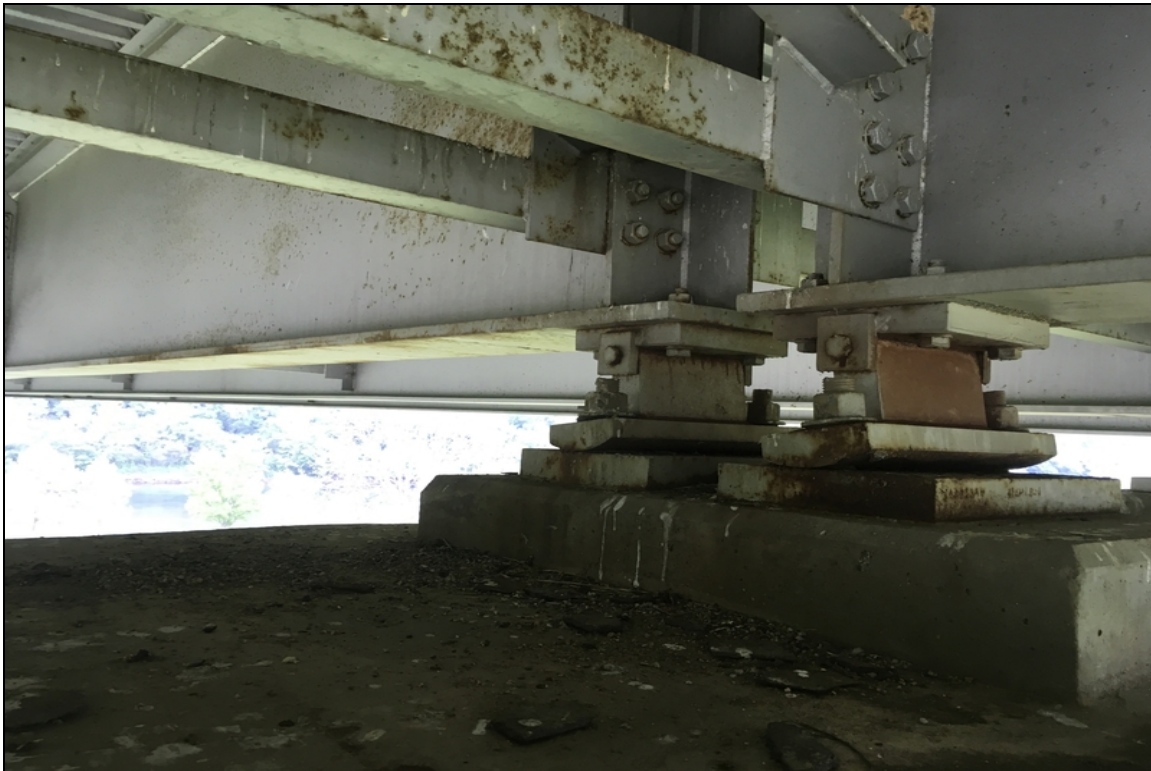
Condition of the 8 interior moveable bearings at pier #3.

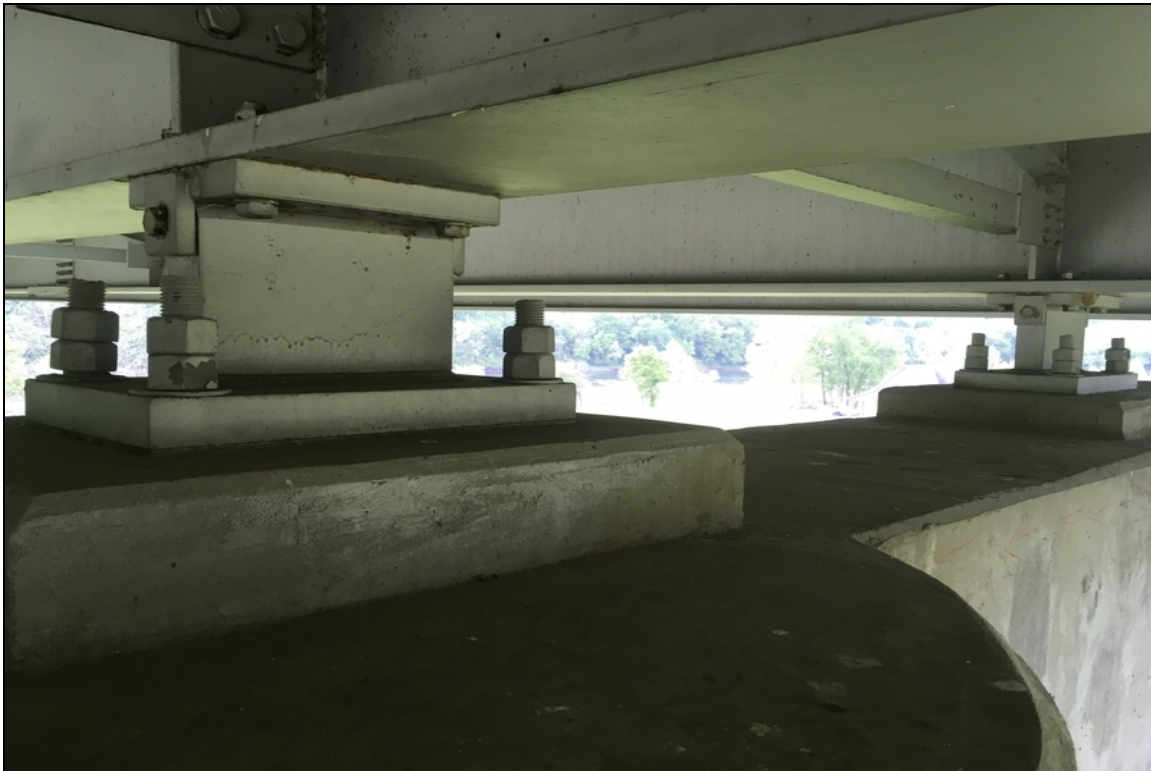
Pier #2 bearing condition. Typical of all 6 at this location.

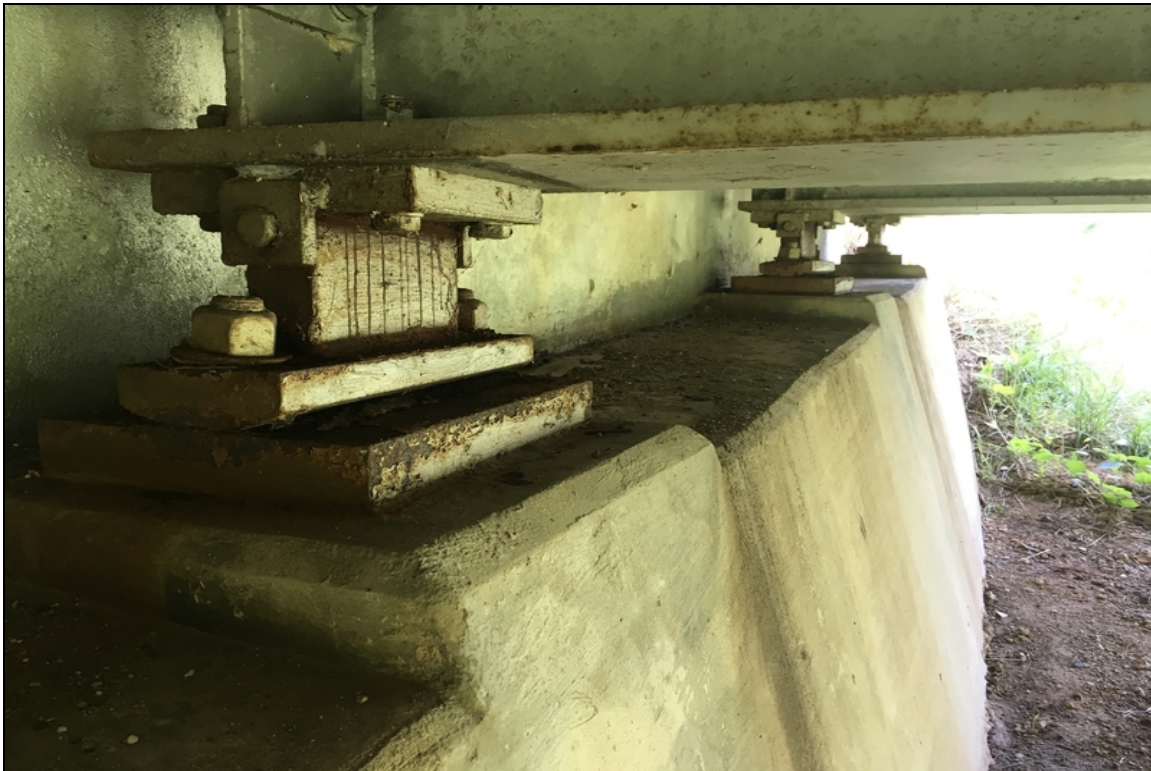
General view of abutment #1 moveable bearings. Typical of all 6 at this location.

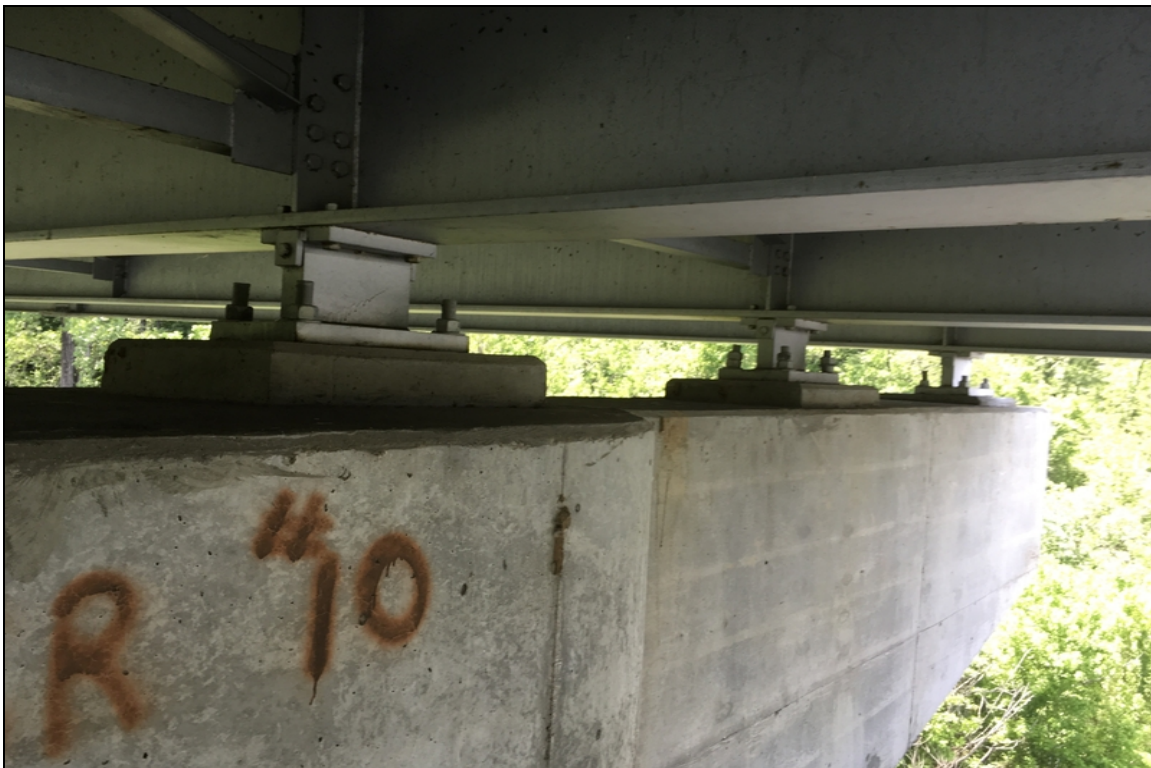
Fixed bearing condition at pier #10. Typical of all 6 at this location.

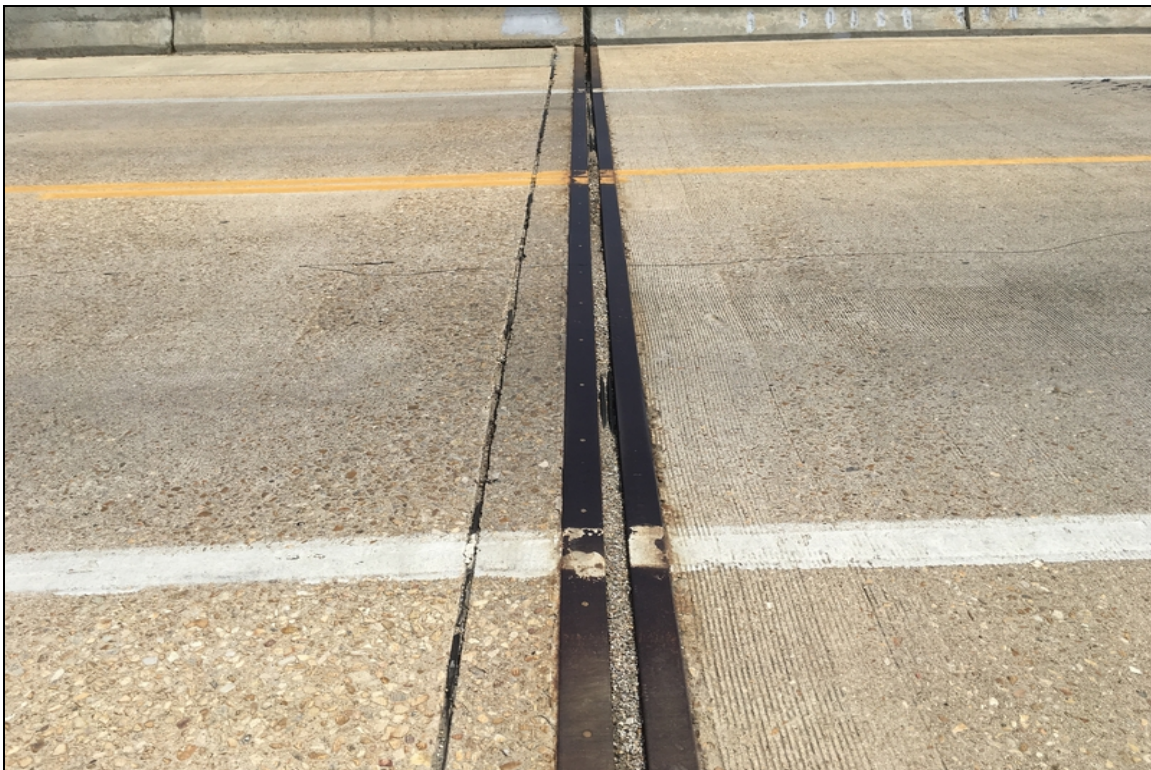
302	Compression Joint Seal	LF	96	0	48	39	9
2310	Leakage	LF	41	0	17	15	9
2320	Seal Adhesion	LF	24	0	0	24	0
2350	Debris Impaction	LF	31	0	31	0	0
(302)							
Abutment #1 compression joint seal- has debris impaction at the extreme ends wth areas of adhesion loss. The armoring plates have pack rust on the vertical faces.							
Abutment #2 compression joint seal- has debris impaction at the extreme ends wth areas of adhesion loss. The right and left lanes have cs4 leakage due to the seal being dislodged. The armoring plates have pack rust on the vertical faces.							
303	Assembly Joint with Seal	LF	132	0	44	88	0
2350	Debris Impaction	LF	132	0	44	88	0

General view of the abutment #1 compression joint seal condition.

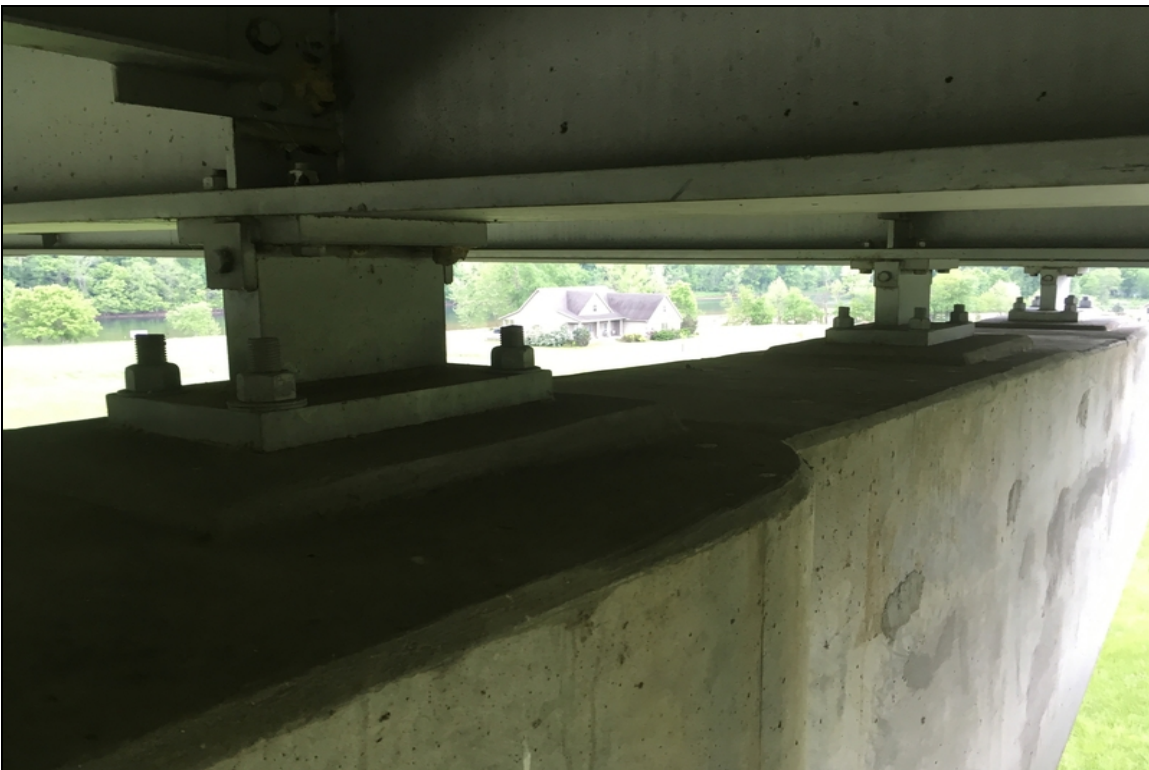
Fixed bearing condition at pier #1. Typical of all 6 at this location.
