Bridge #00338(Routine, Underwater type 2)

SH 14 Marion over CROOKED CREEK

Team Lead: Benjamin Smith Inspection Date: September 21, 2021

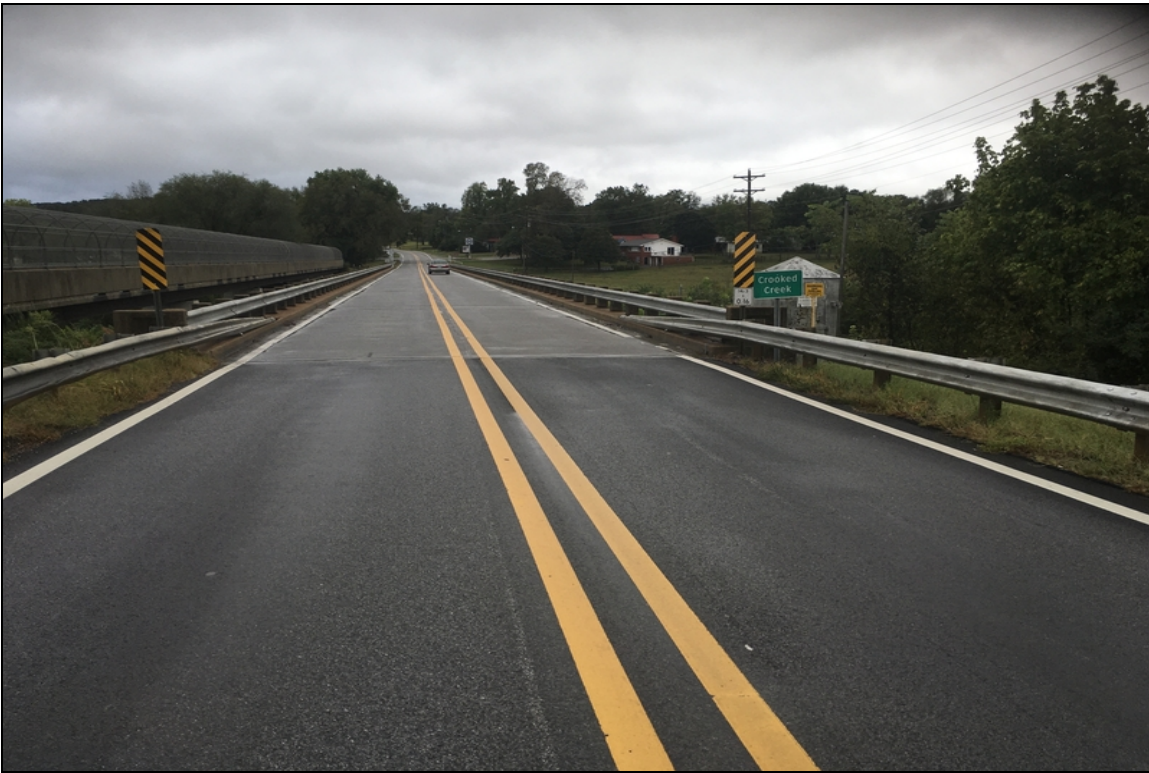
Approach view in direction of log mile.

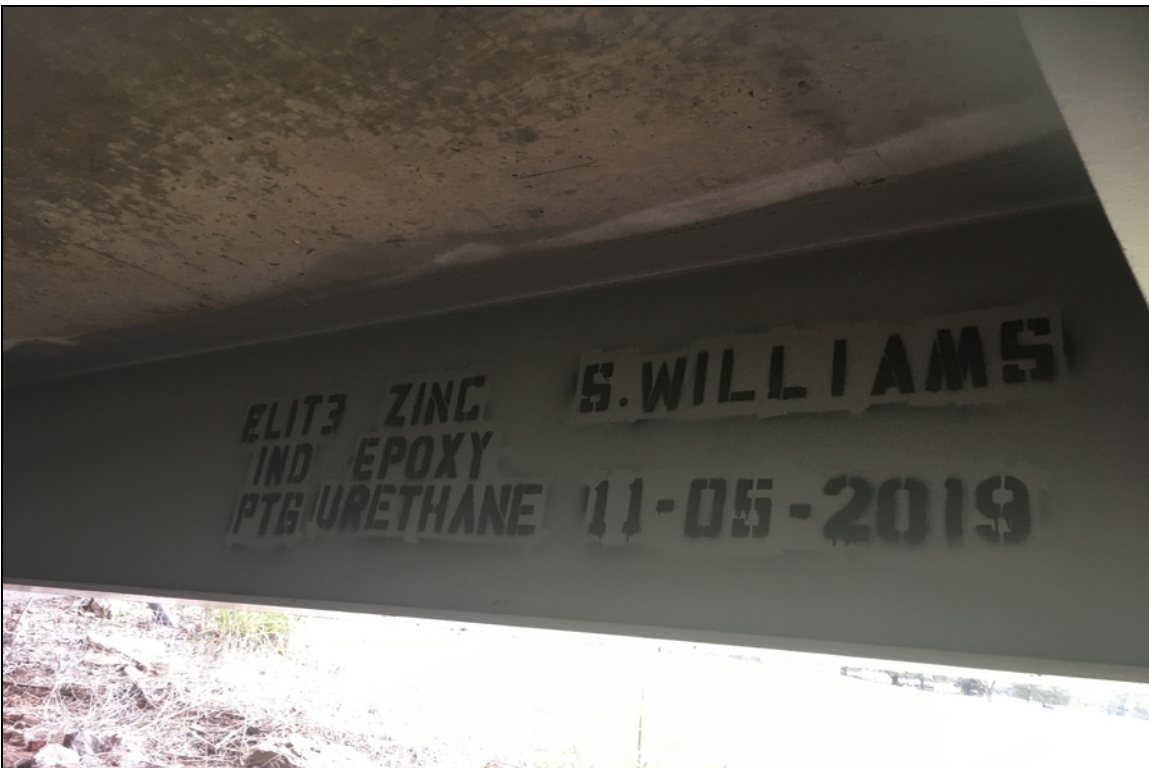
Paint rehab stencil.

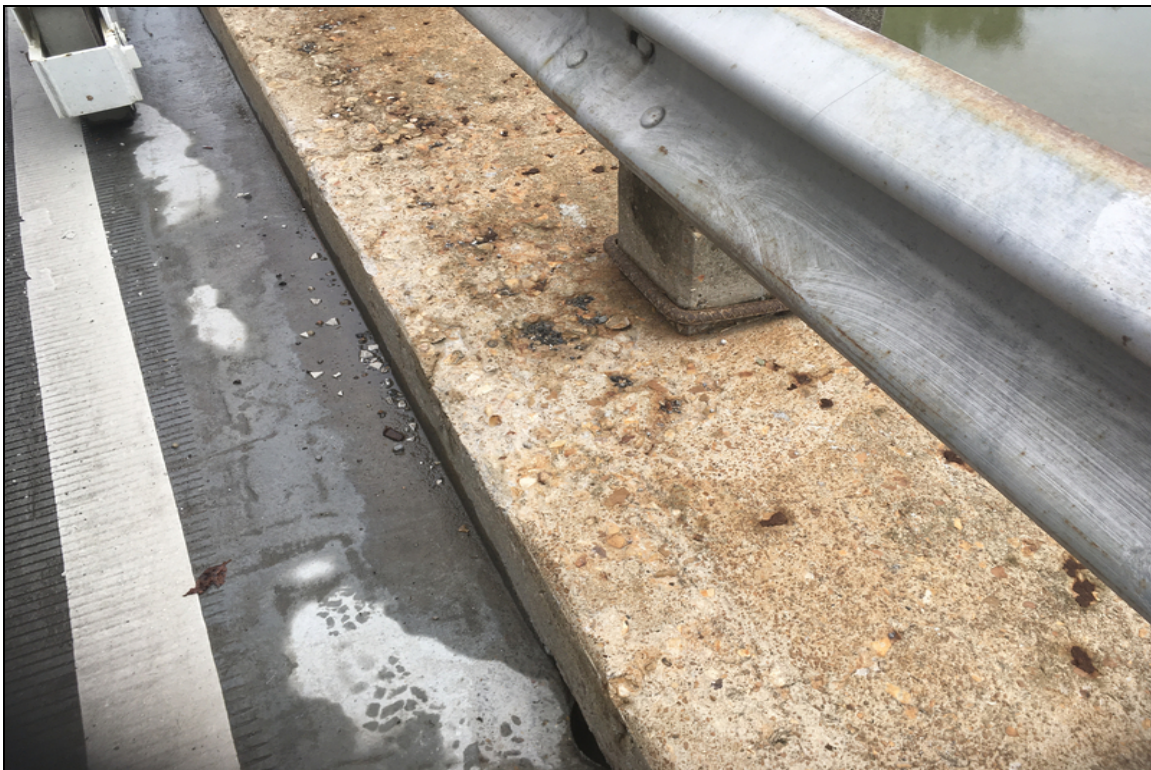
Typical view of the curb section of the deck.

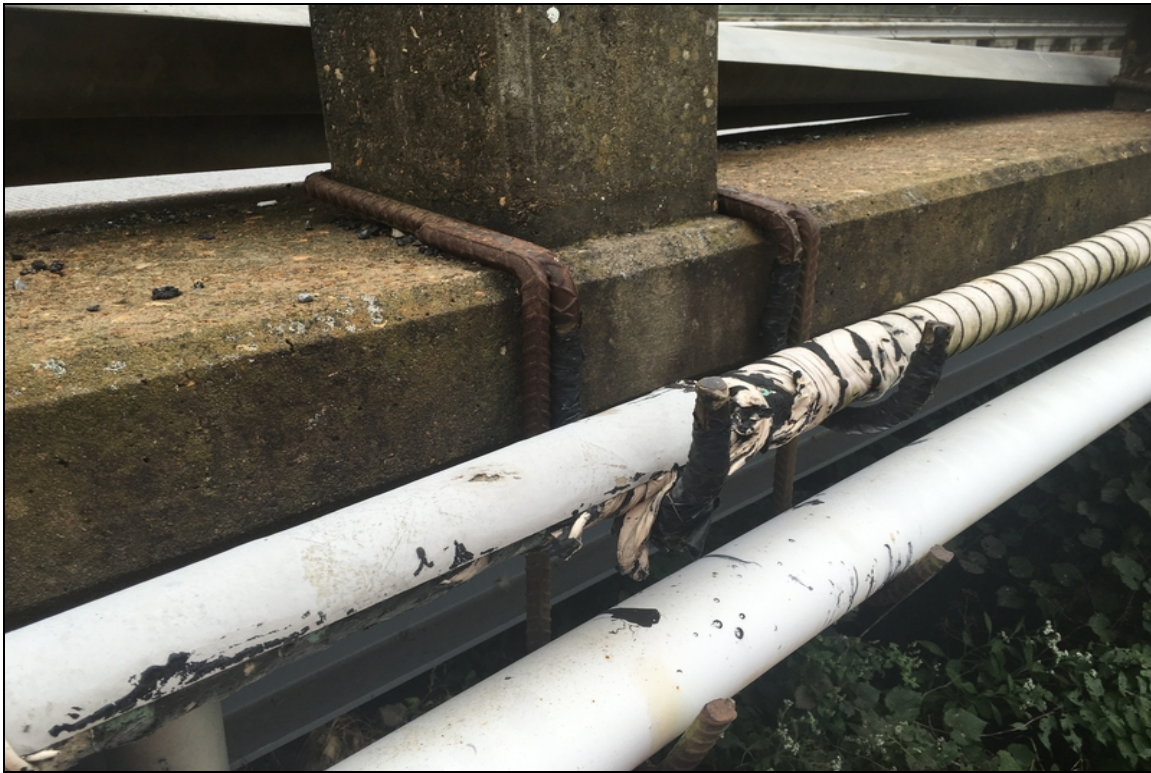
Typical utility attachment on the right side of the structure.

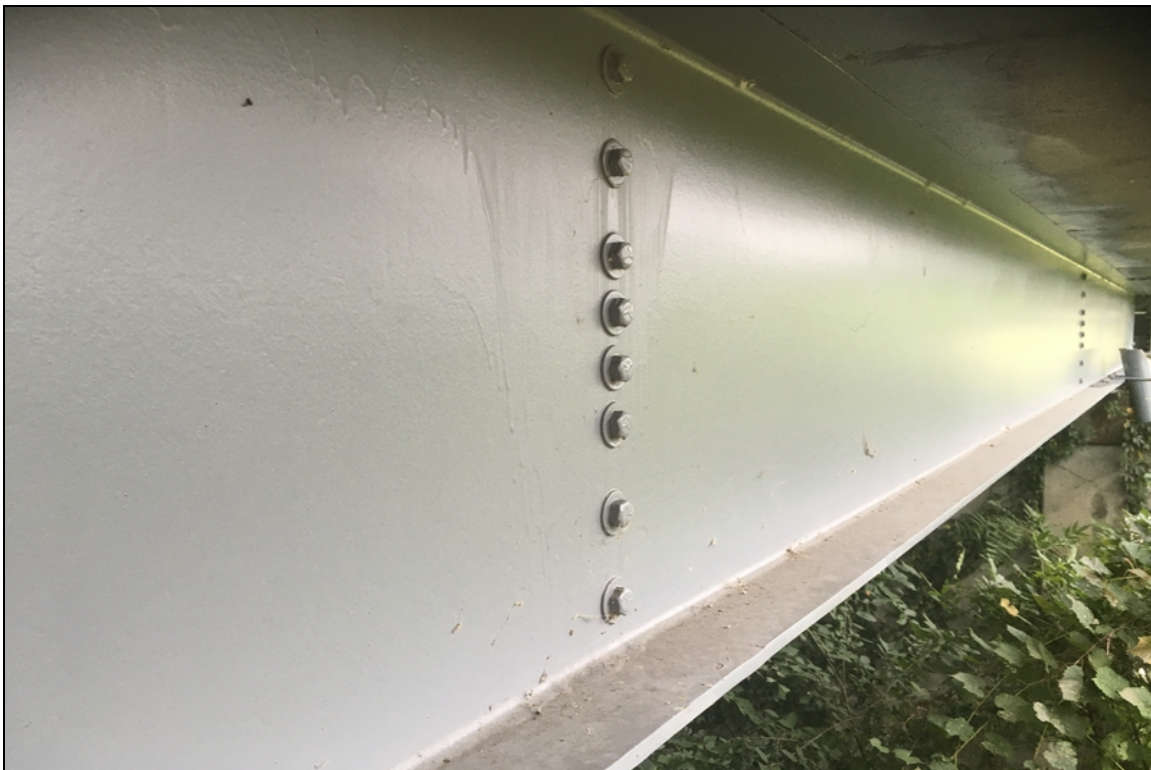
Typical view of paint condition.

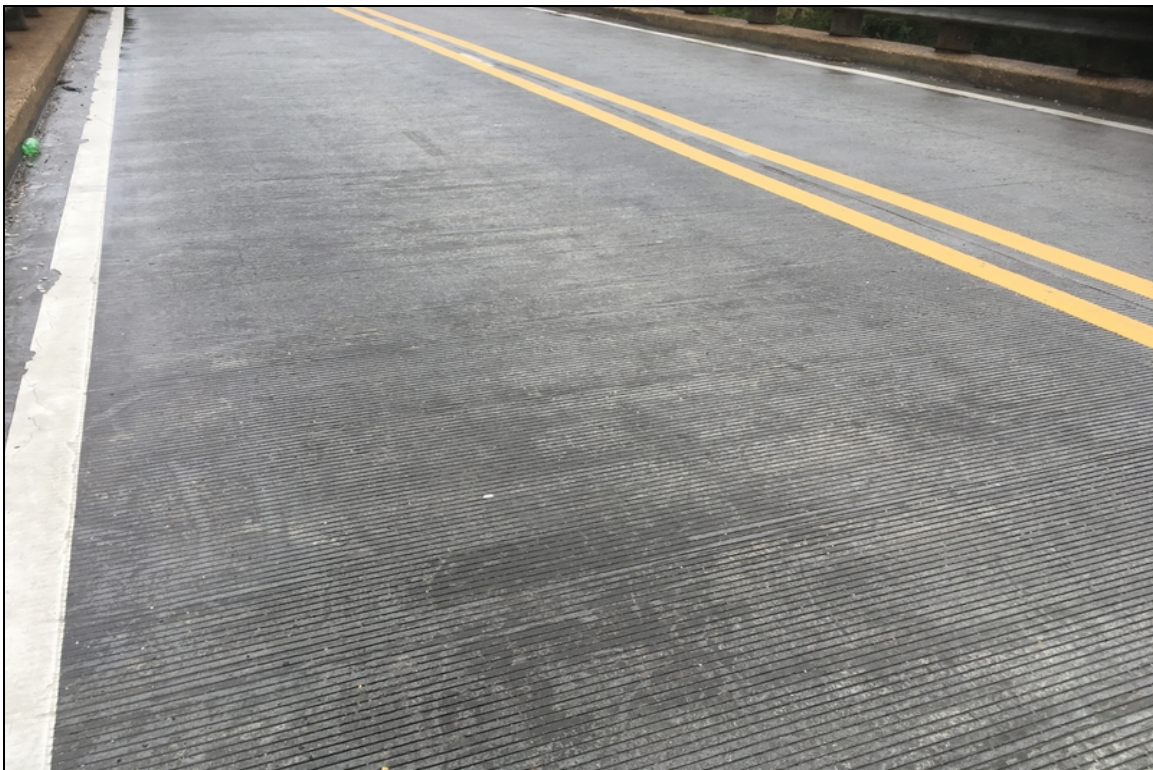
Typical view of driving surface.

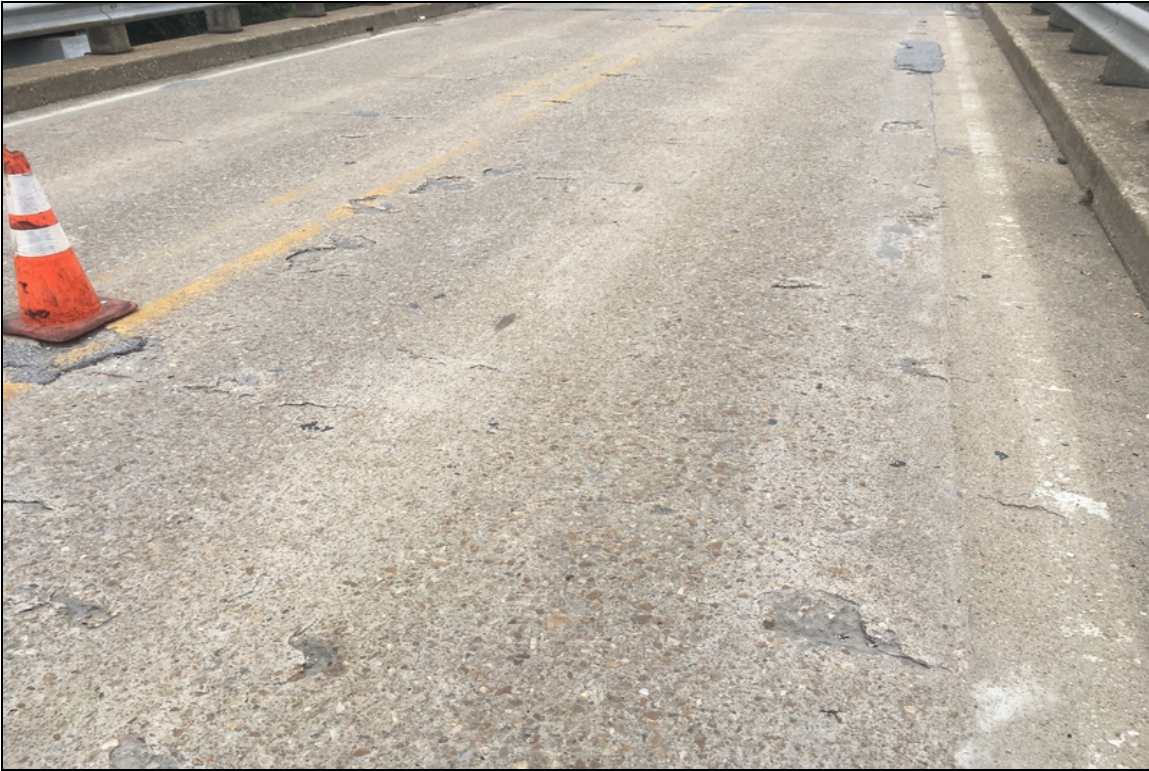
Span #2 driving surface.

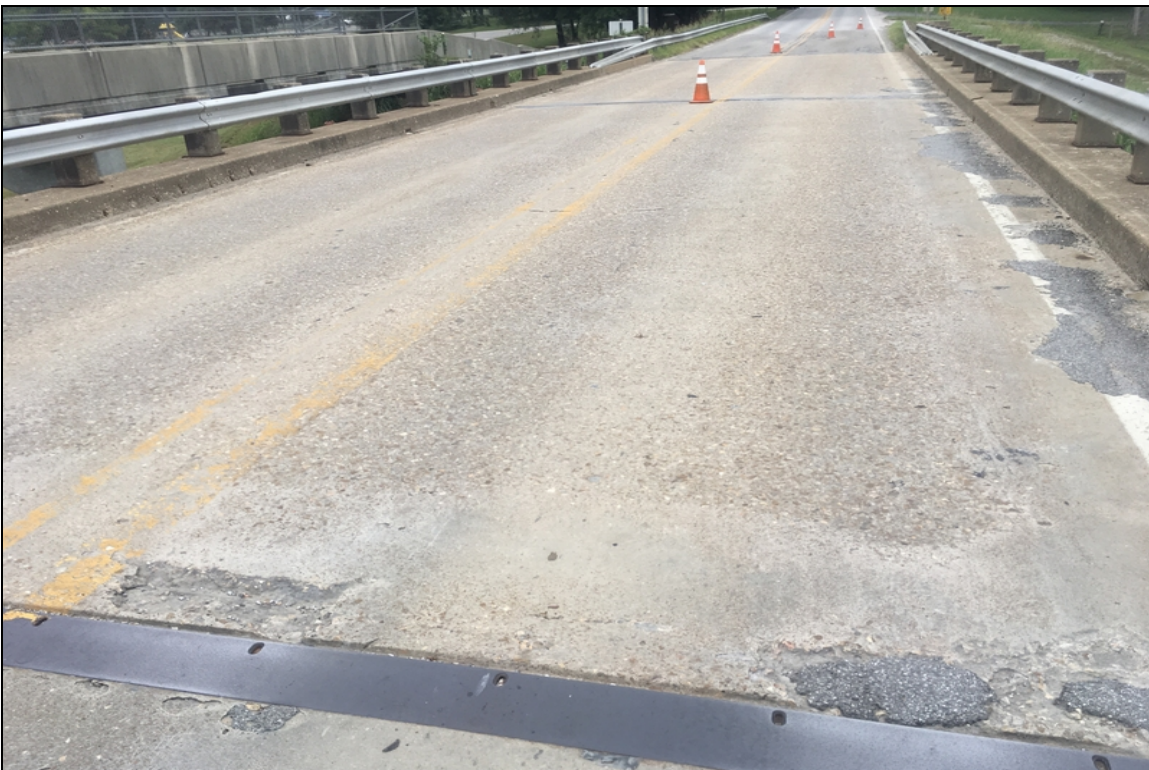
Span #7 driving surface.

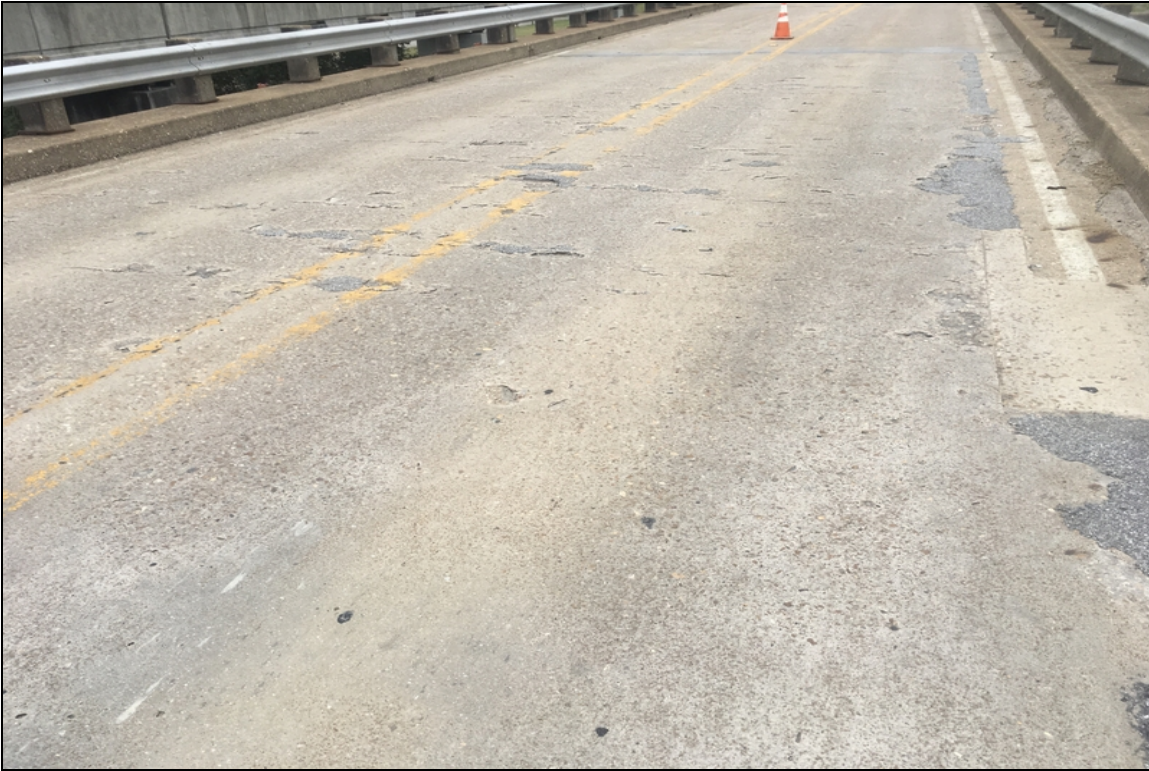
Span #4 driving surface.

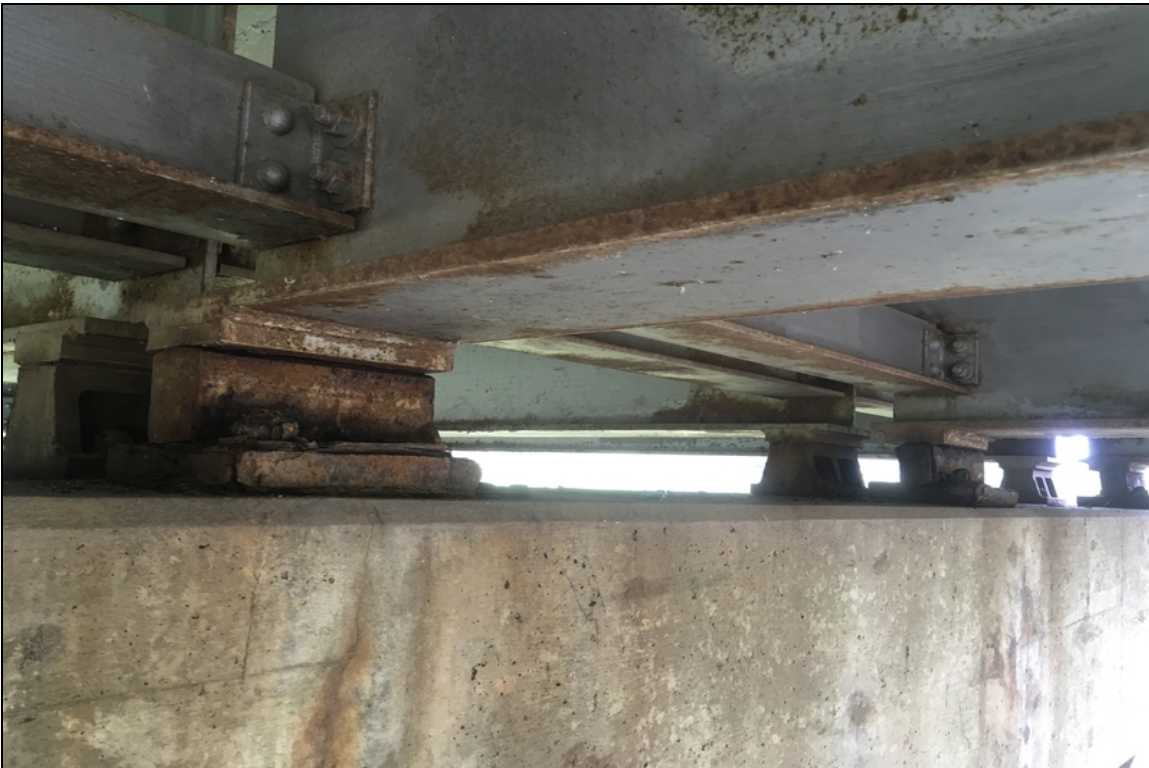
Bearing condition over pile bent #4.

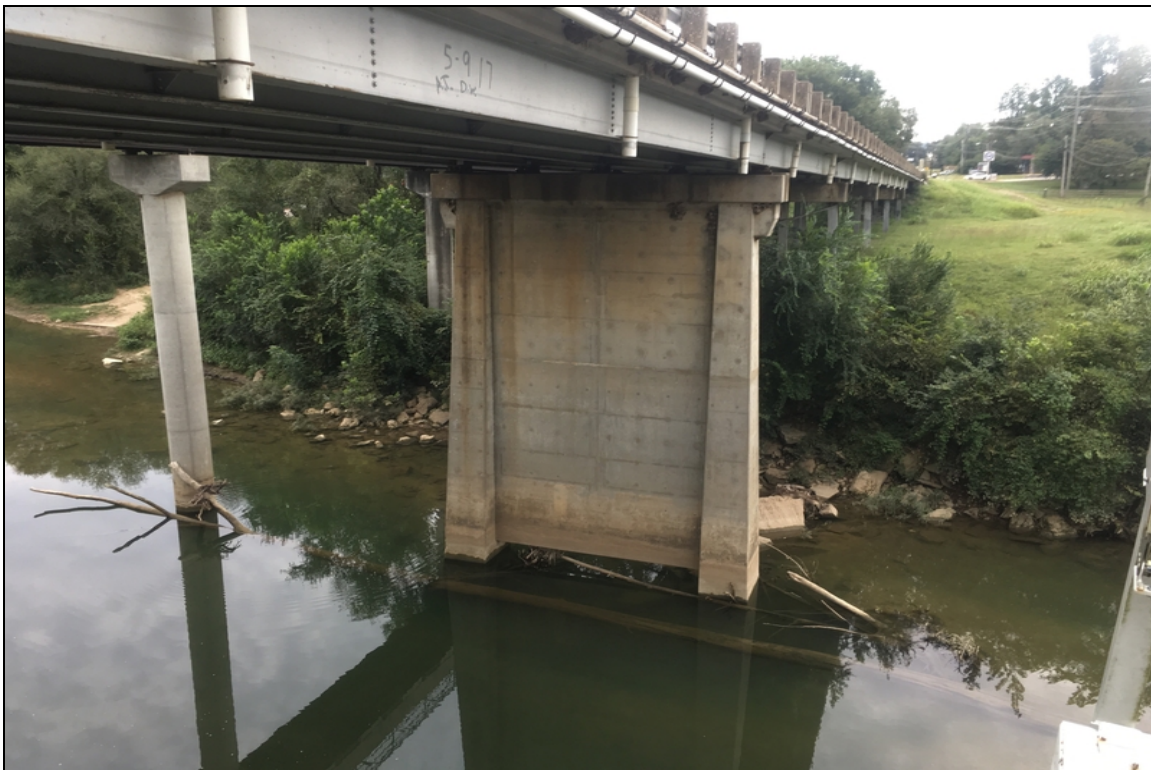
Typical view of the piers in the channel.

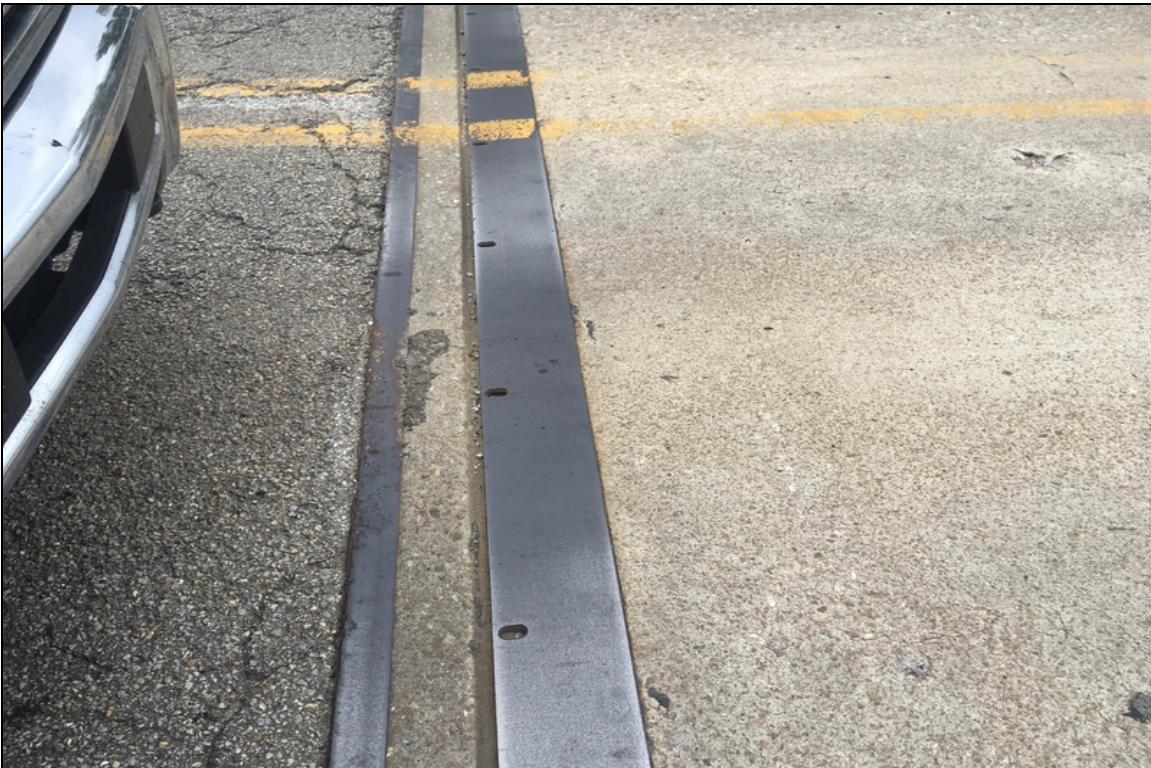
Assembly joint at abutment #1.

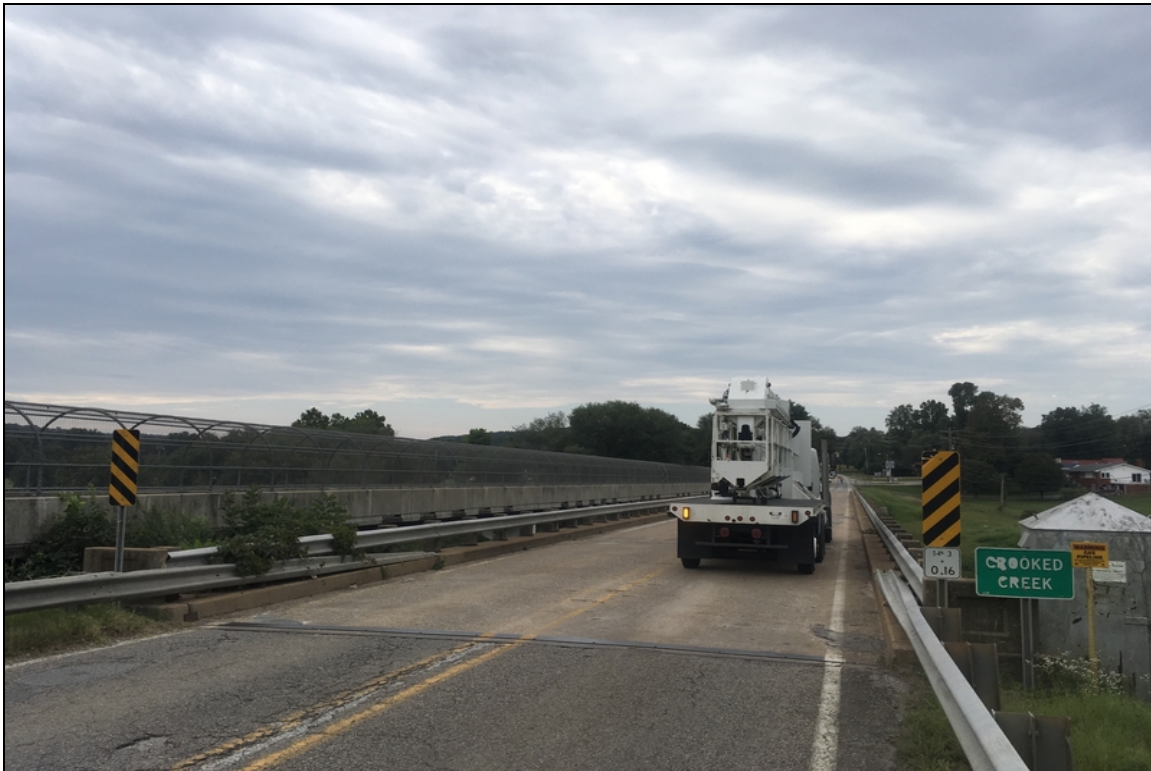
Approach view in direction of log mile.

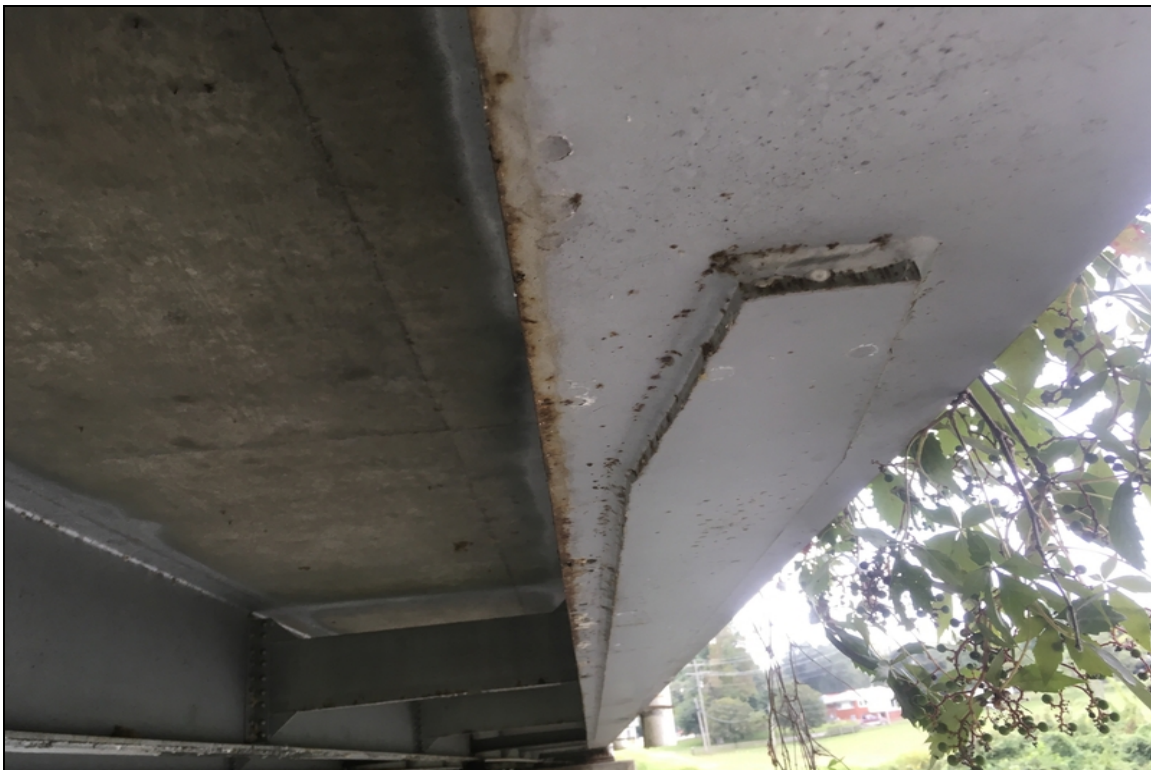
Cover plate detail.

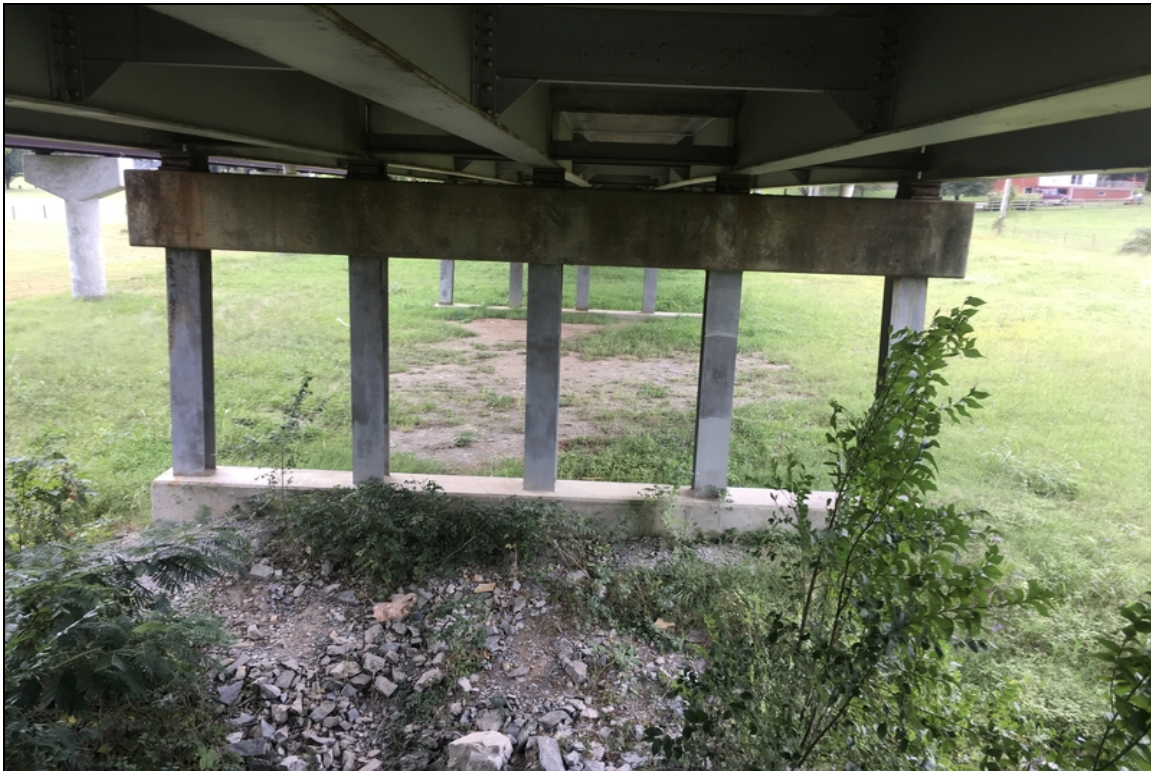
Pile bent #5 general view.

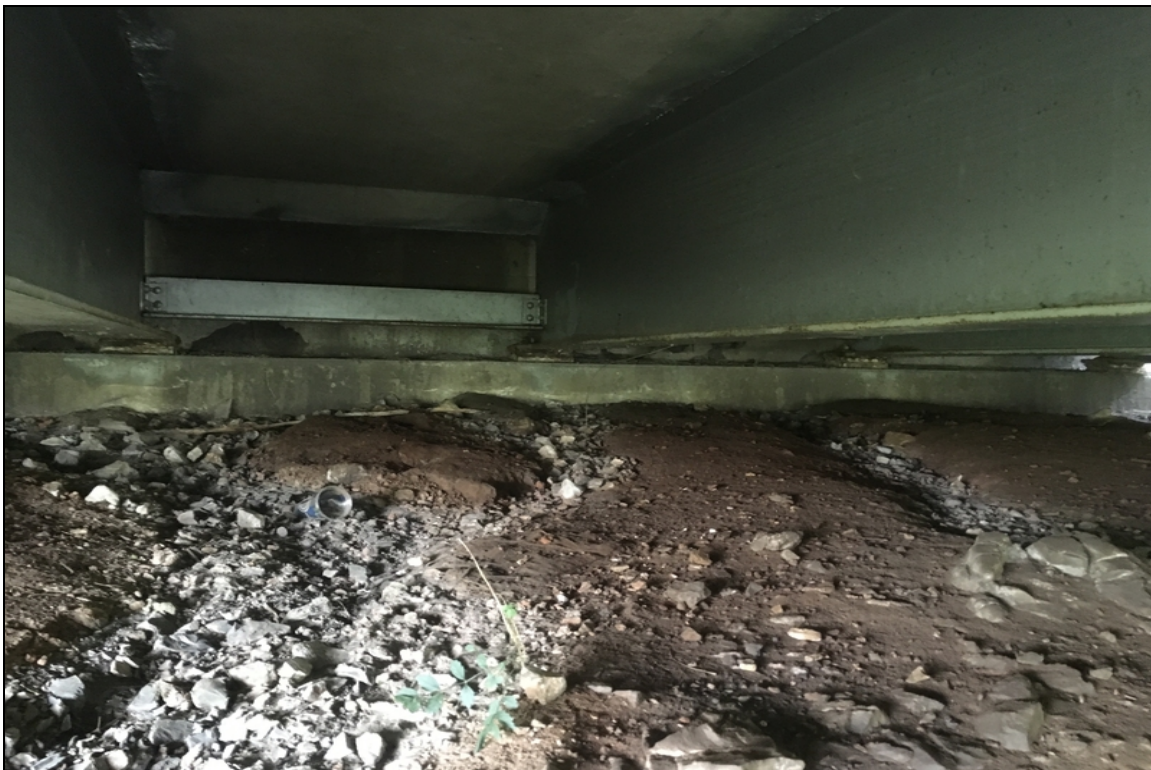
General view of abutment #1.

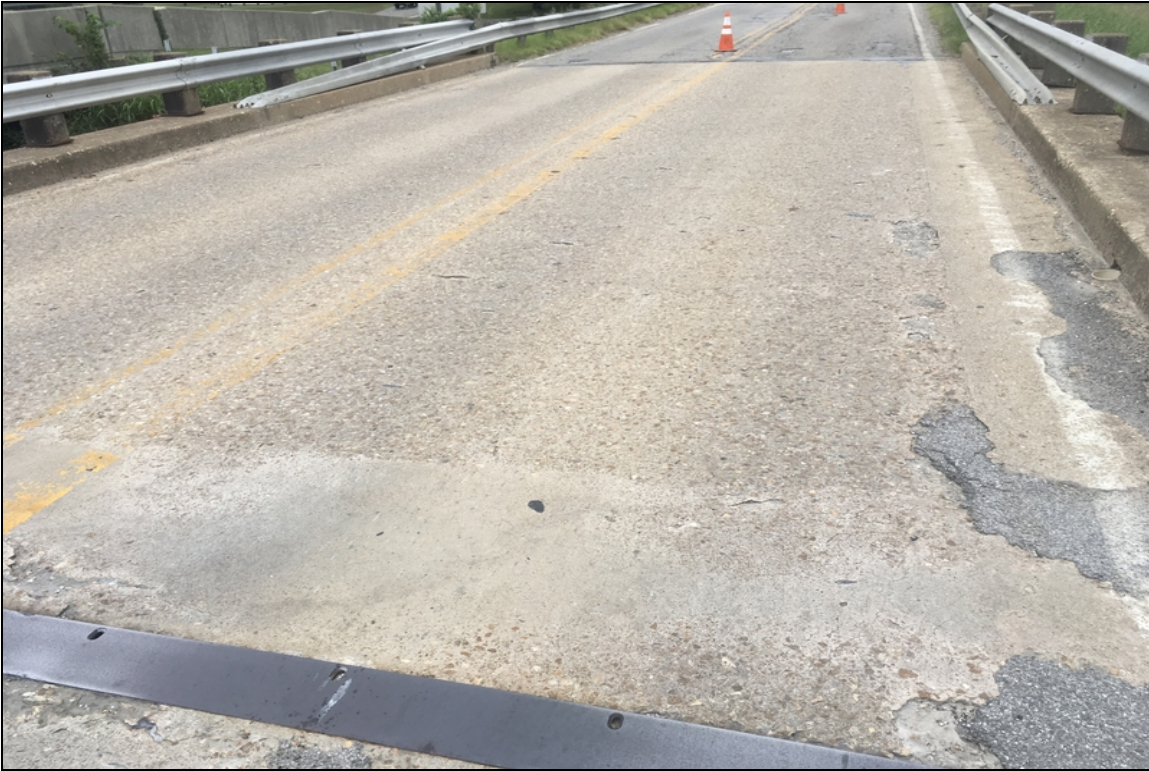
Span #8 driving surface.

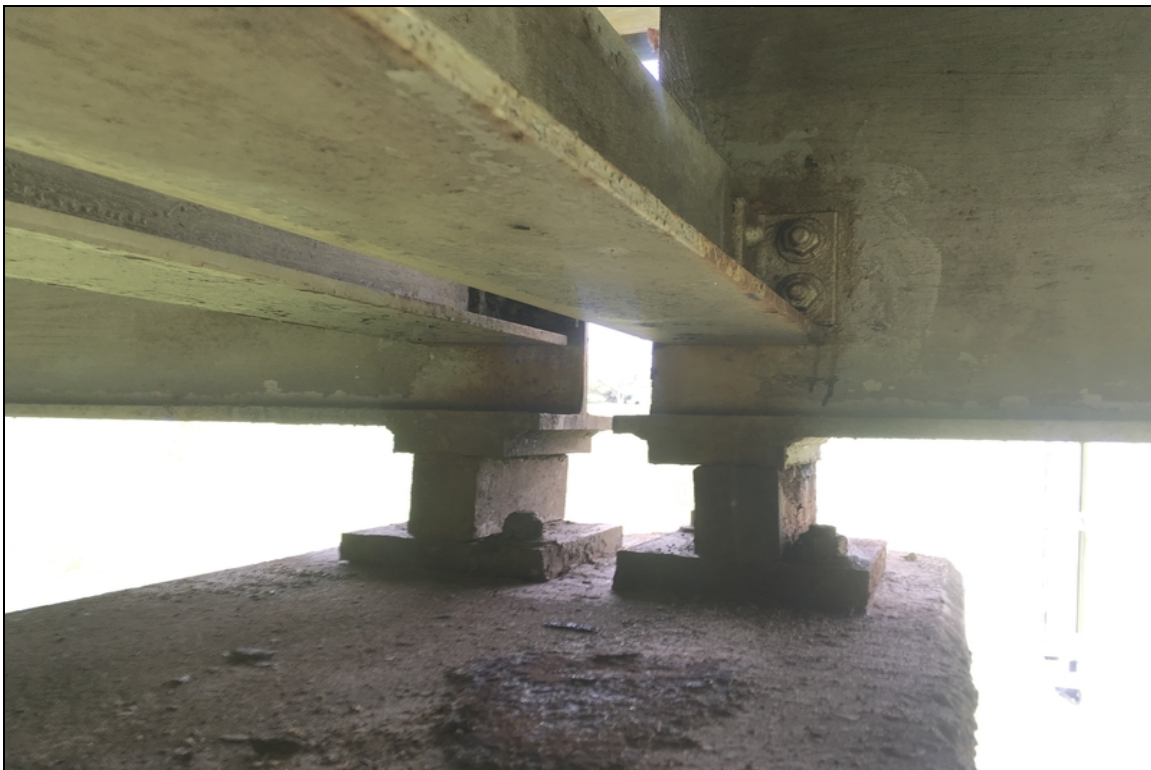
Bearing #5 at bent #7 is not centered beneath the sole plate.

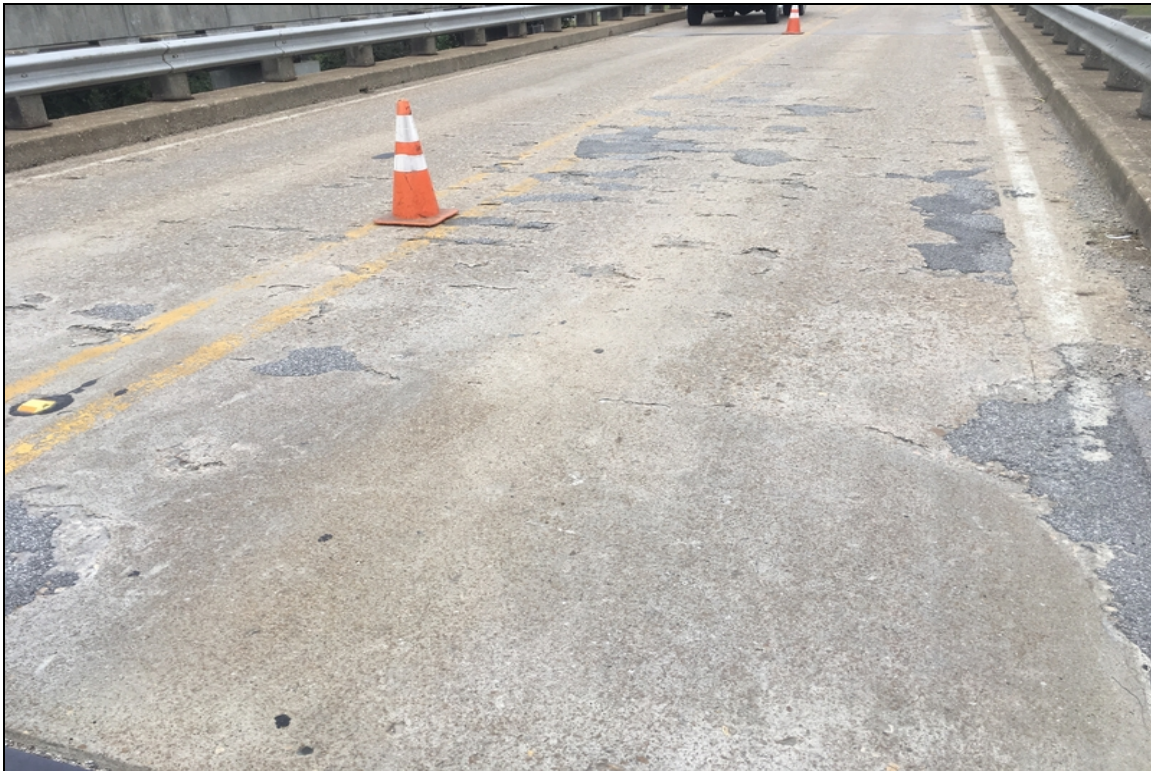
Span #3 driving surface.

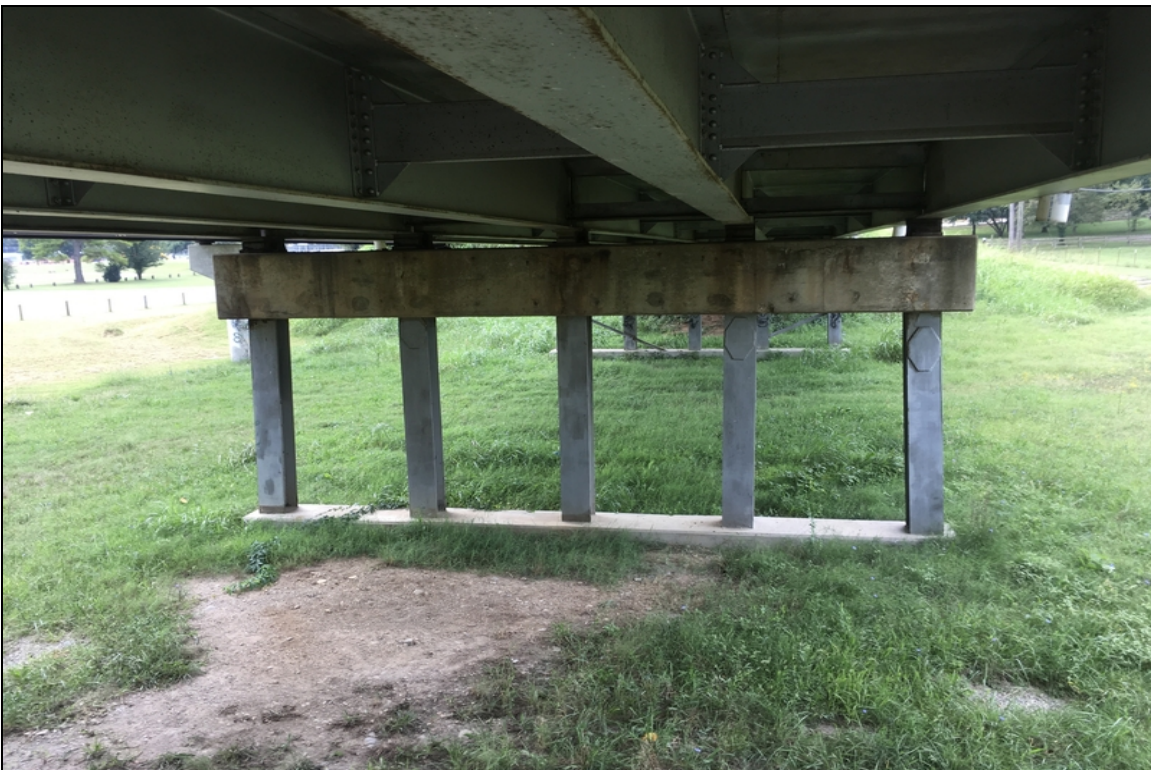
General view of pile bent #6.

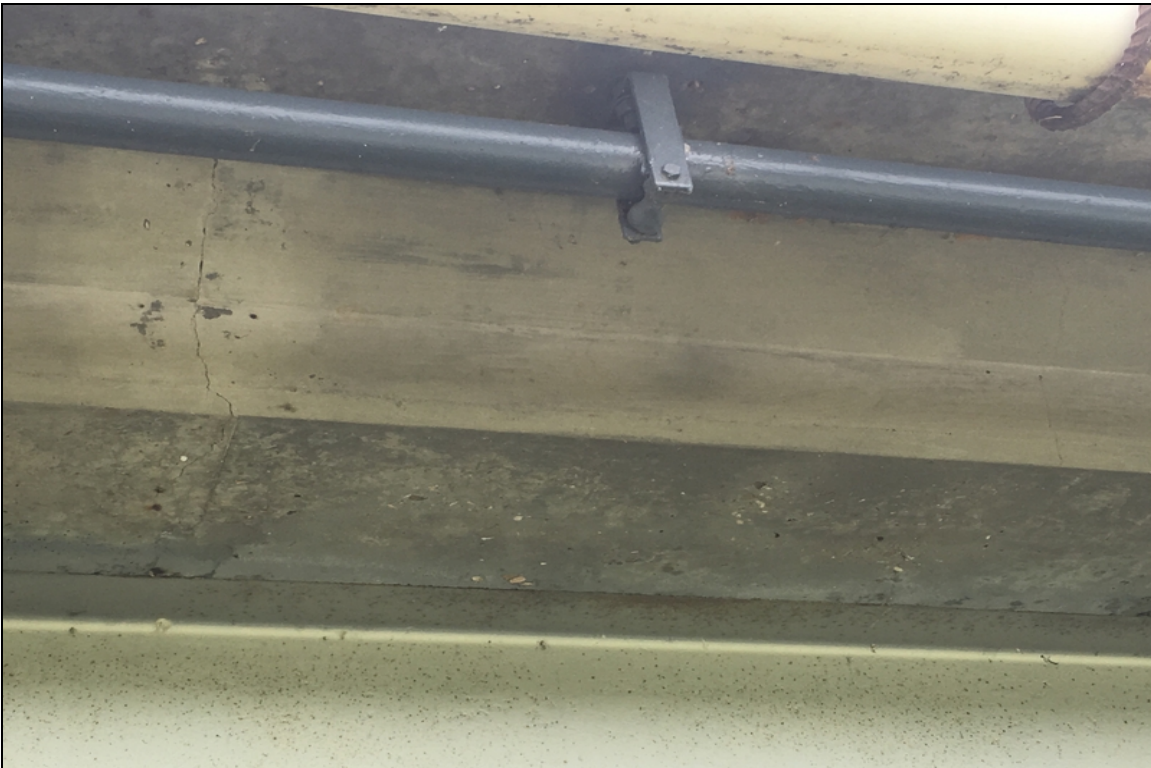
2nd Utility mount on the right side of the structure

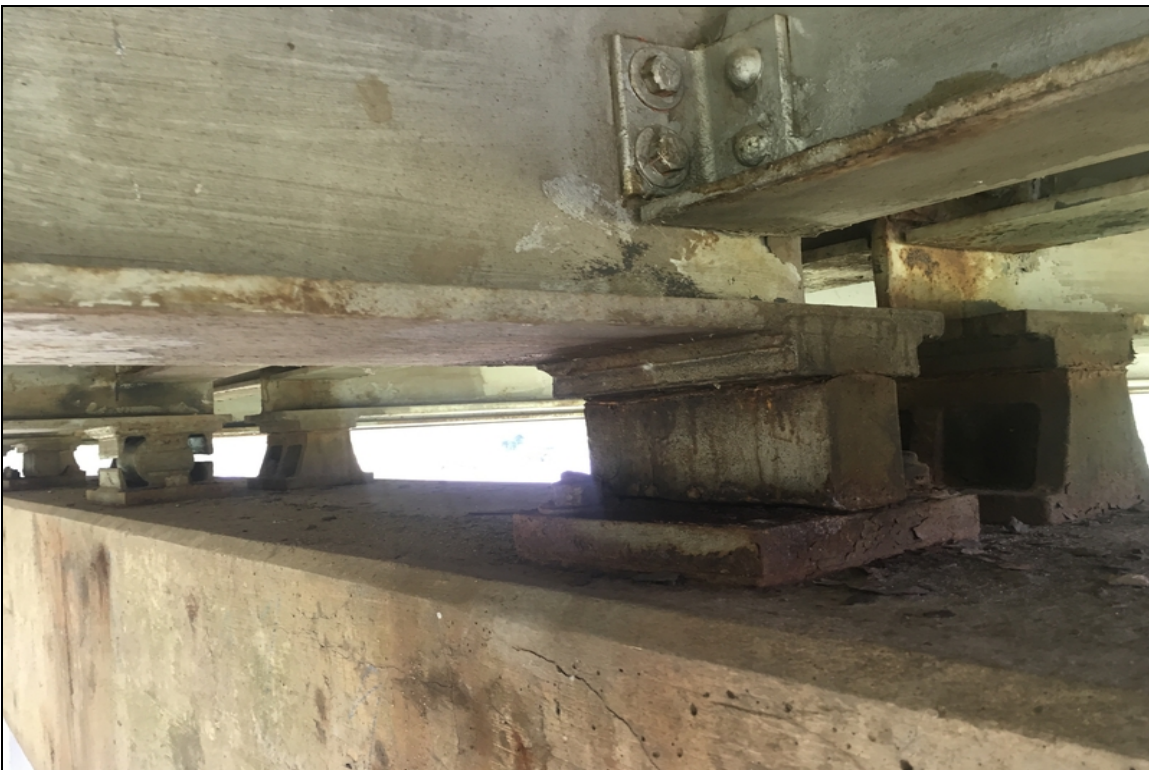
Bearing condition at pile bent #6.

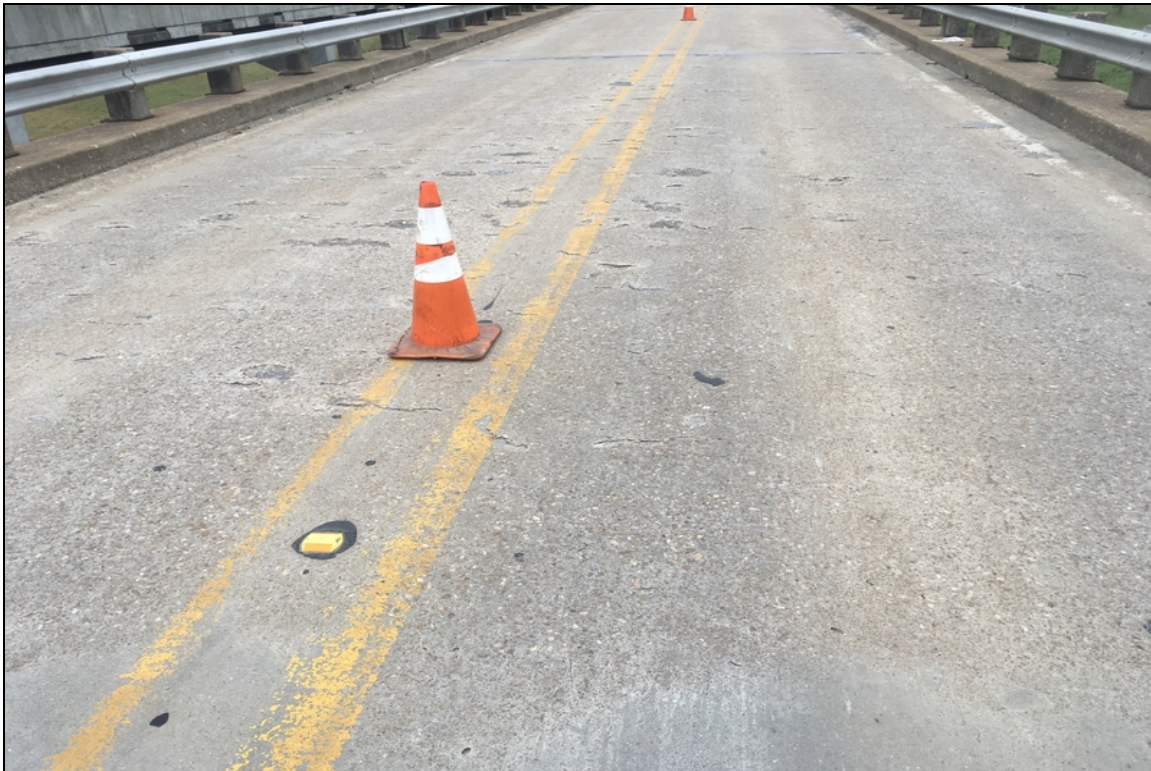
Span #5 driving surface.

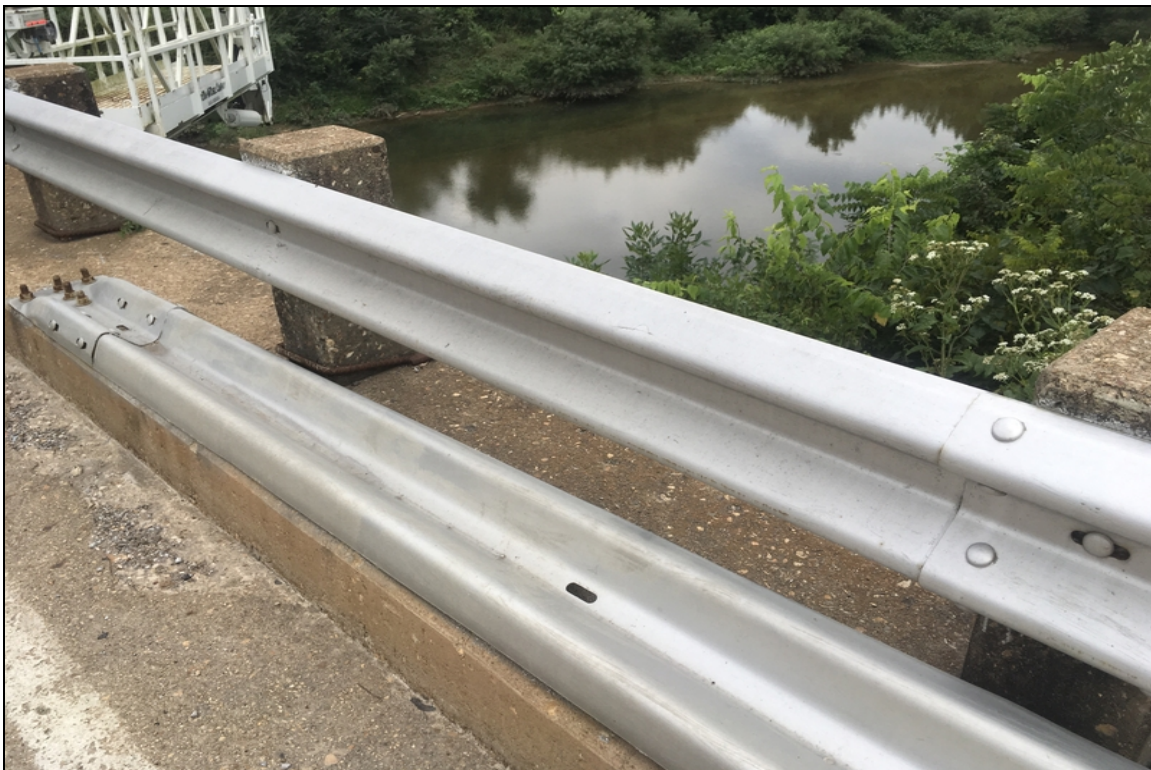
Typical metal rail condition.

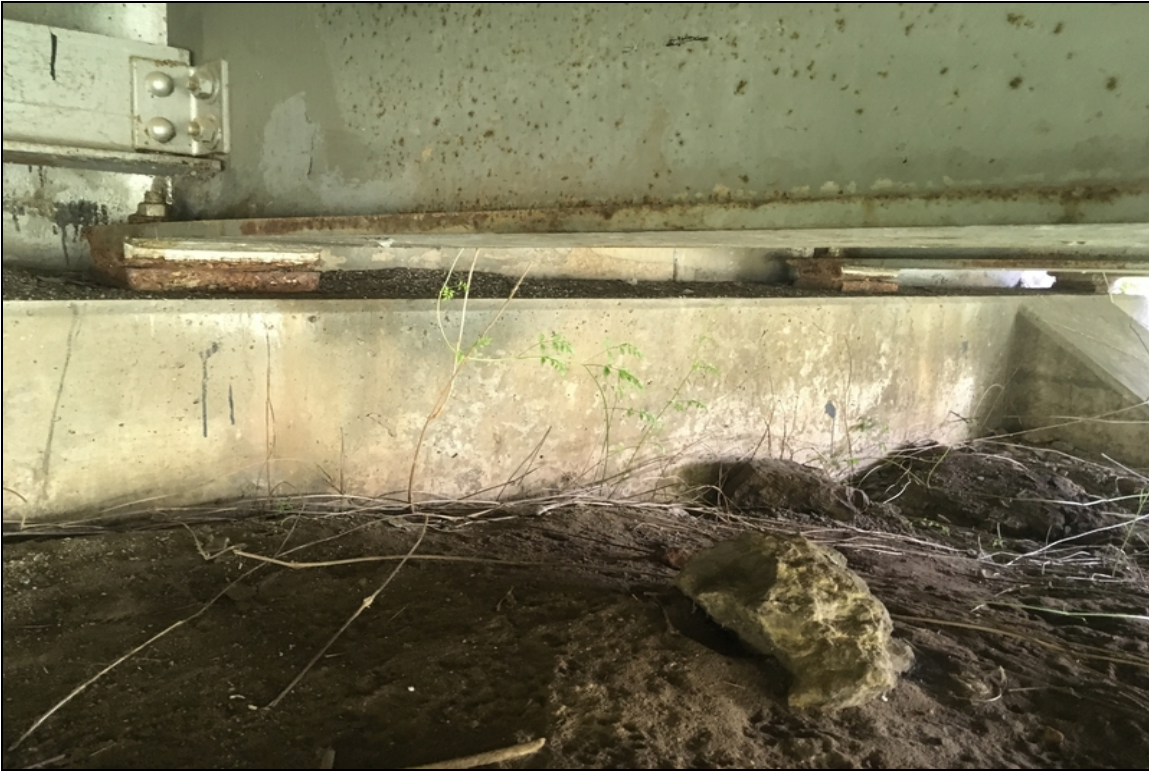
Bearing condition at abutment #2.

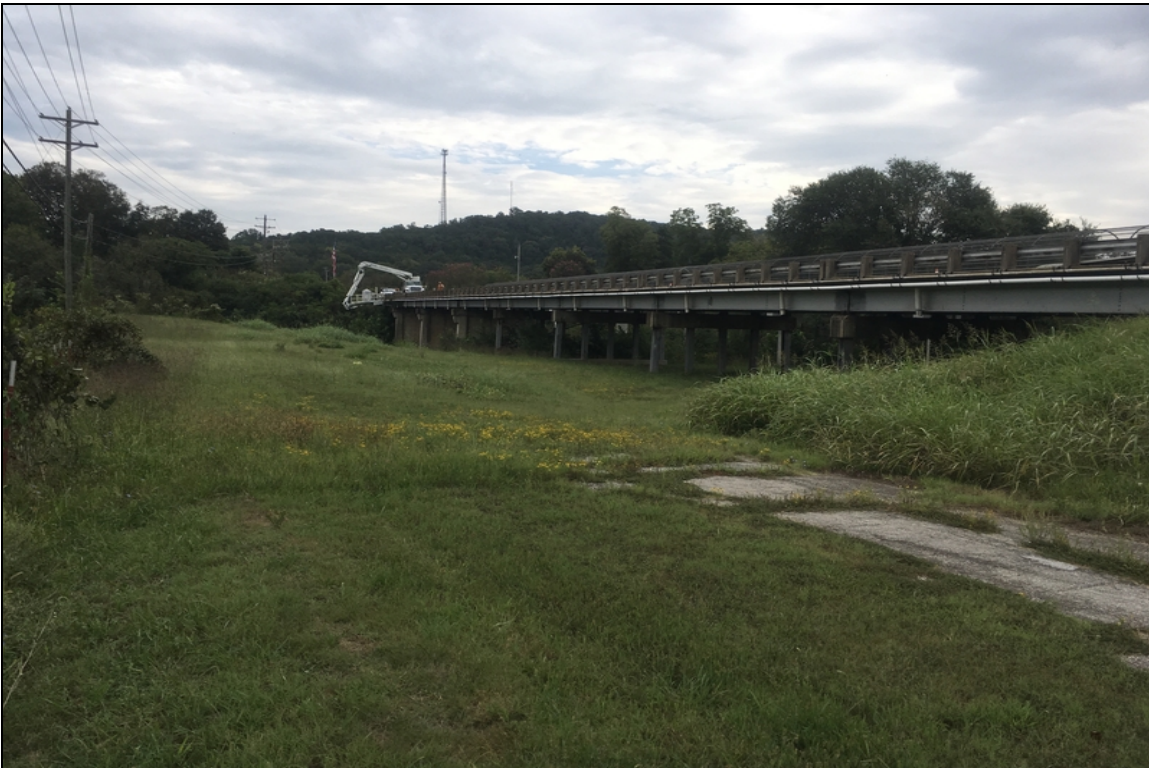
Elevation view. Log mile from left to right.
