Bridge #00338(Routine, Underwater type 2)

SH 14 Marion over CROOKED CREEK

Team Lead: Benjamin Smith Inspection Date: September 21, 2021

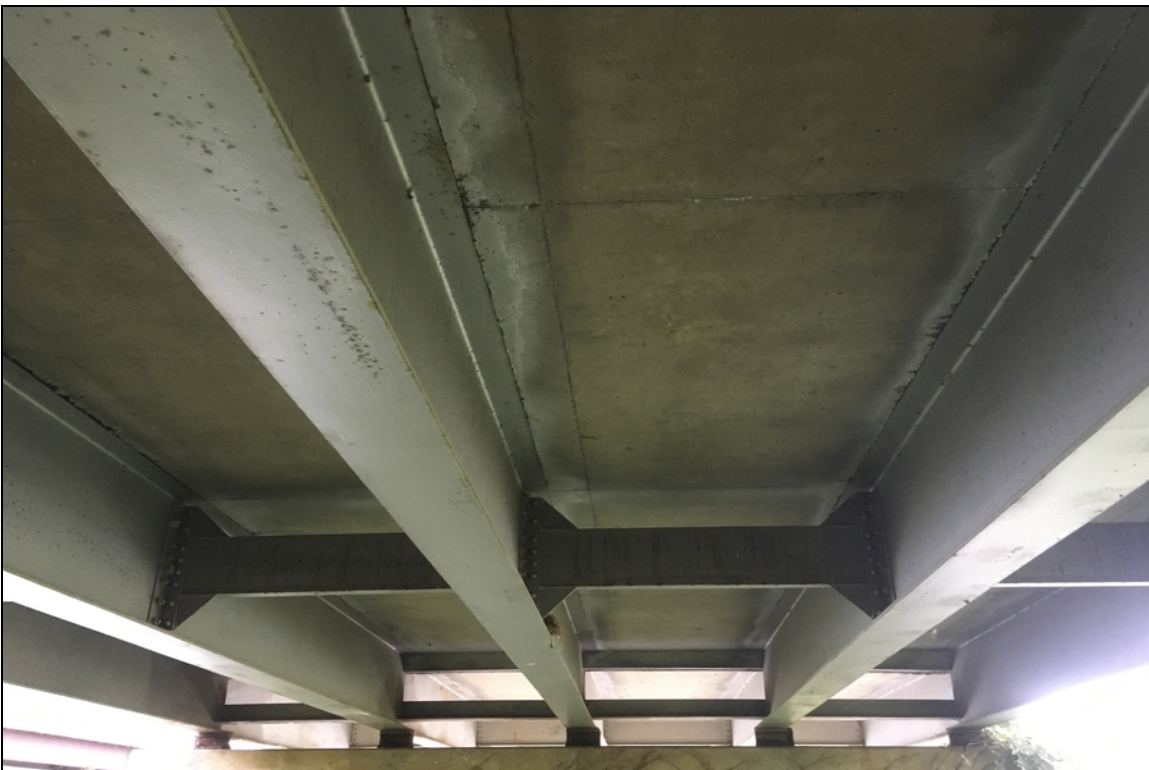
General view of the undersurface.

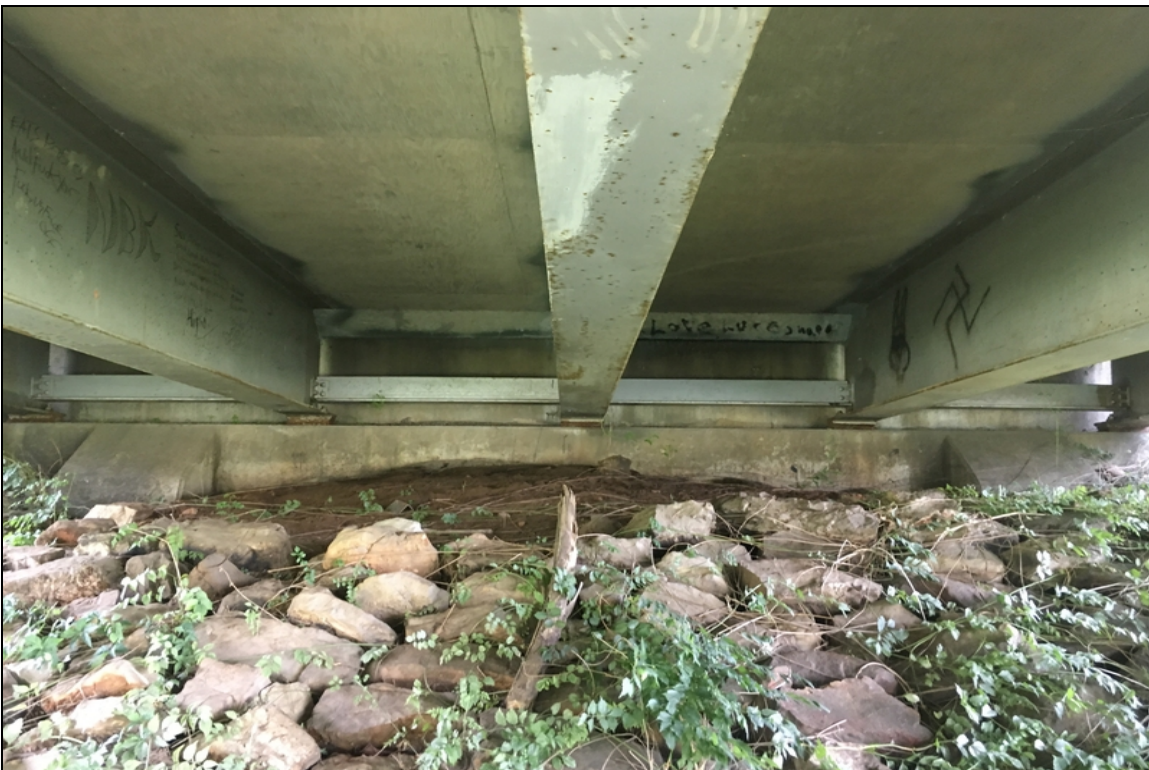
General view of of abutment #2.

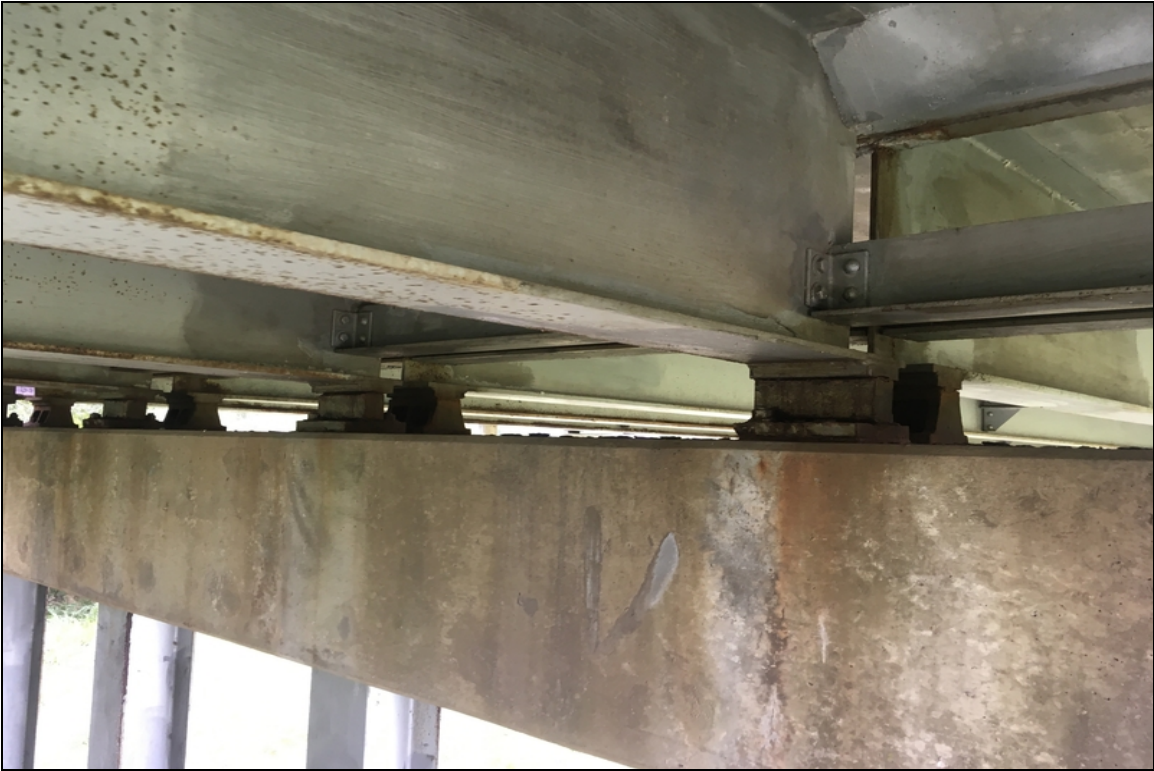
Pile bent #5 bearing condition.

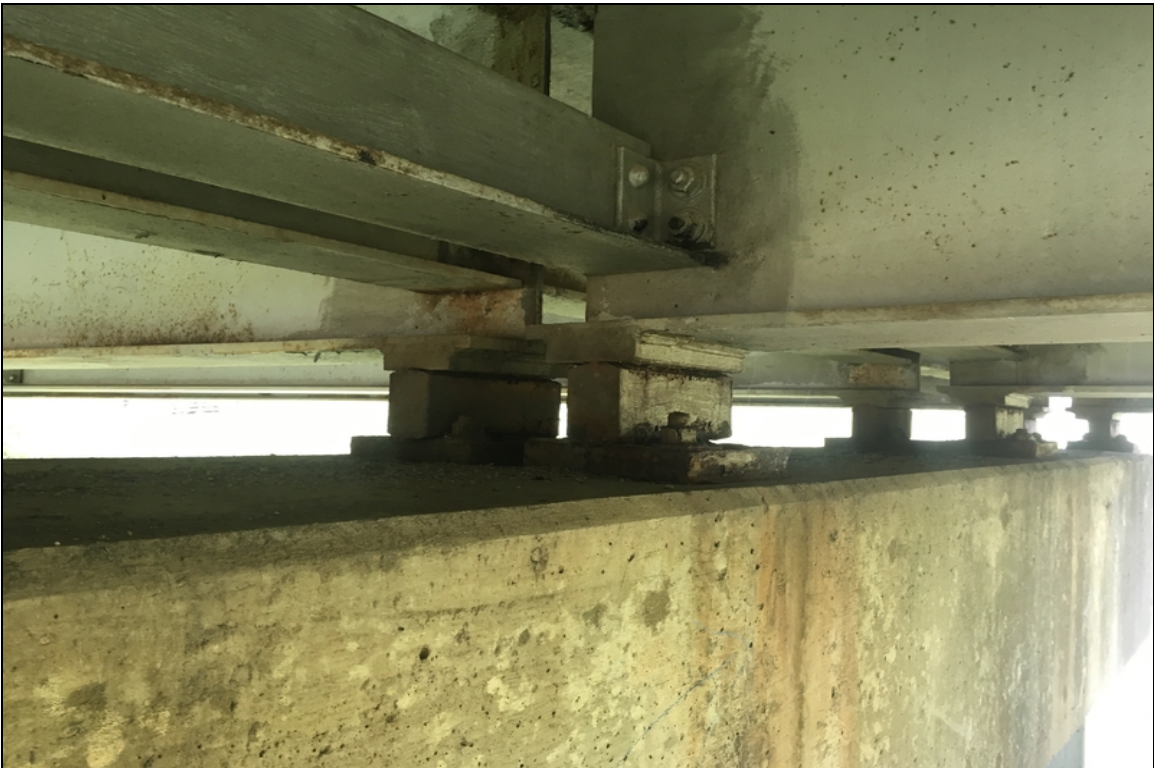
Bent #7 bearing condition.

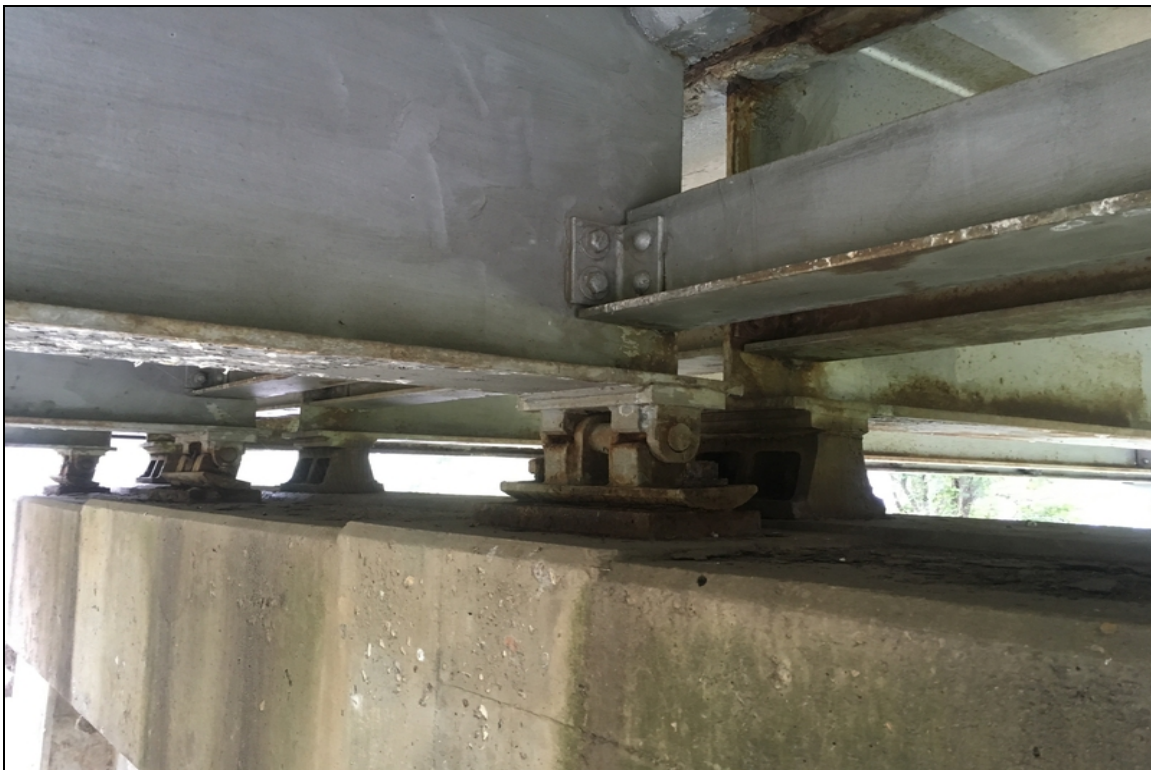
Bearing condition at pier #3.

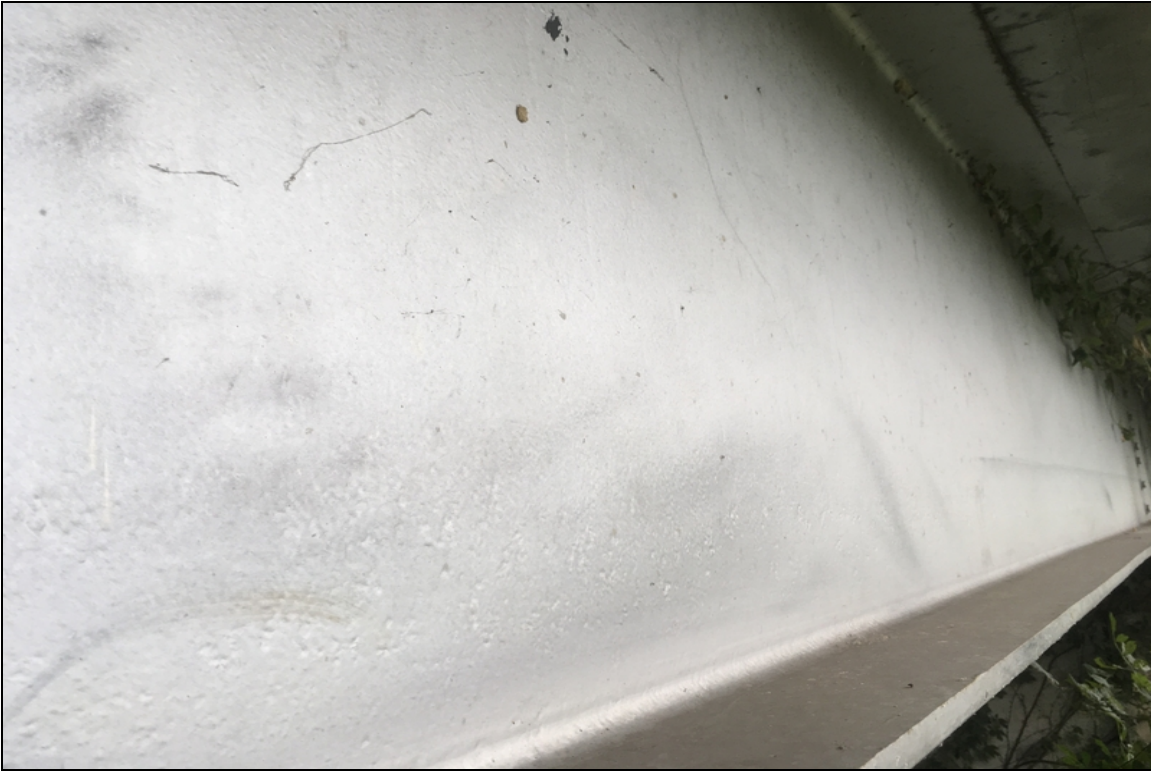
Typical beam paint condition of the exterior of beam #5.

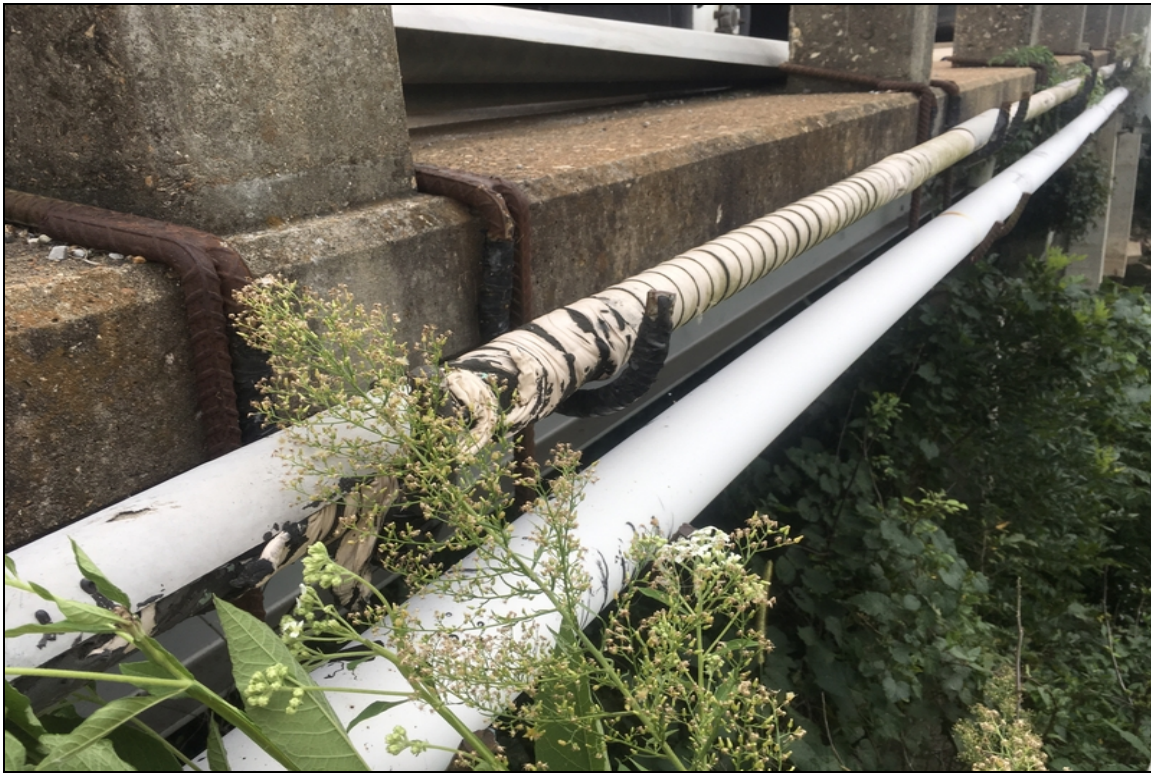
Utility attachment on the right side of the structure.

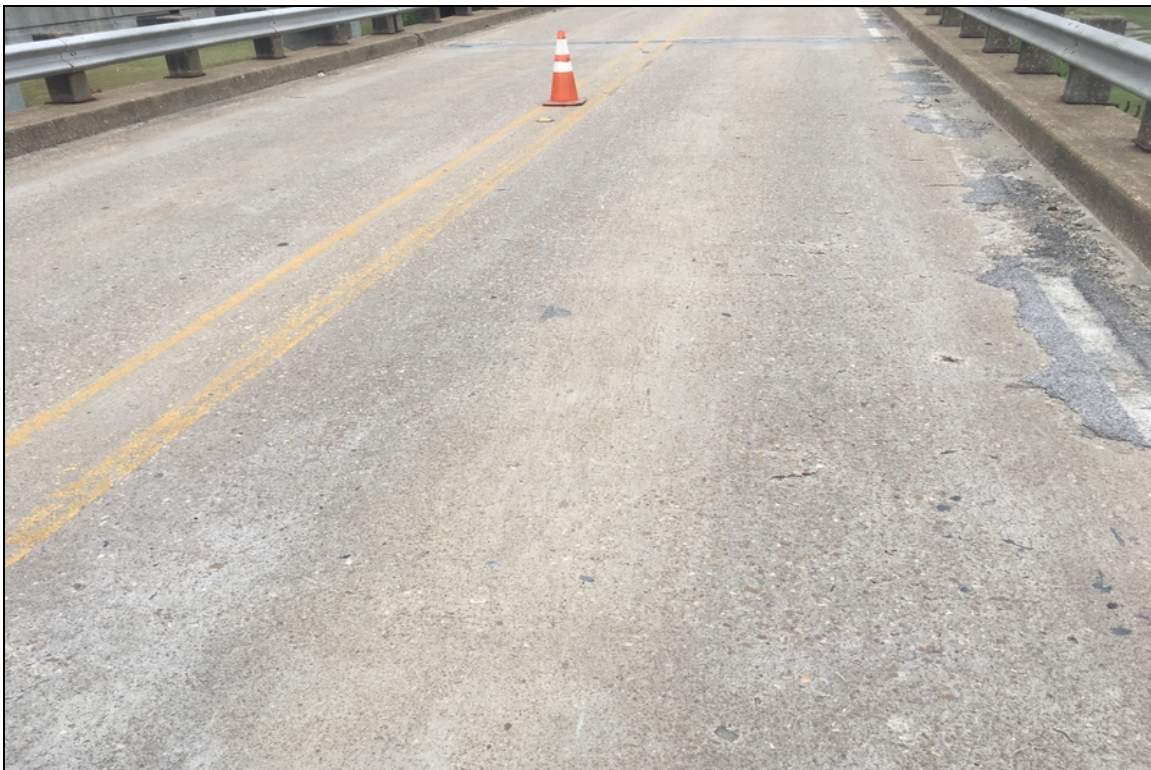
Span #6 driving surface.

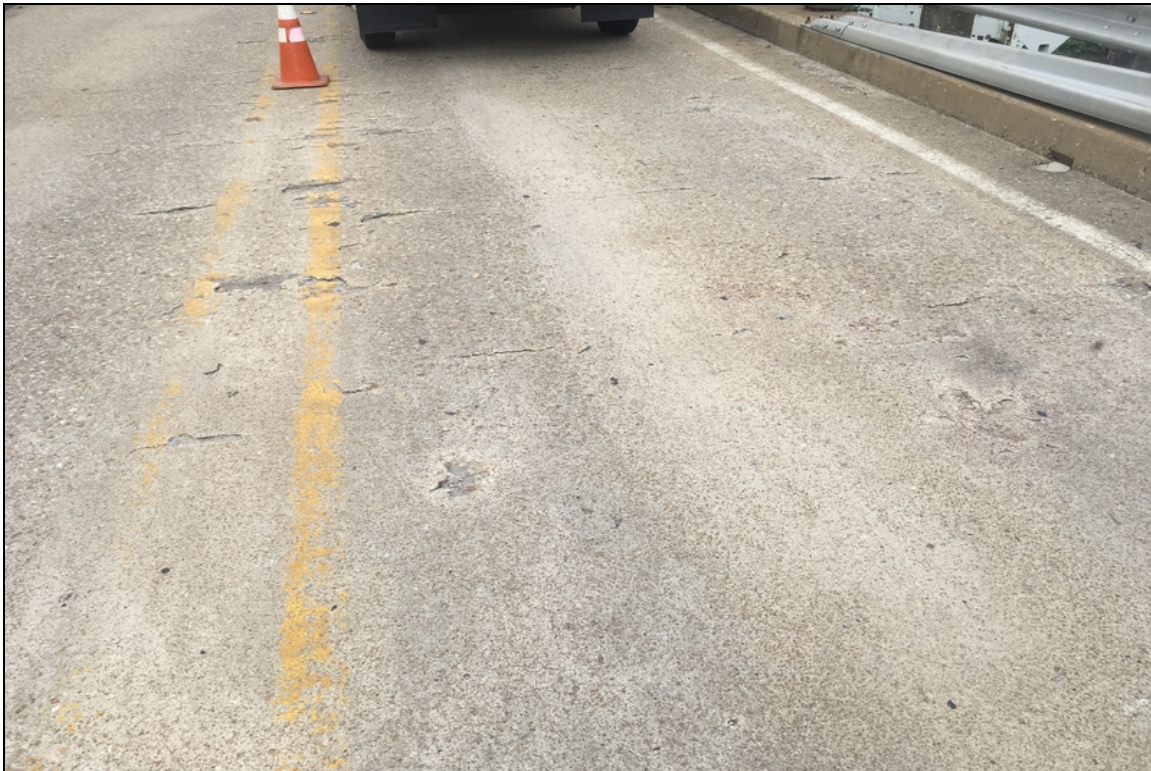
Span #1 driving surface.

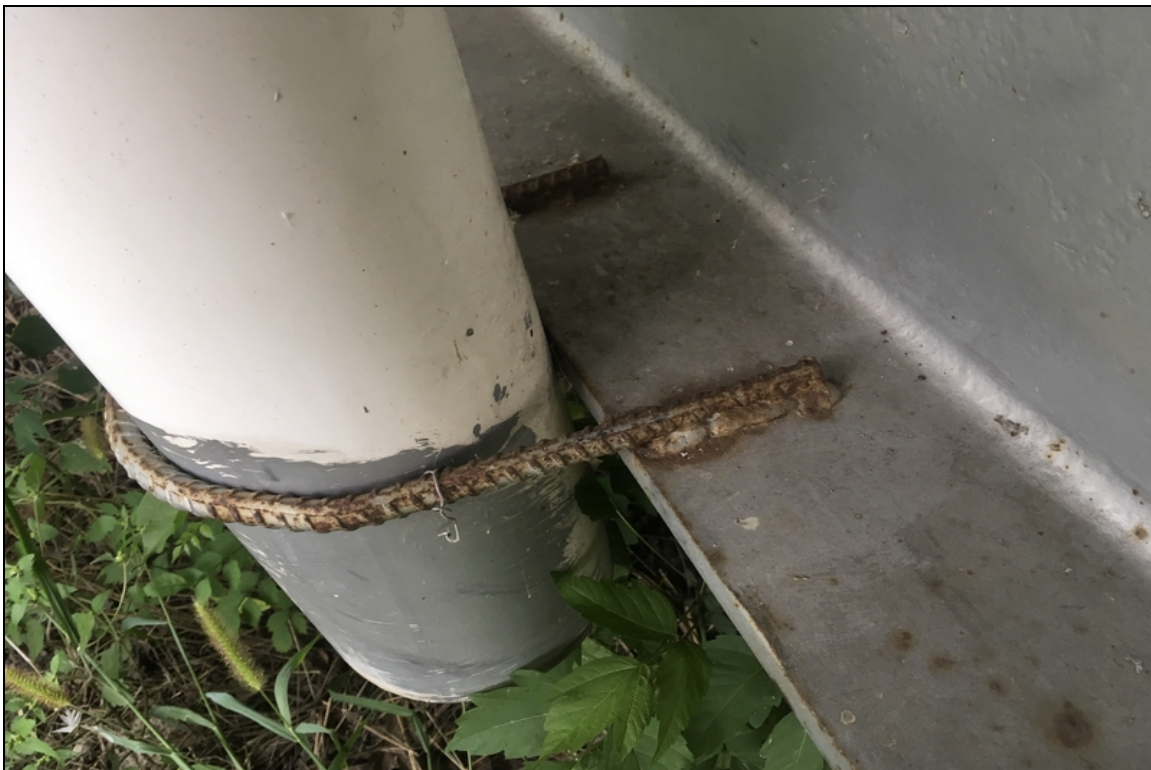
Typical welded detail of the drain extensions on the bottom flange of the fascia beams.

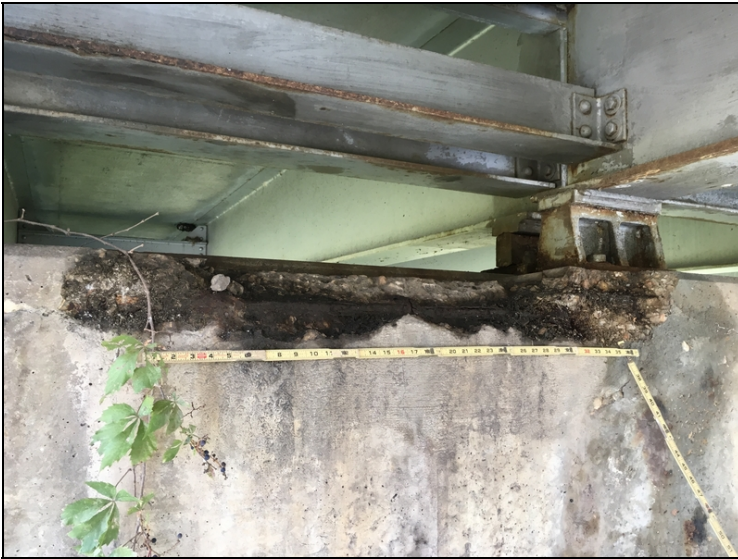
Pier #1 has a spall with rebar exposed on the back side of the cap and a large 3' spall with rebar exposed in the top edge of the cap in bay #4.
