**Bridge #B6476**(Routine, Underwater type 2)

**SH 412 EB Benton 2 over ILLINOIS RIVER**

**Location: Benton Co 8.17 W OKLINE**

**Team Lead:** Nathan Rowland **Inspection Date:** June 15, 2021

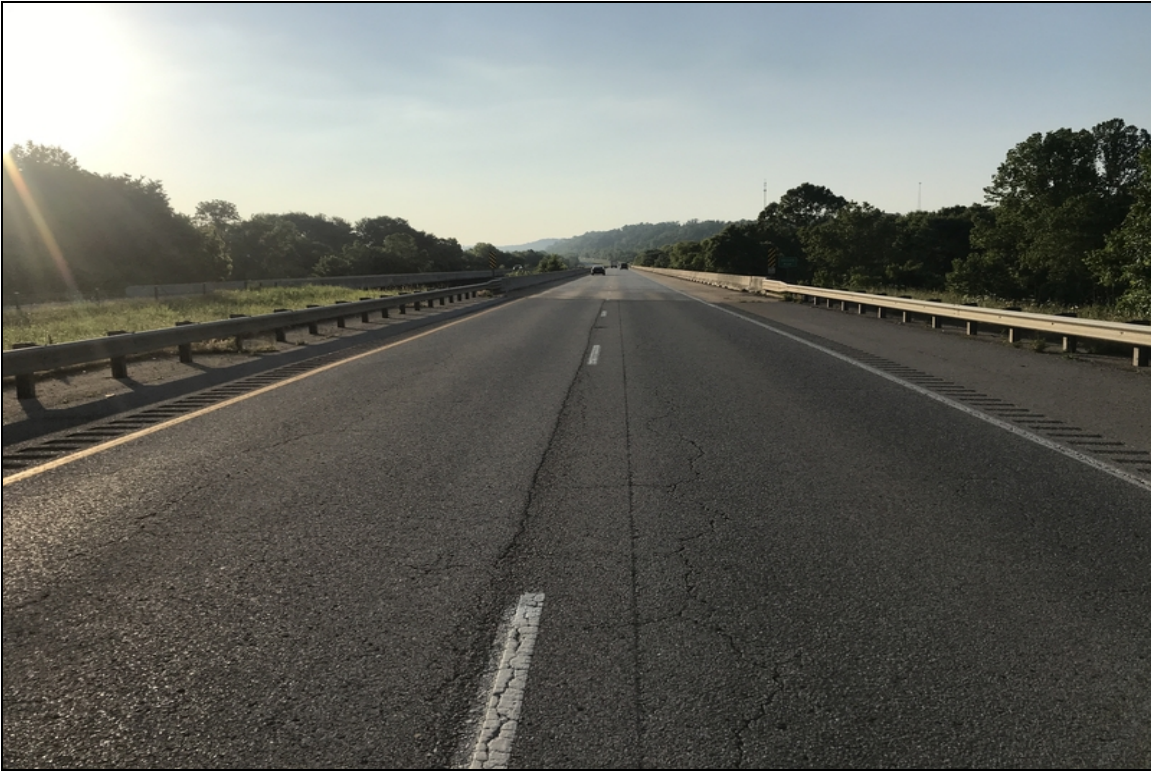
Inventory looking east

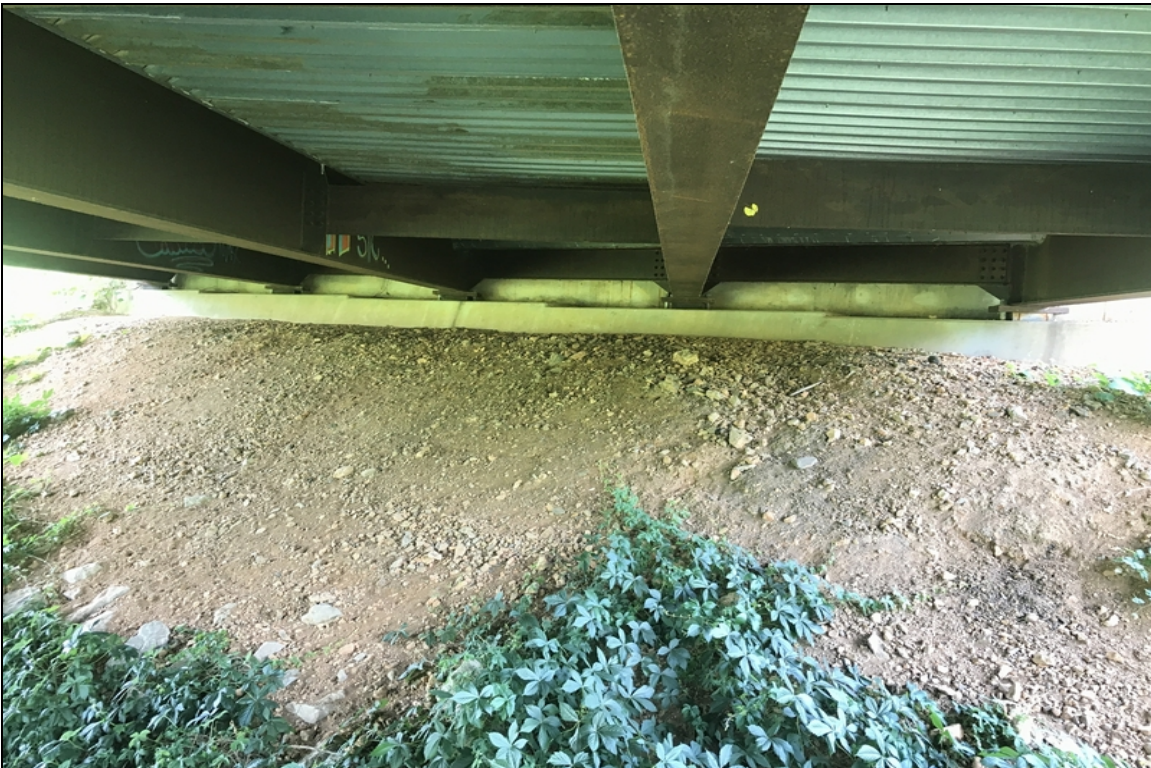
View of abutment #2

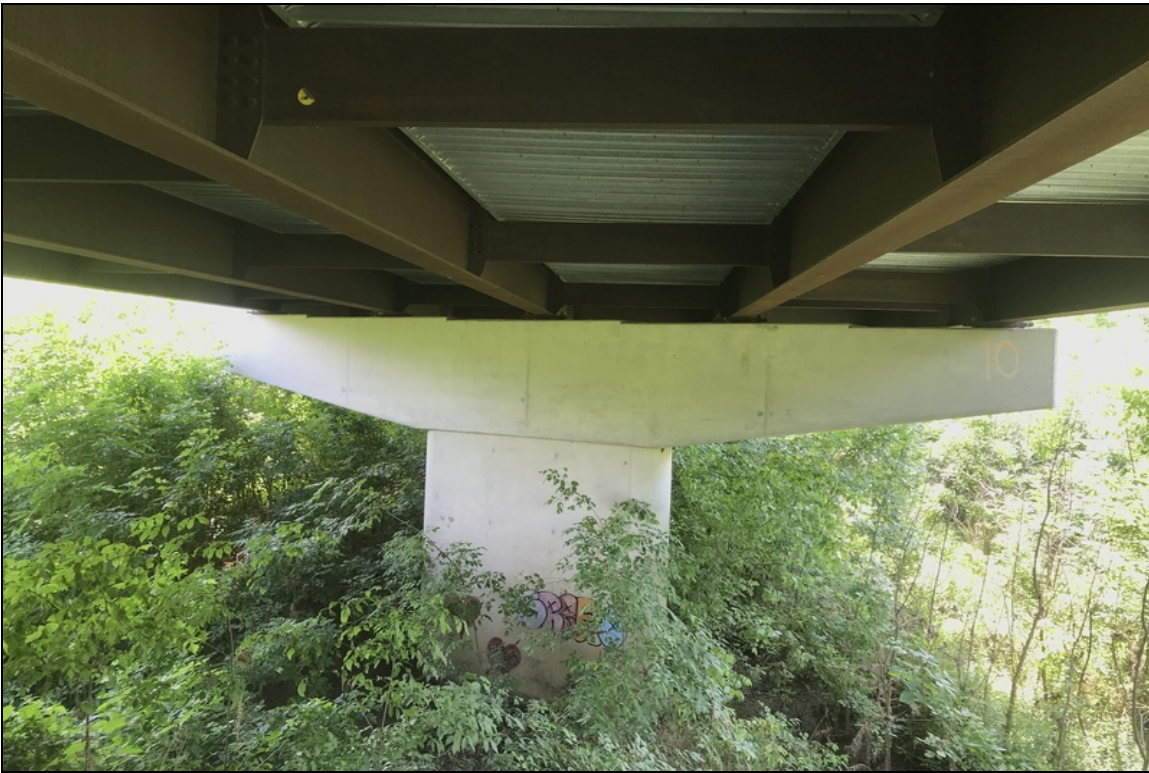
View of bent #3 behind side.

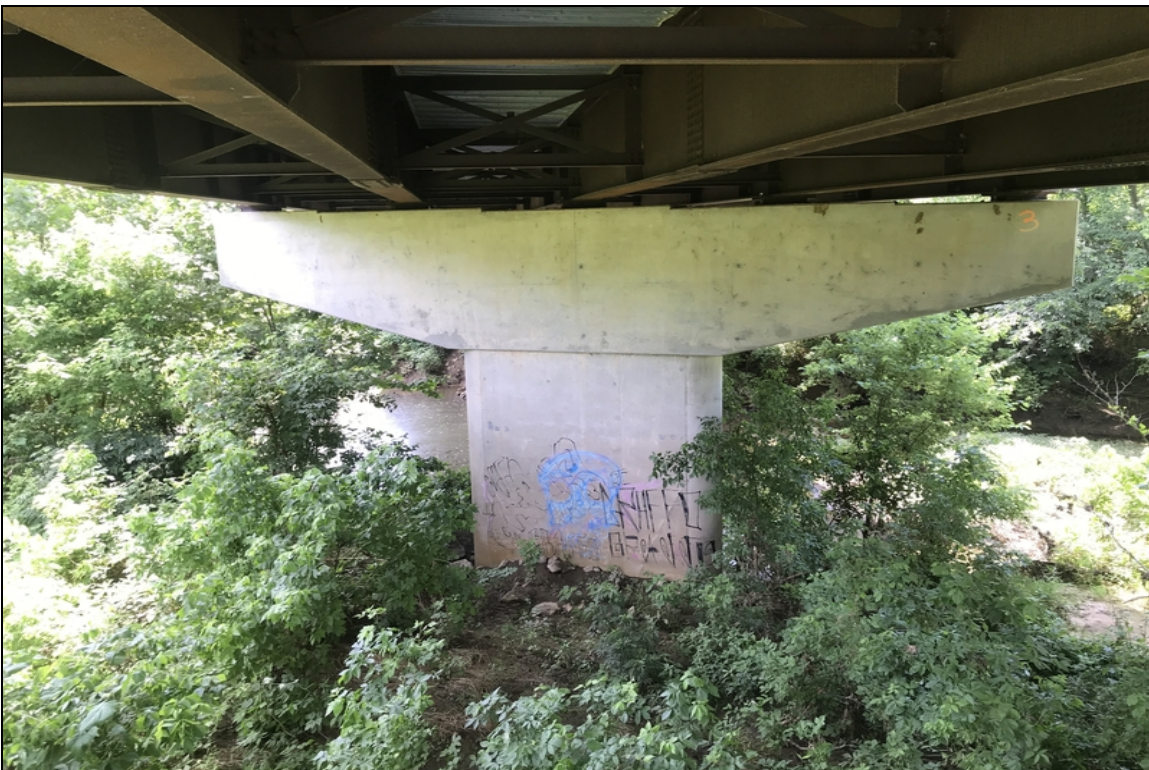
View of bent #3 behind side.

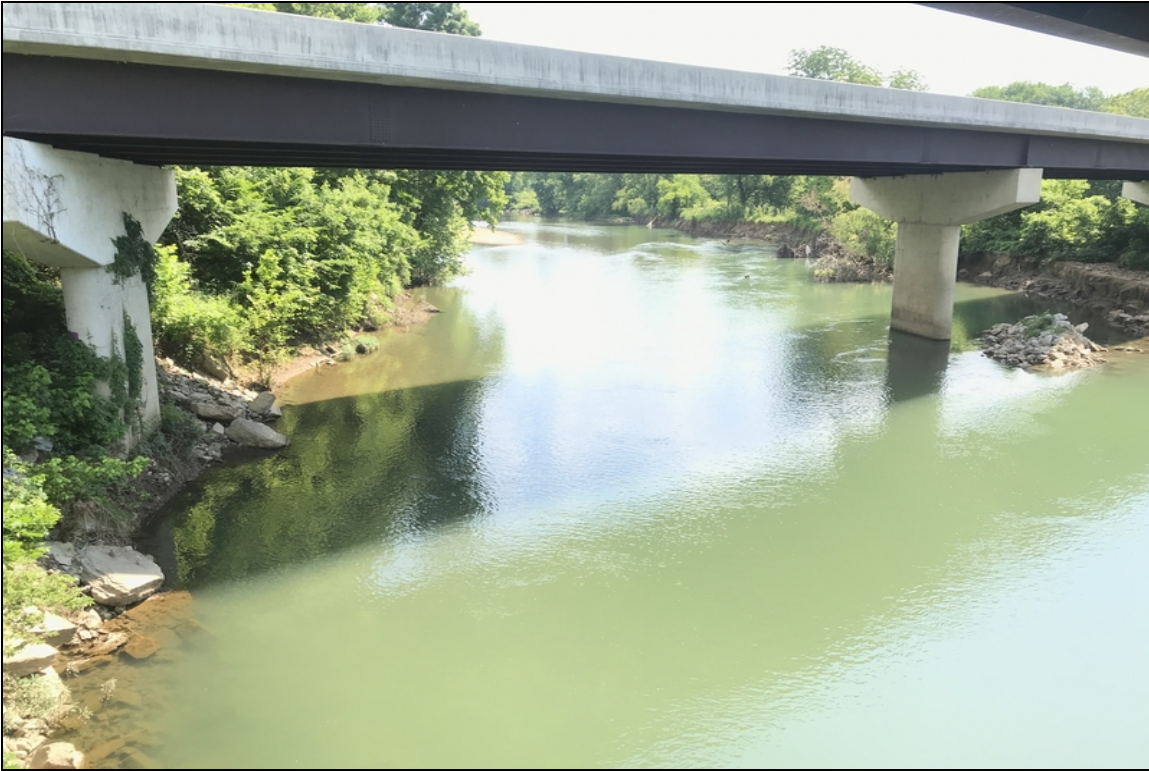
Upstream view

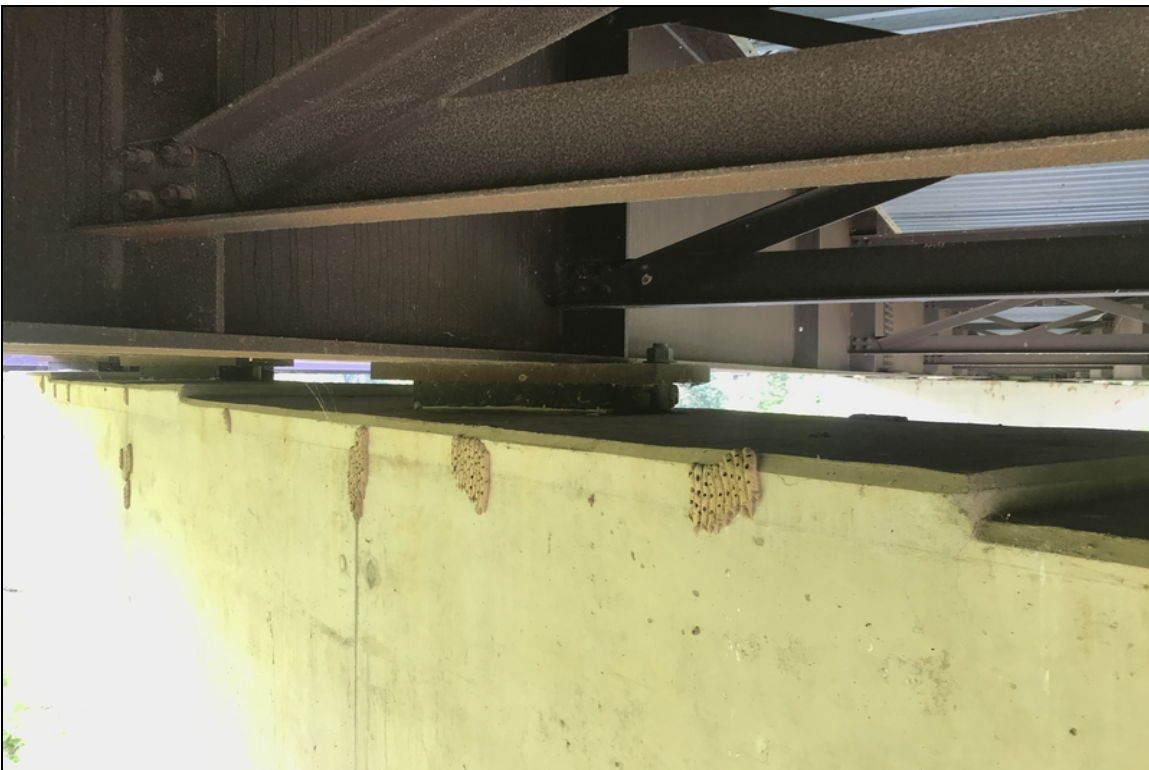
General view of bearings at bent #1.

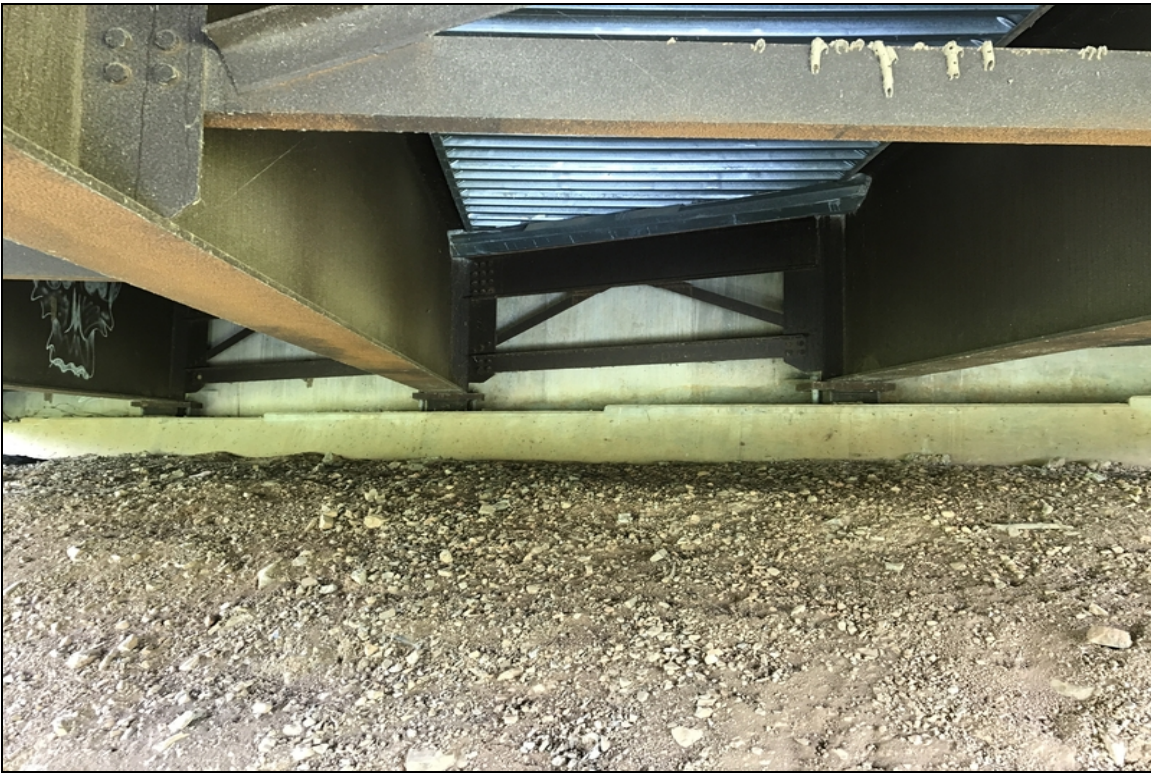
General view of abutment #1.

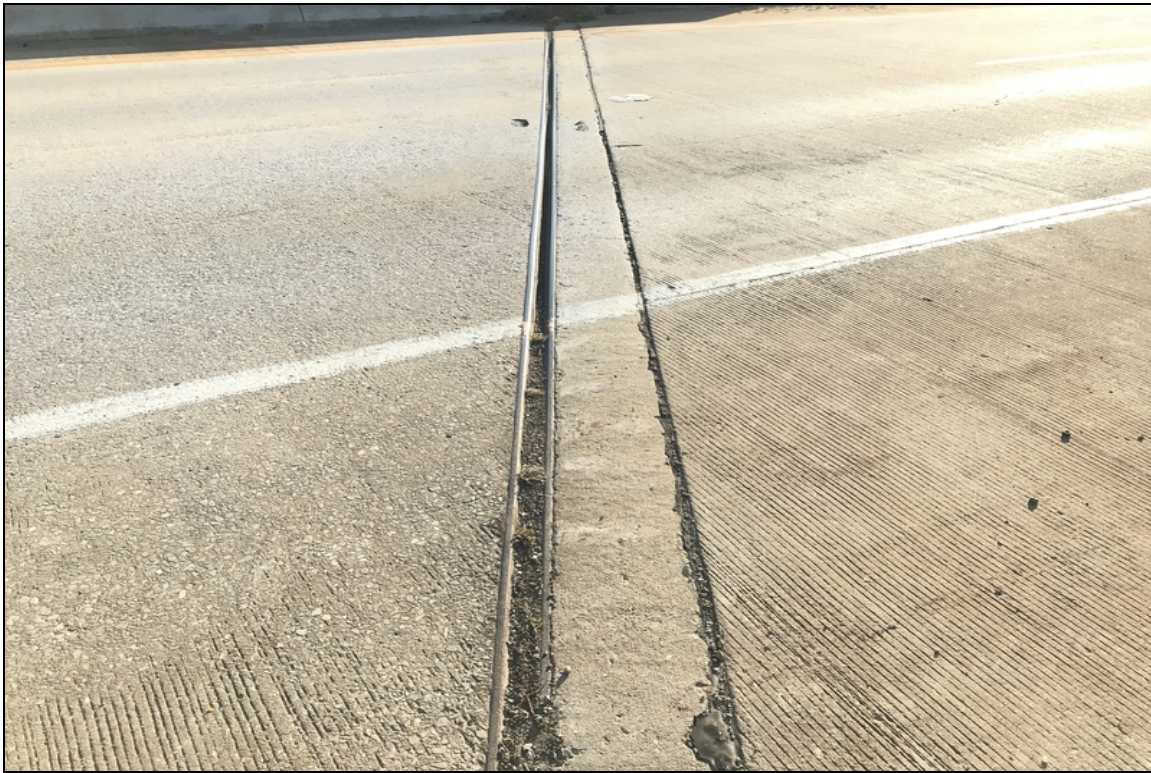
(300)							
06/16/2021 WNR & DBM:							
- The strip seal expansion joints have heavy debris impaction.							
-All joints have minimal loss of adhesive, and are full of sand & debris.							
310	Elastomeric Bearing	EA	125	119	6	0	0
1000	Corrosion	EA	6	0	6	0	0
515	Steel Protective Coating	SF	250	250	0	0	0
3430	Oxide Film Degradation Color/Texture Adherence(Steel Protective Coatings)	SF	0	0	0	0	0

View of expansion joint at abutment #2.

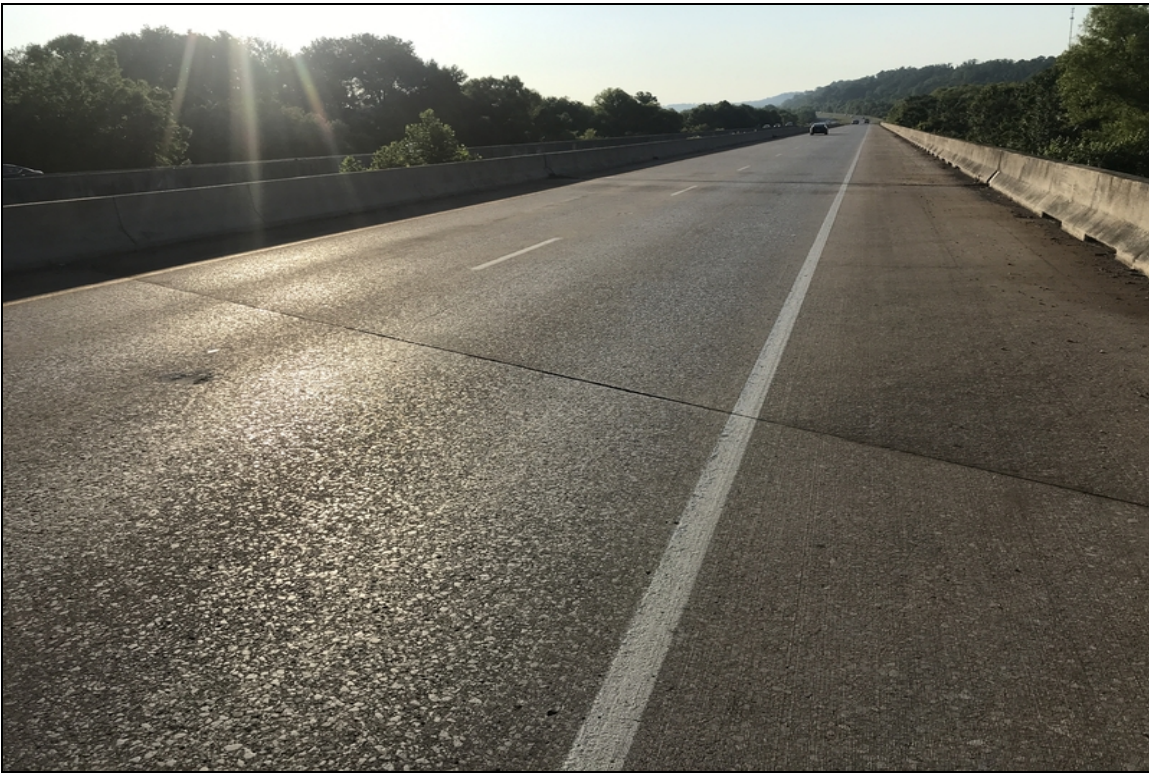
General view of deck

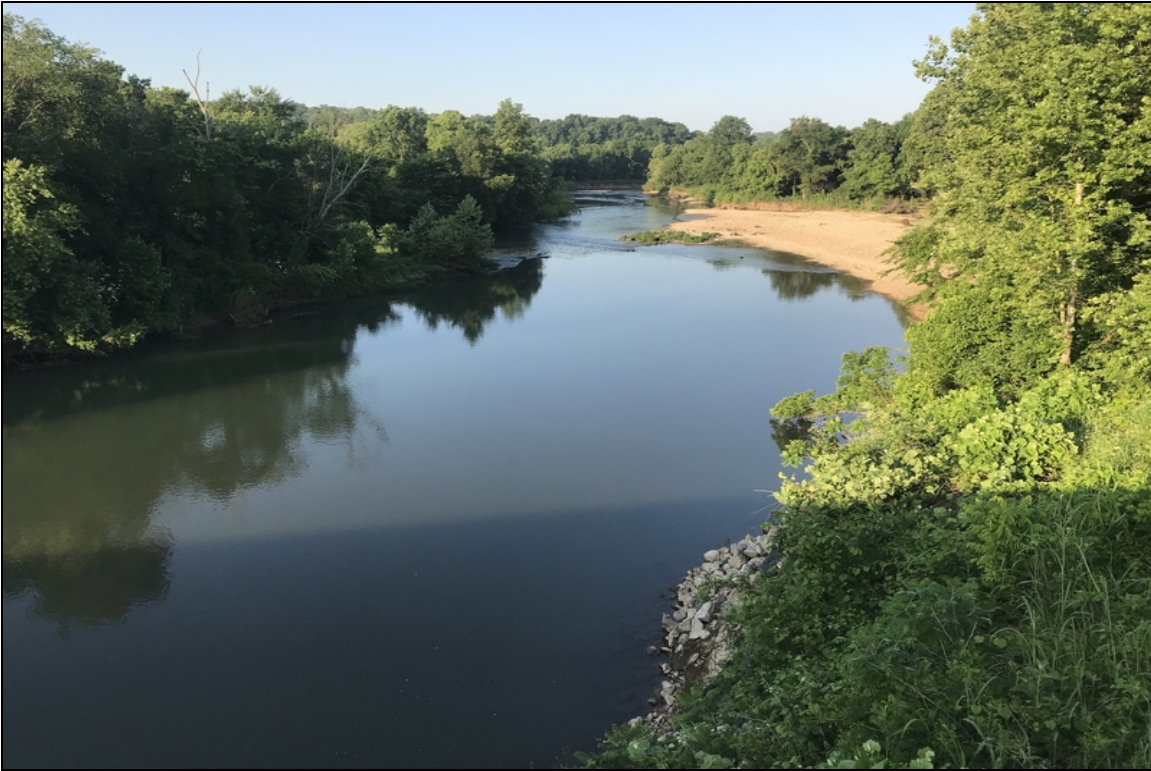
Downstream view

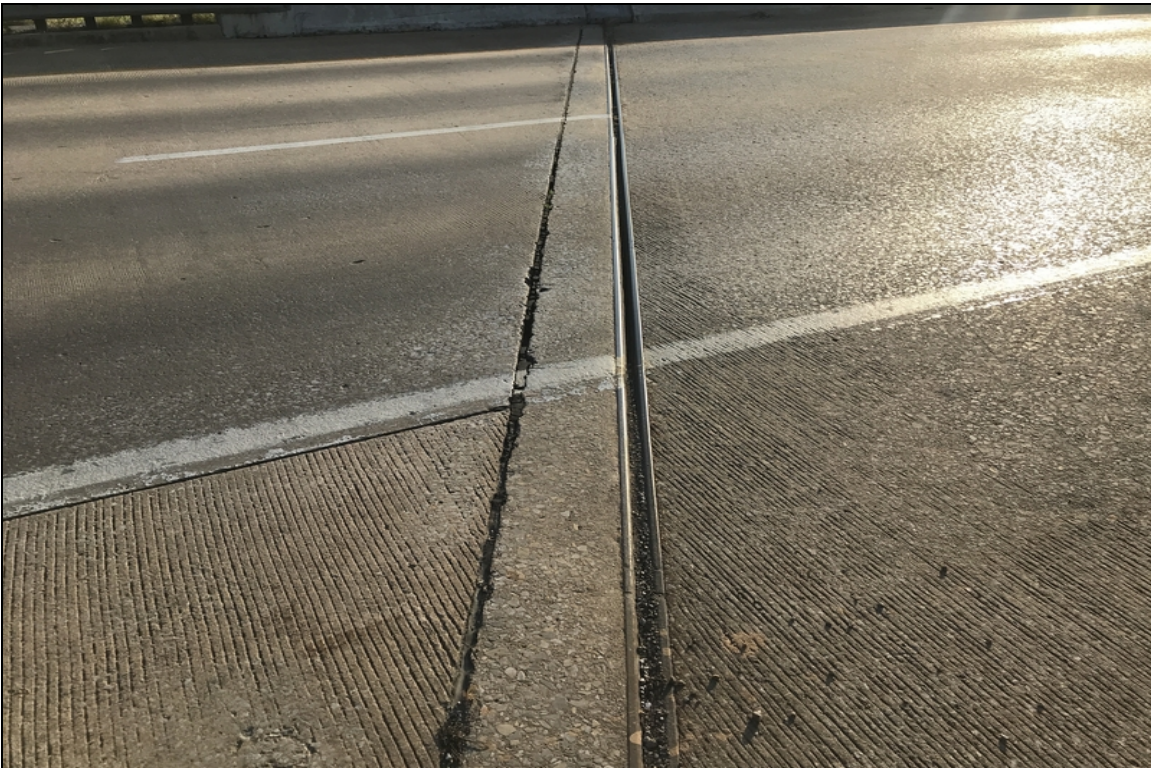
View of abutment #1 expansion joint

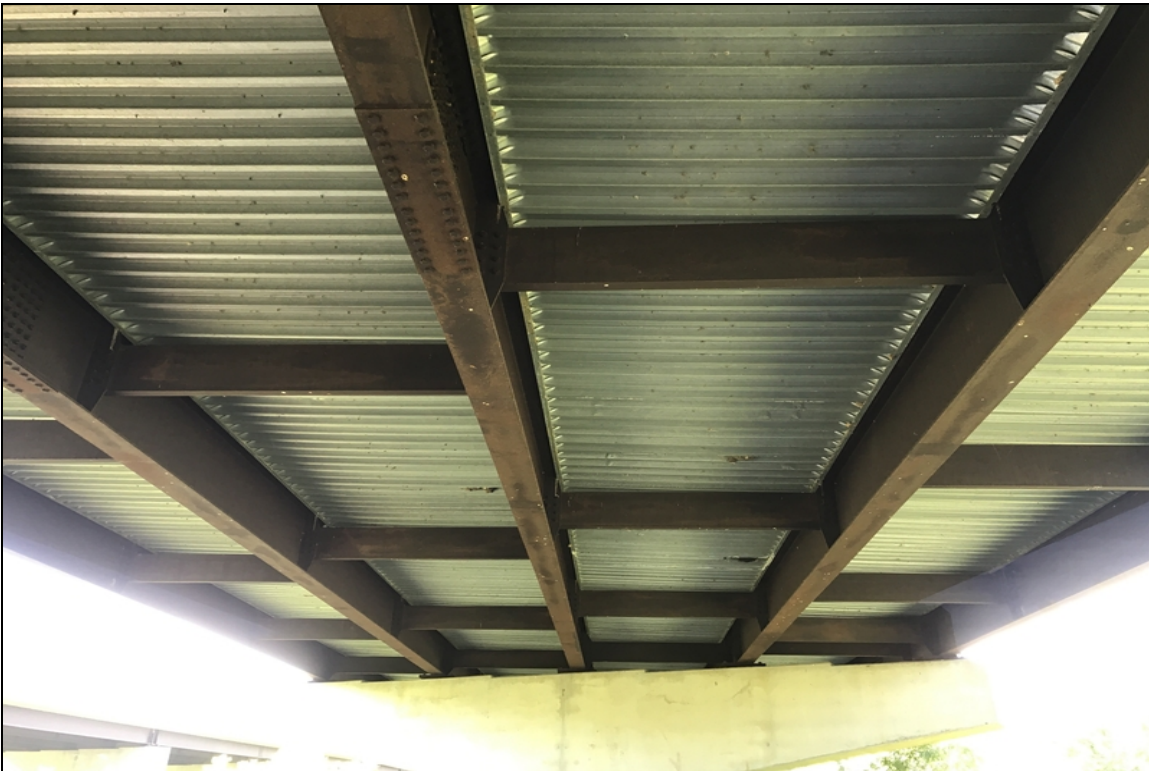
General view of undersurface.

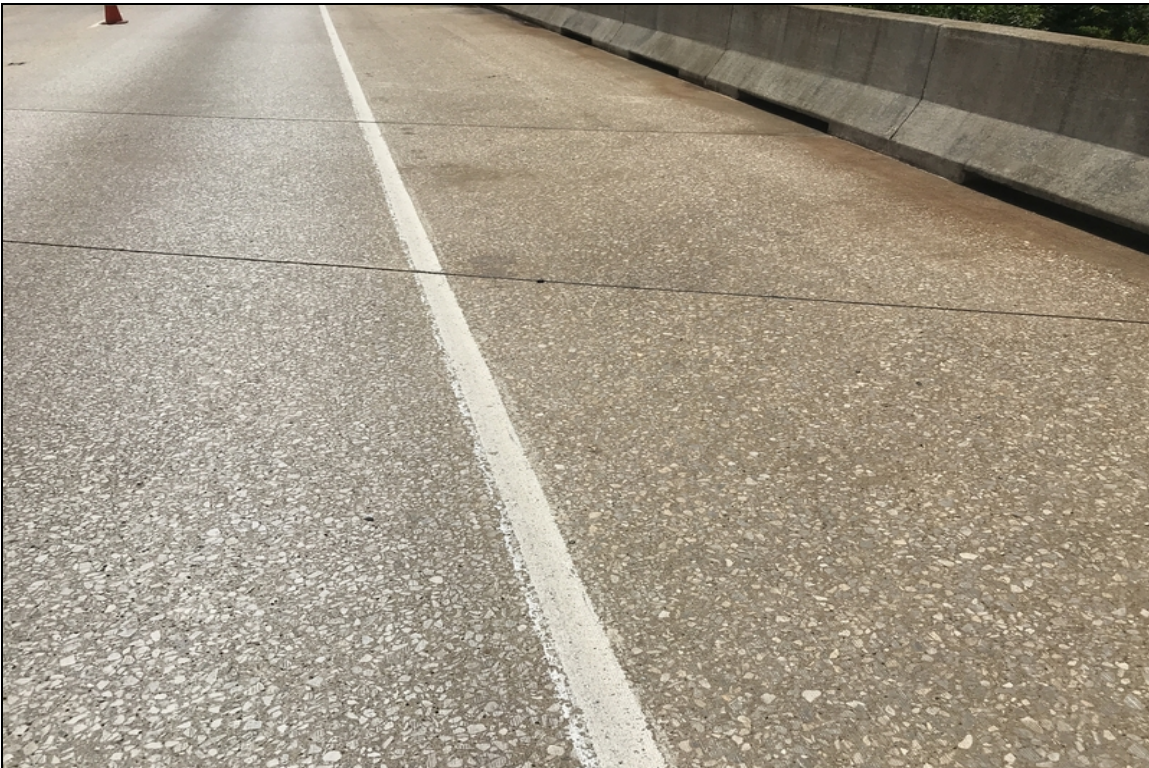
Entire deck surface appears to have been milled down.

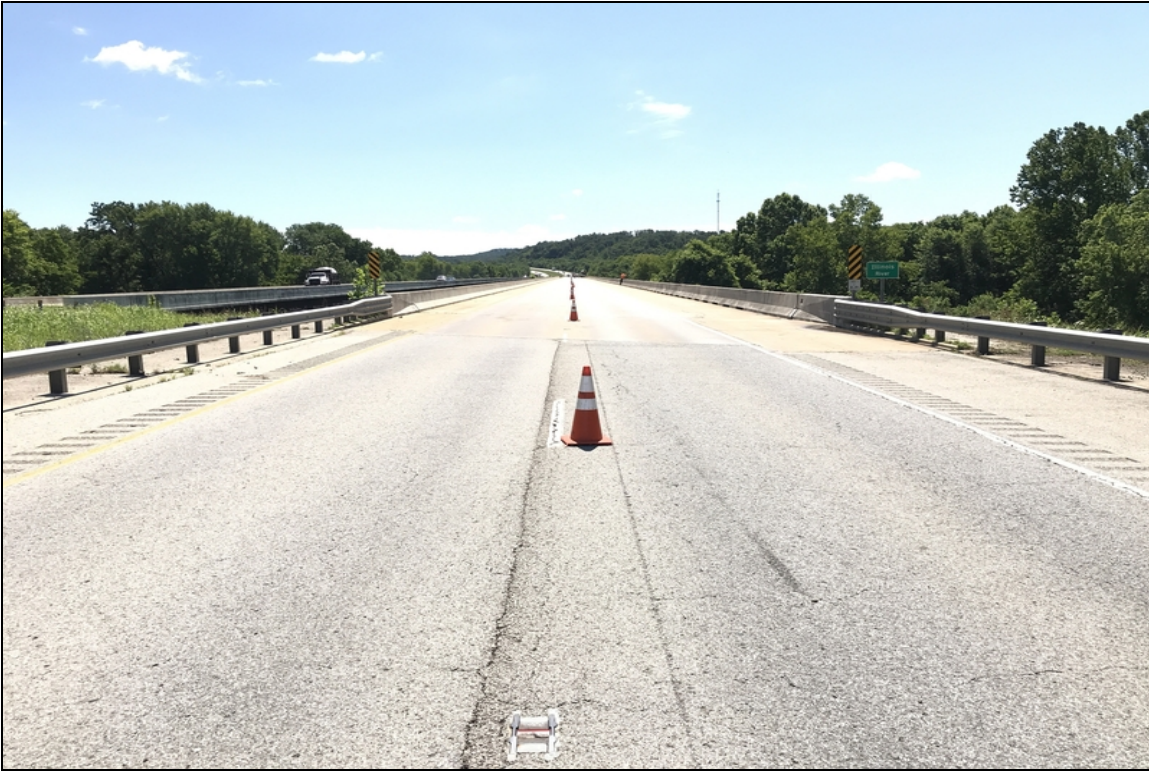
Inventory looking East

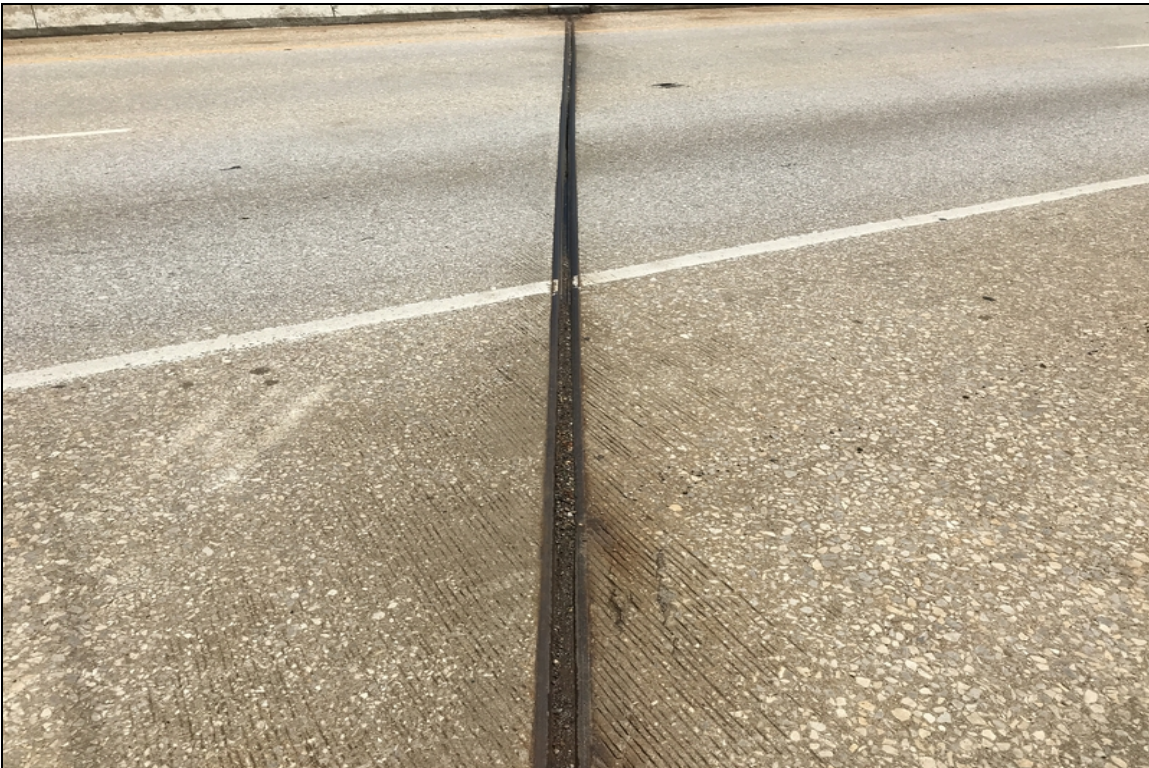
Expansion joint at bent #16 debris impaction.

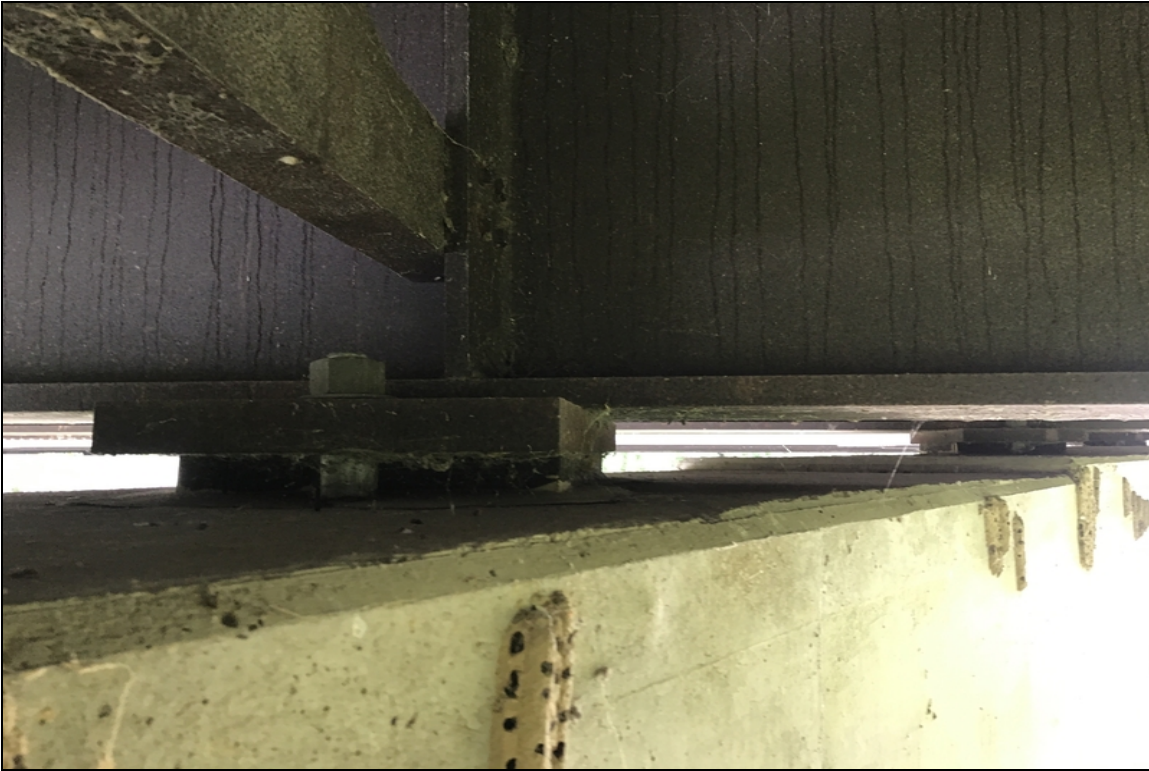
General view of bearings at bent #2

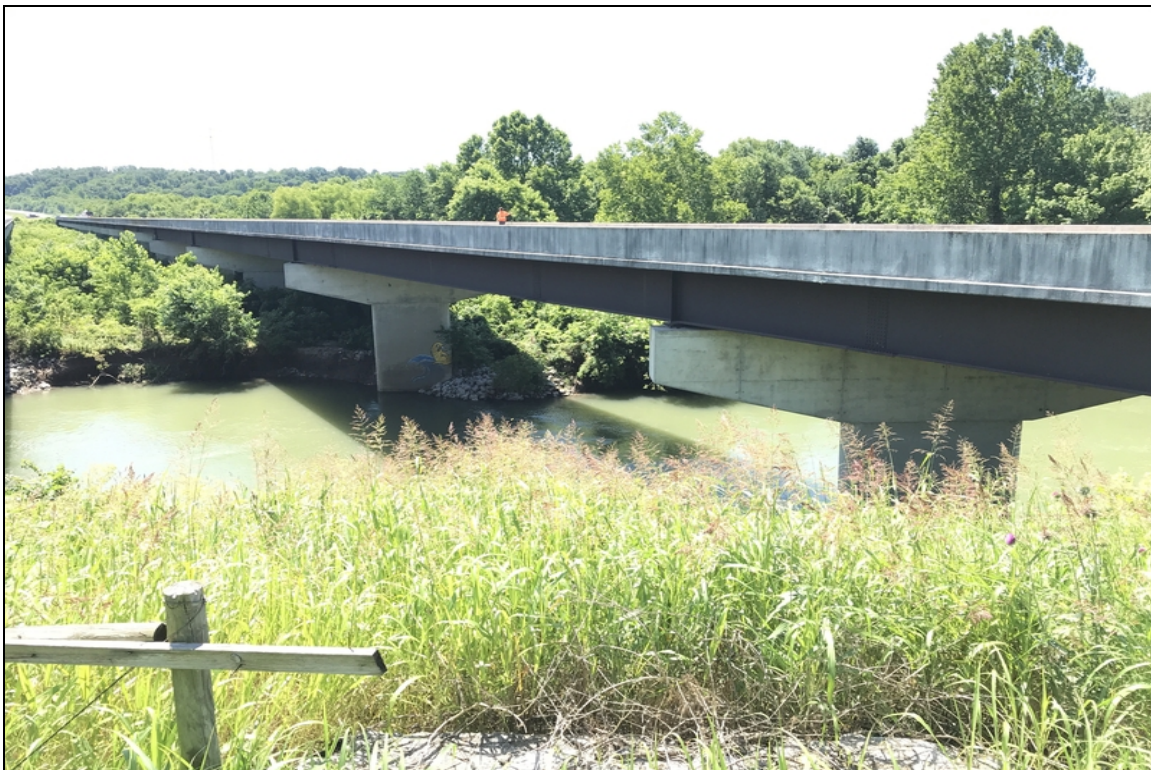
Elevation looking south

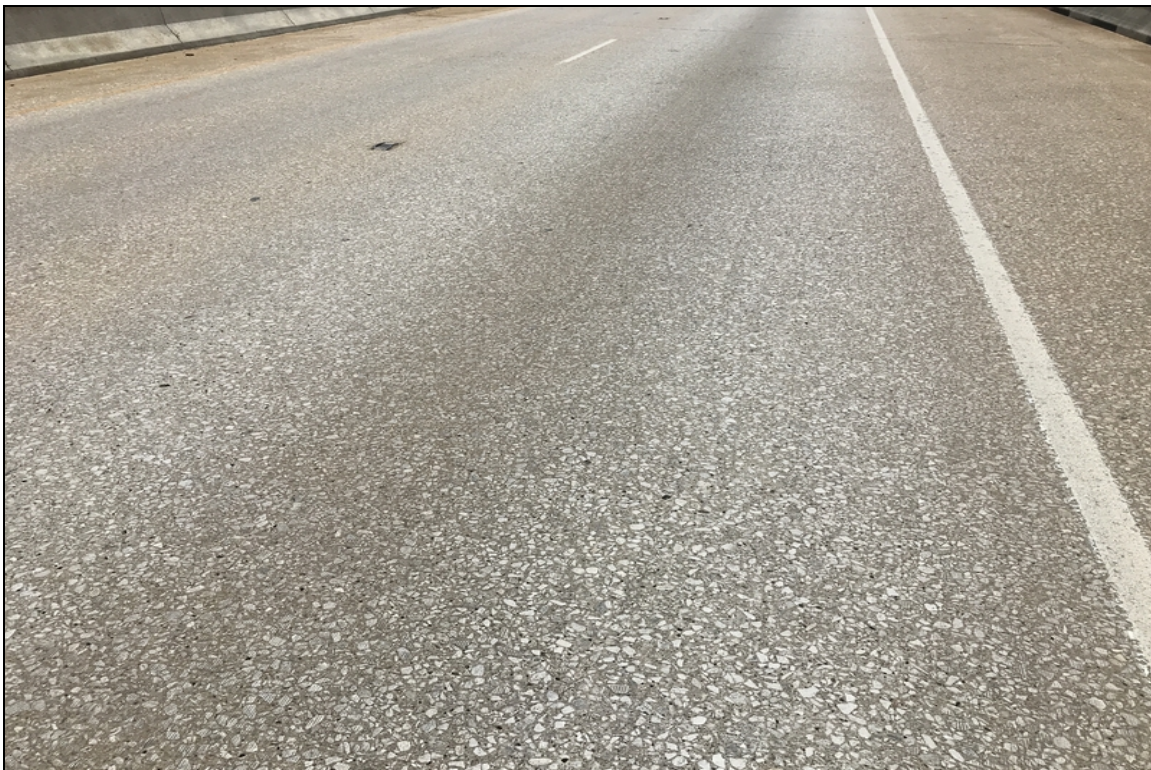
Typical condition of deck surface.

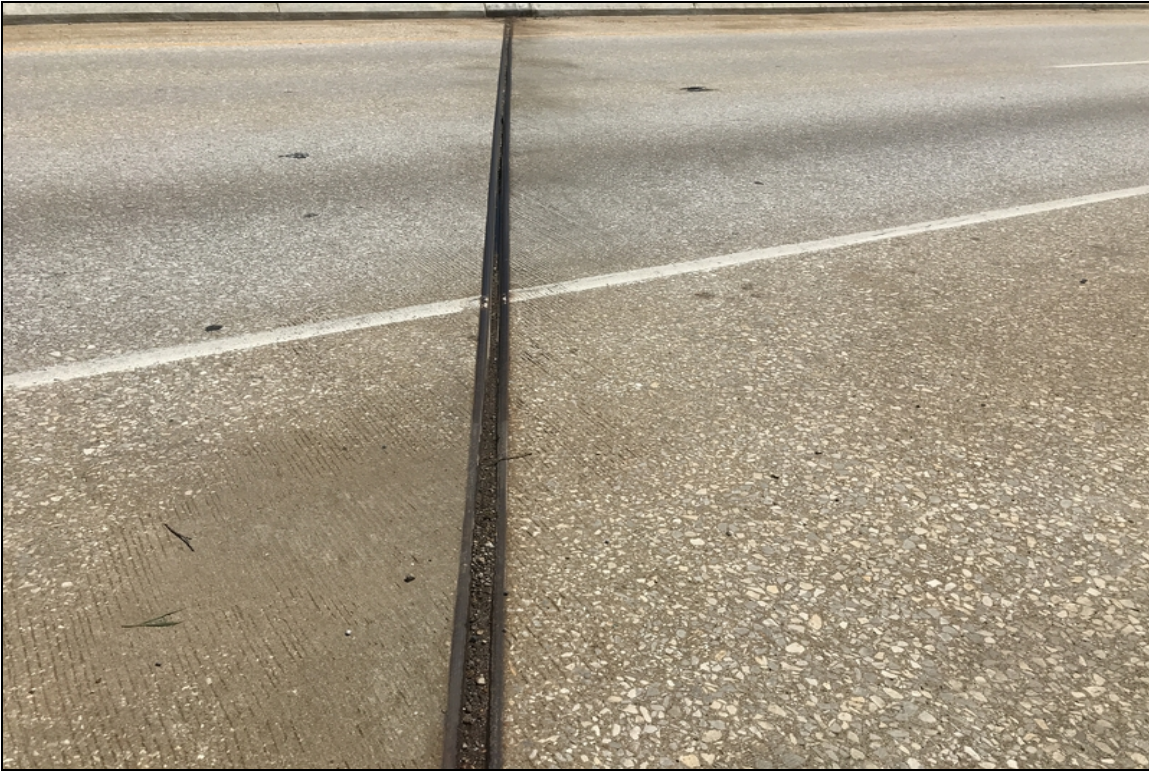
Bent #8 expansion joint.

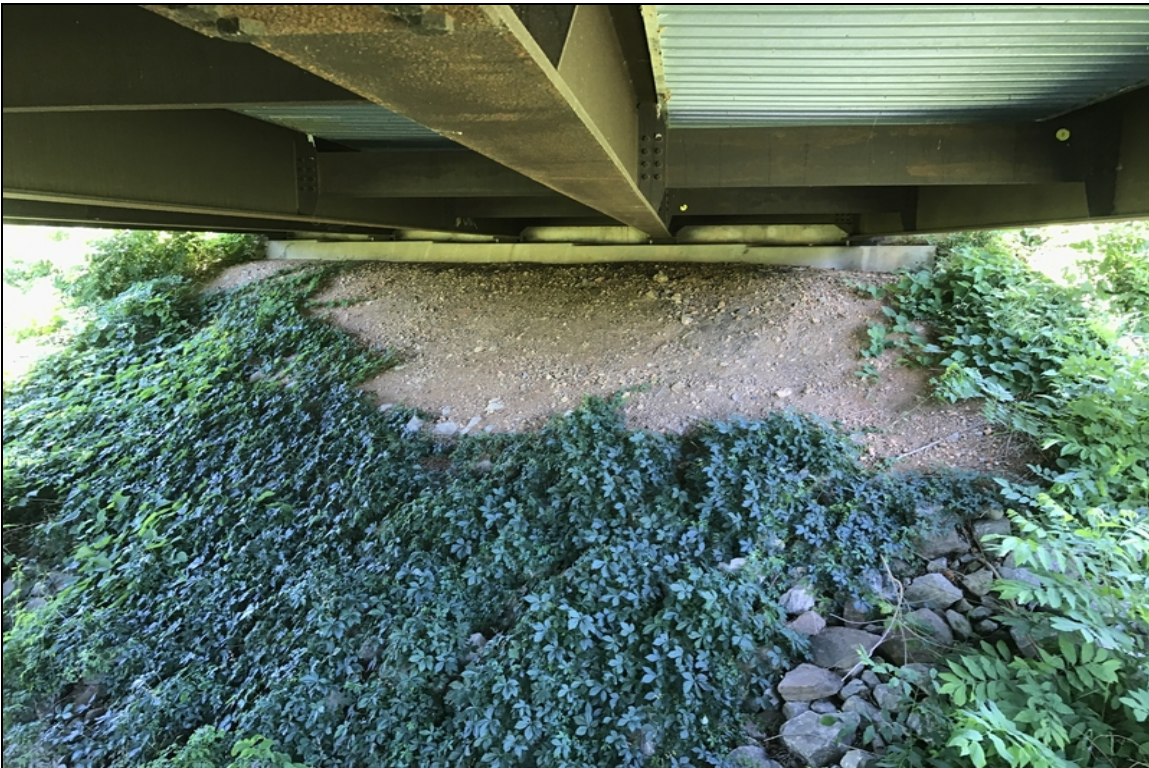
General view of abutment #2.

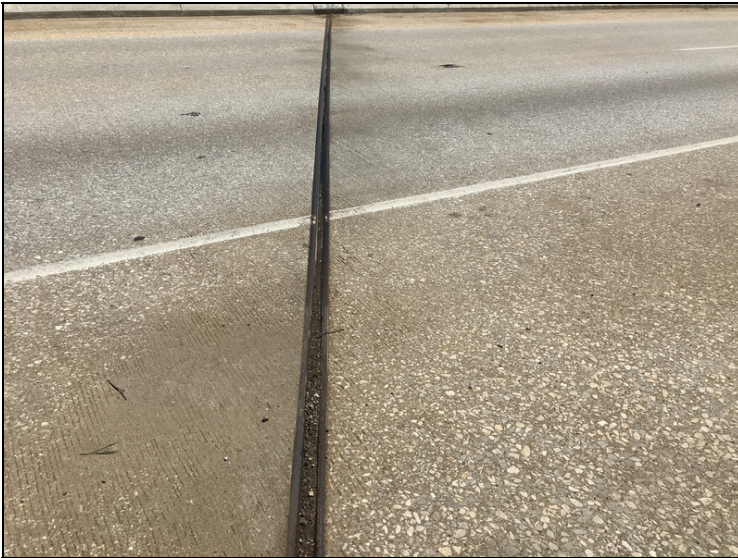
Bent #8 expansion joint.

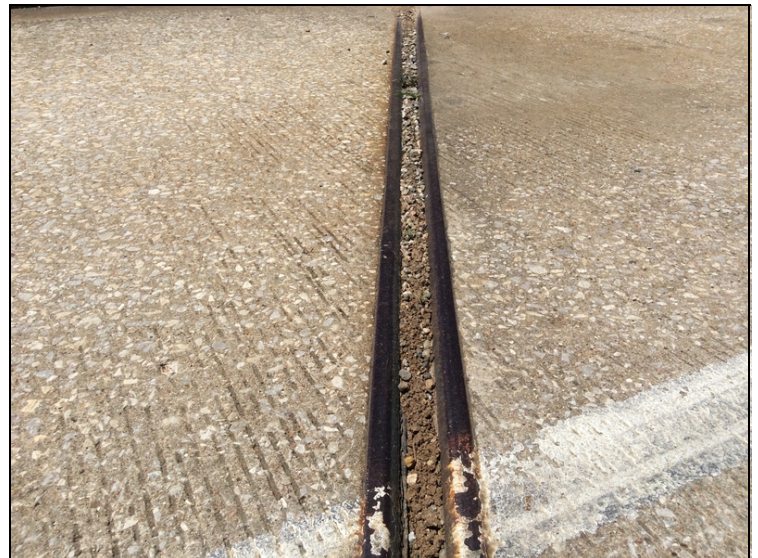
Strip seal expansion joint-Dirt and debris compaction.

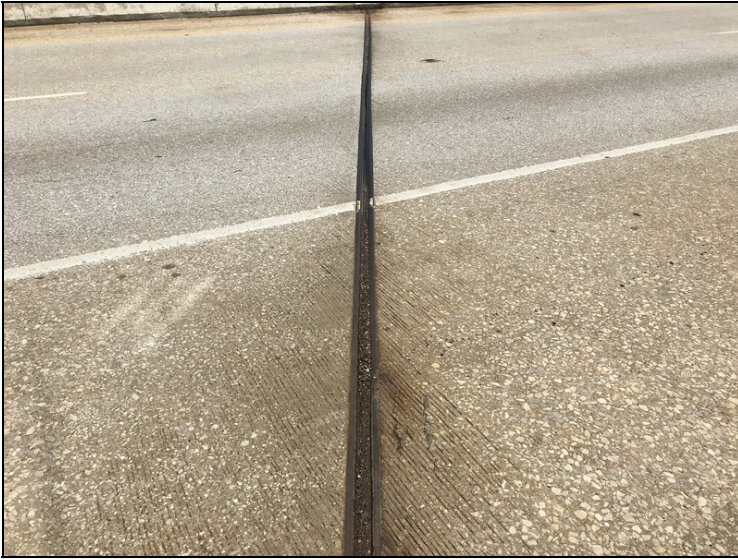
Expansion joint at bent #16 debris impaction.

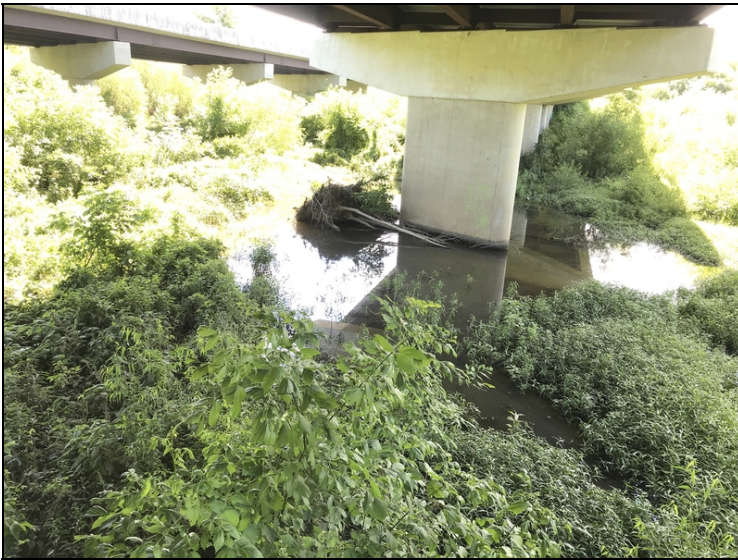
Drift accumulation adjacent to bent #14.

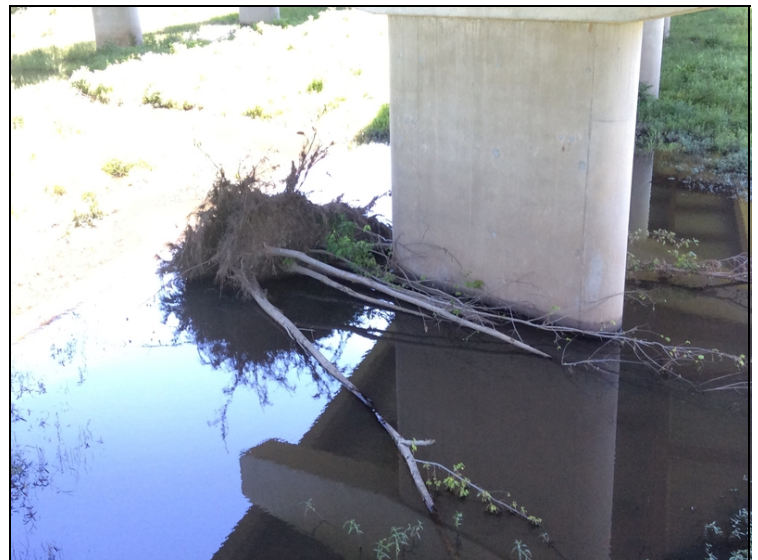
Bent #14-Drift.

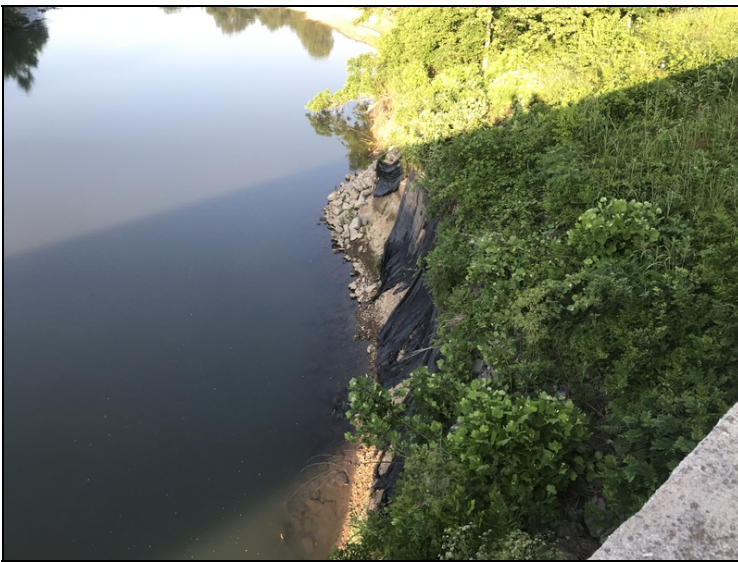
Erosion of the southwest embankment.

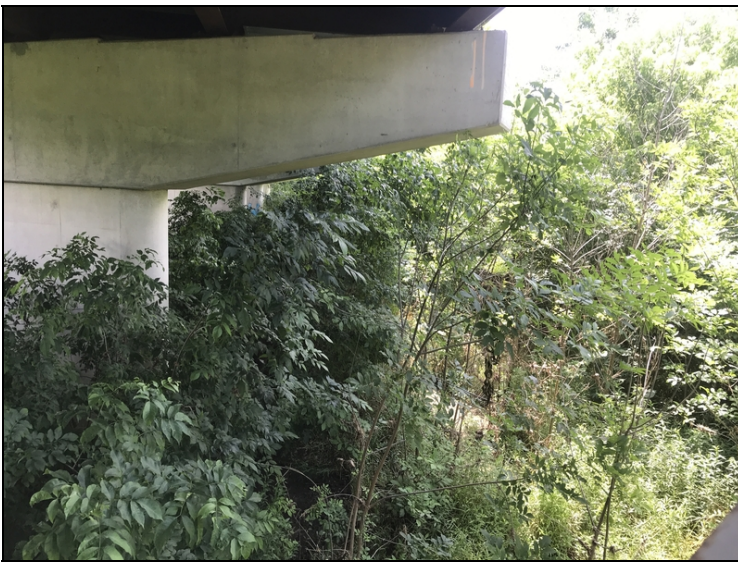
Vegetation under structure is making it difficult to inspect the structure with inspection equipment.
