Bridge #A6478(Routine, Underwater type 2)

US 412, WB Bent CO over ILLINOIS RIVER

Location: 11.6 MI E OF OKLAHOMA LN

Team Lead: Nathan Rowland **Inspection Date:** June 15, 2021

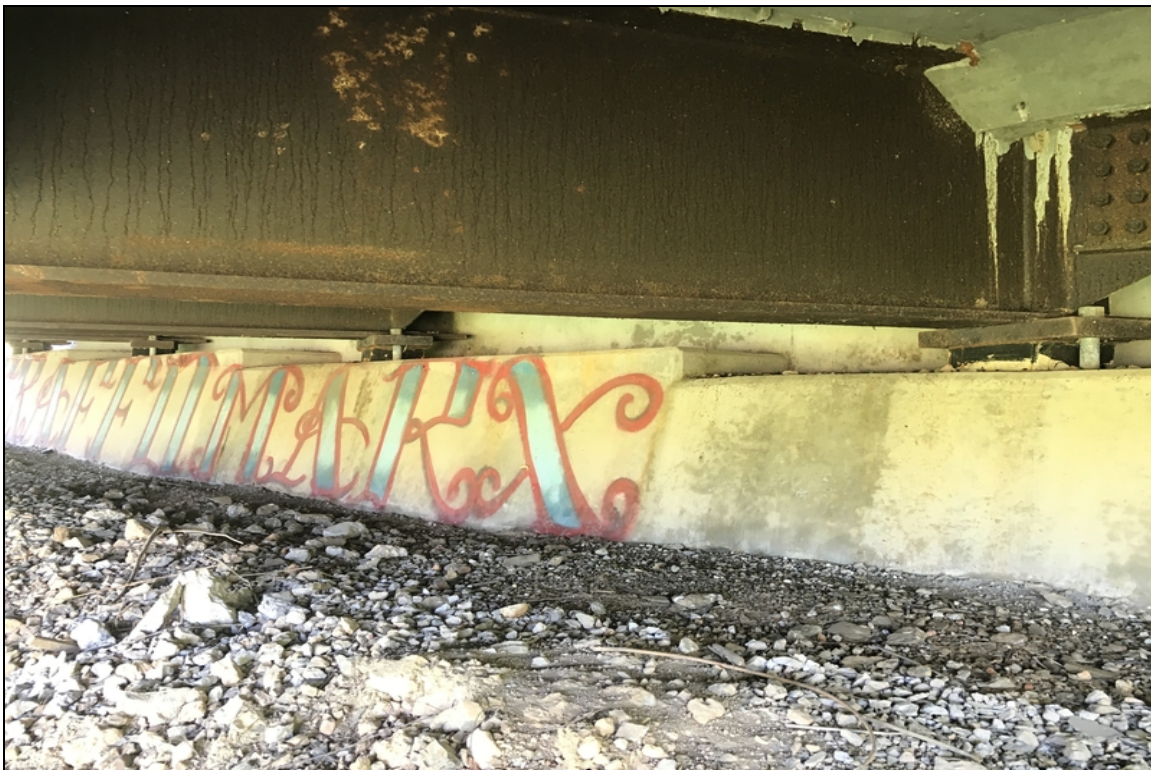
View of bearings at abutment #1.

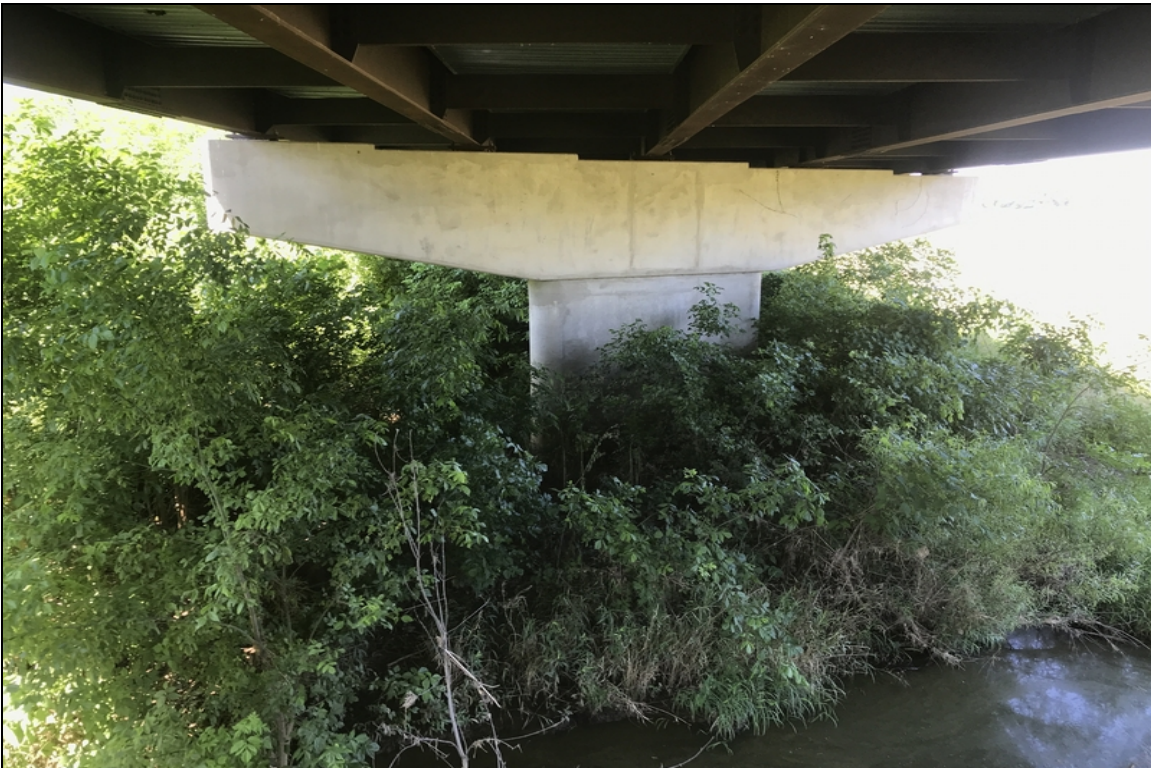
View of bent #11 ahead side.

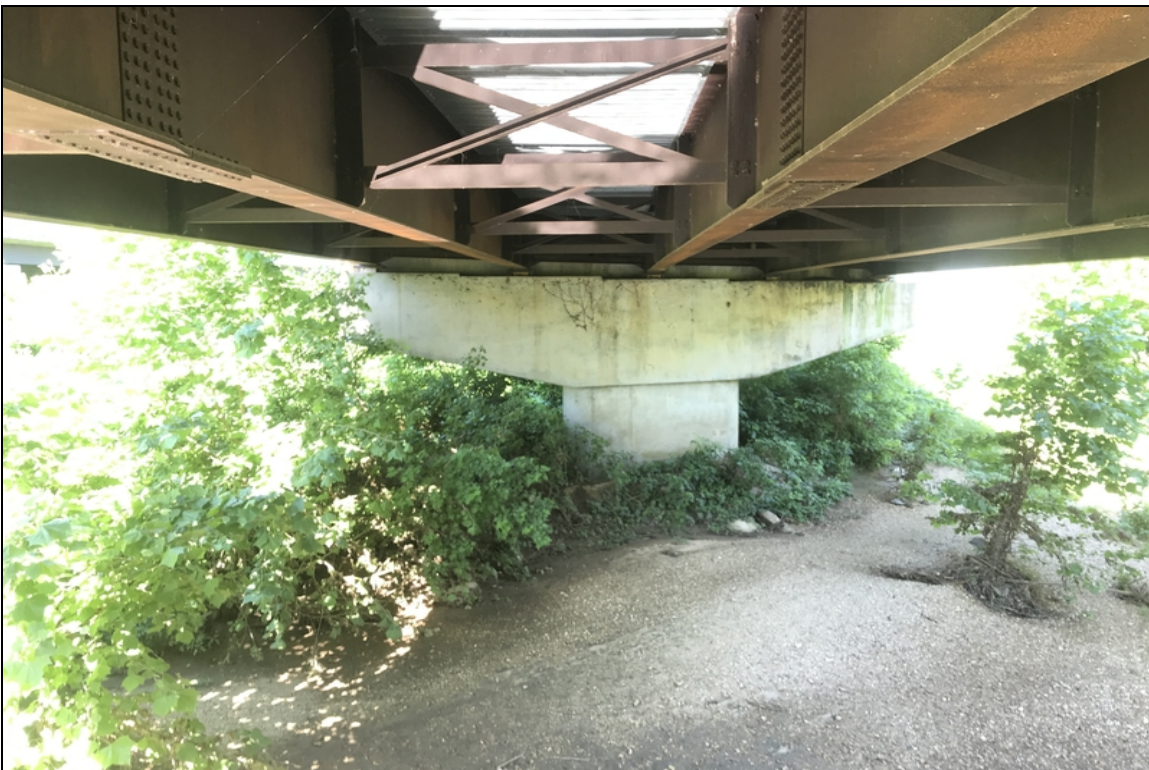
Large amounts of bat Feces accumulated on top of bent #16.

Bent #16 general view.

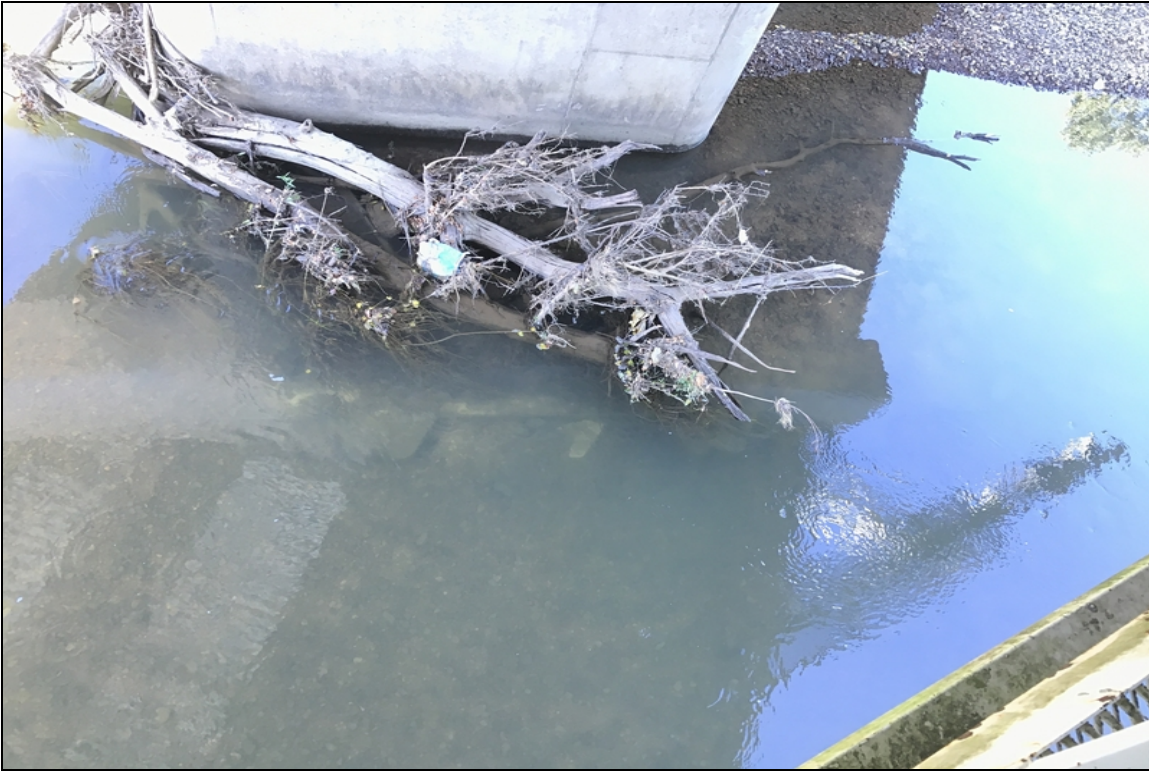
Possibly footing from old structure at bent #17

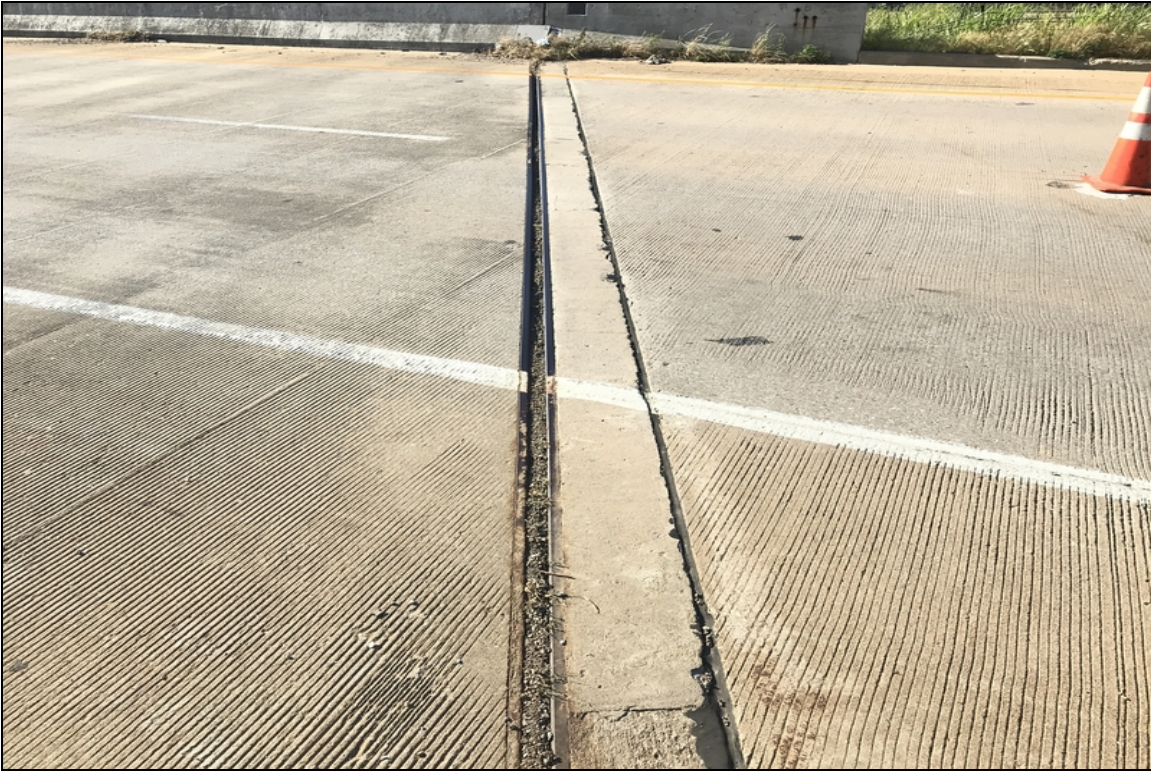
View of abutment #1 expansion joint

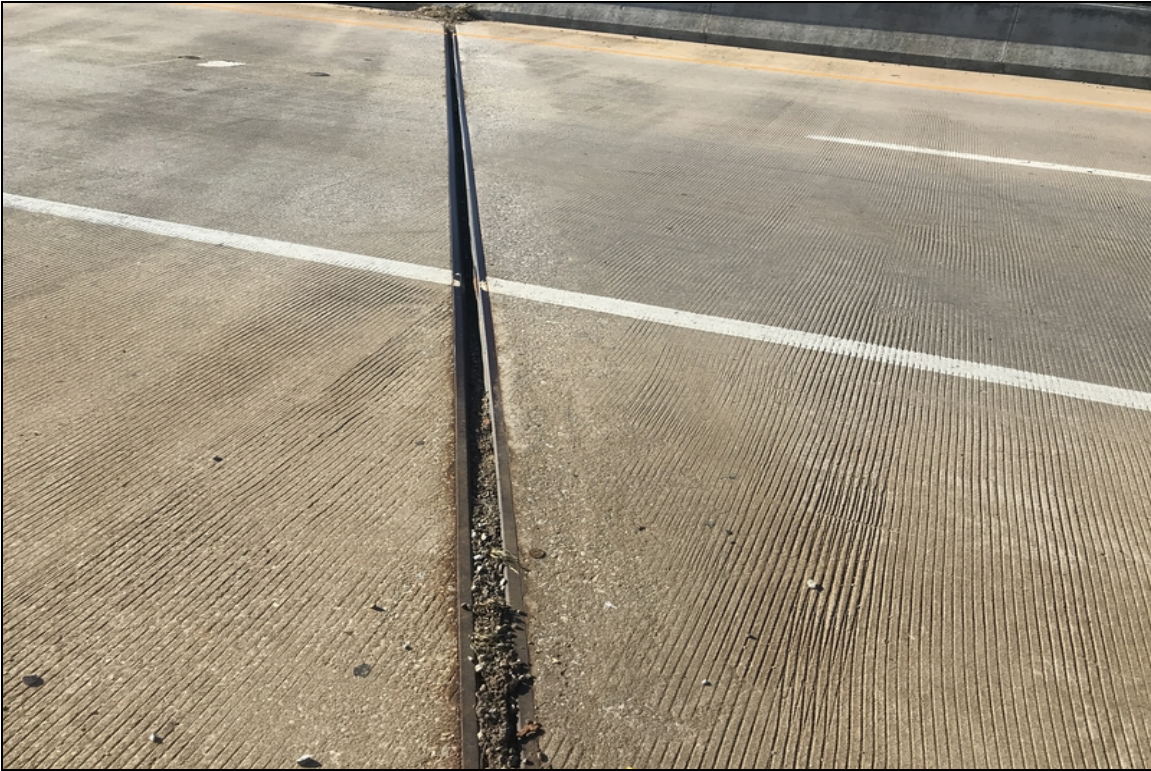
Bent #4 expansion joint

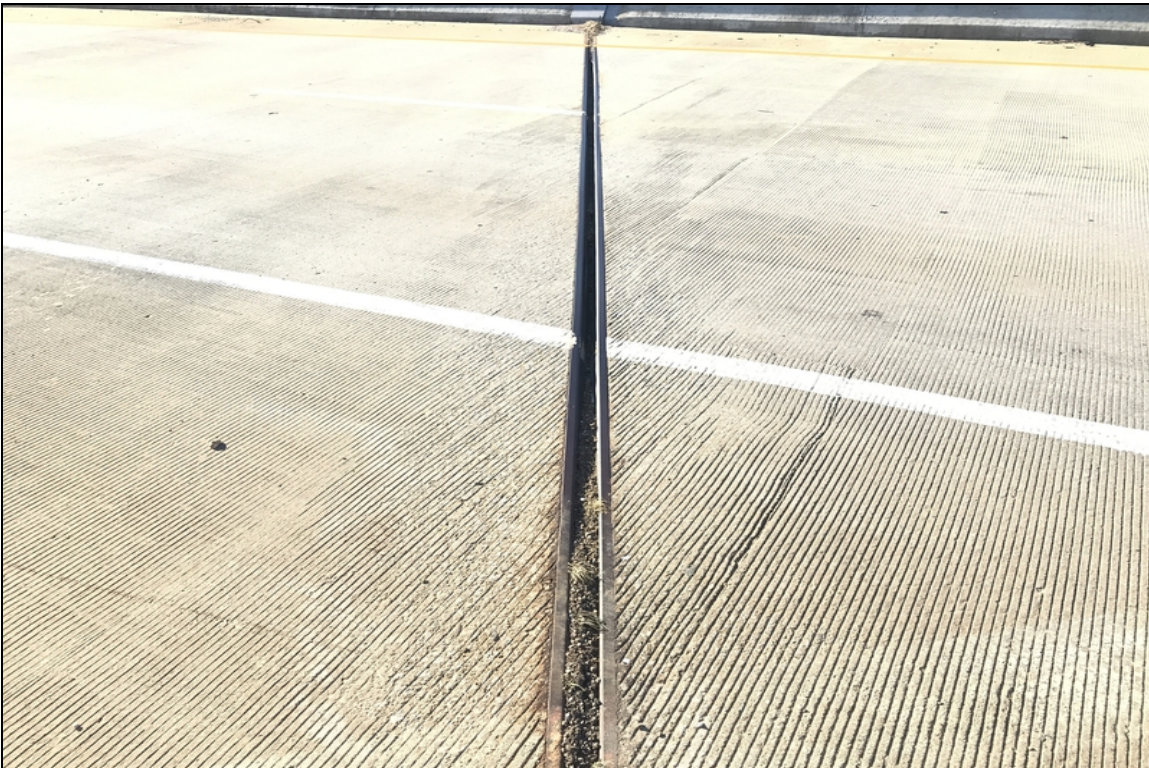
View of expansion joint over bent #8.

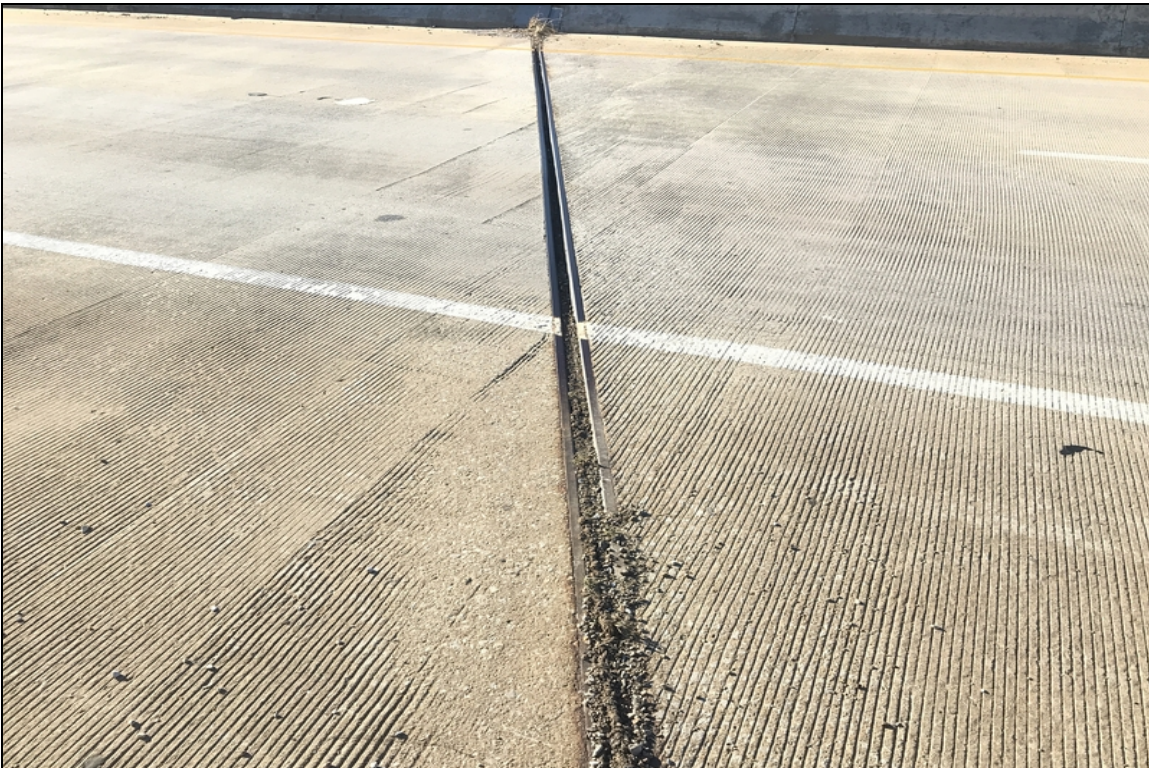
View of expansion joint at bent #12.

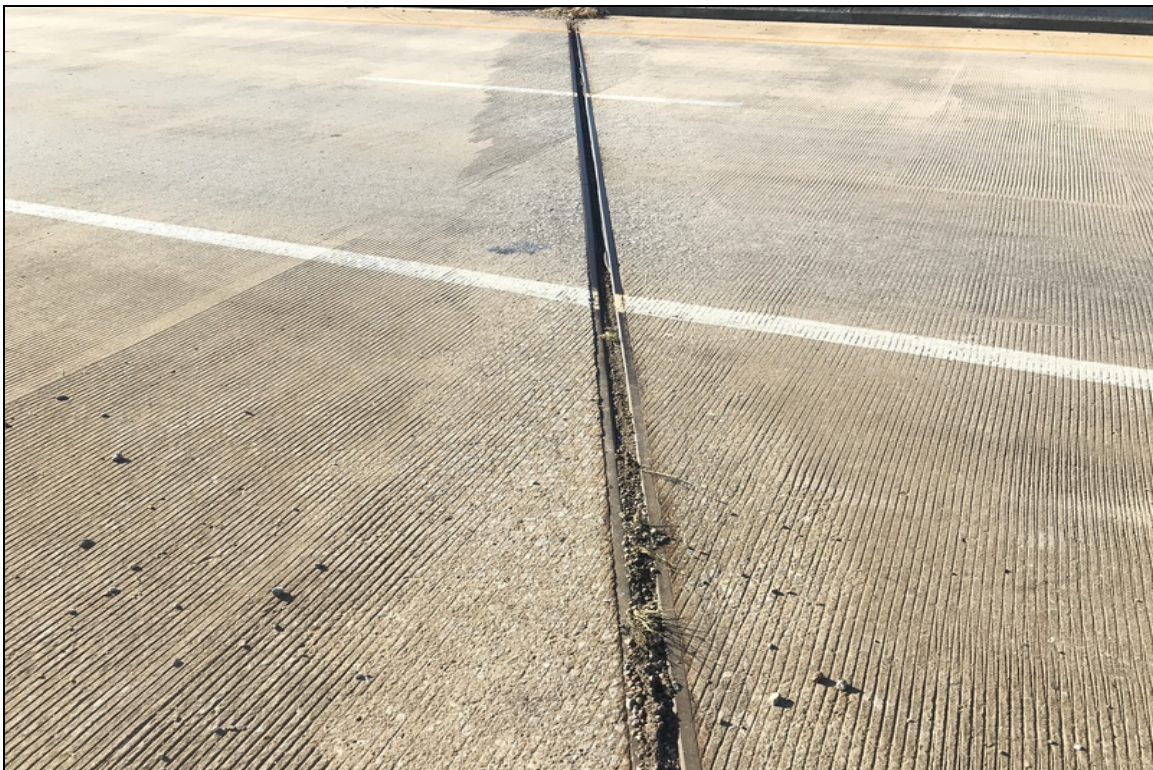
View of expansion joint at bent #16

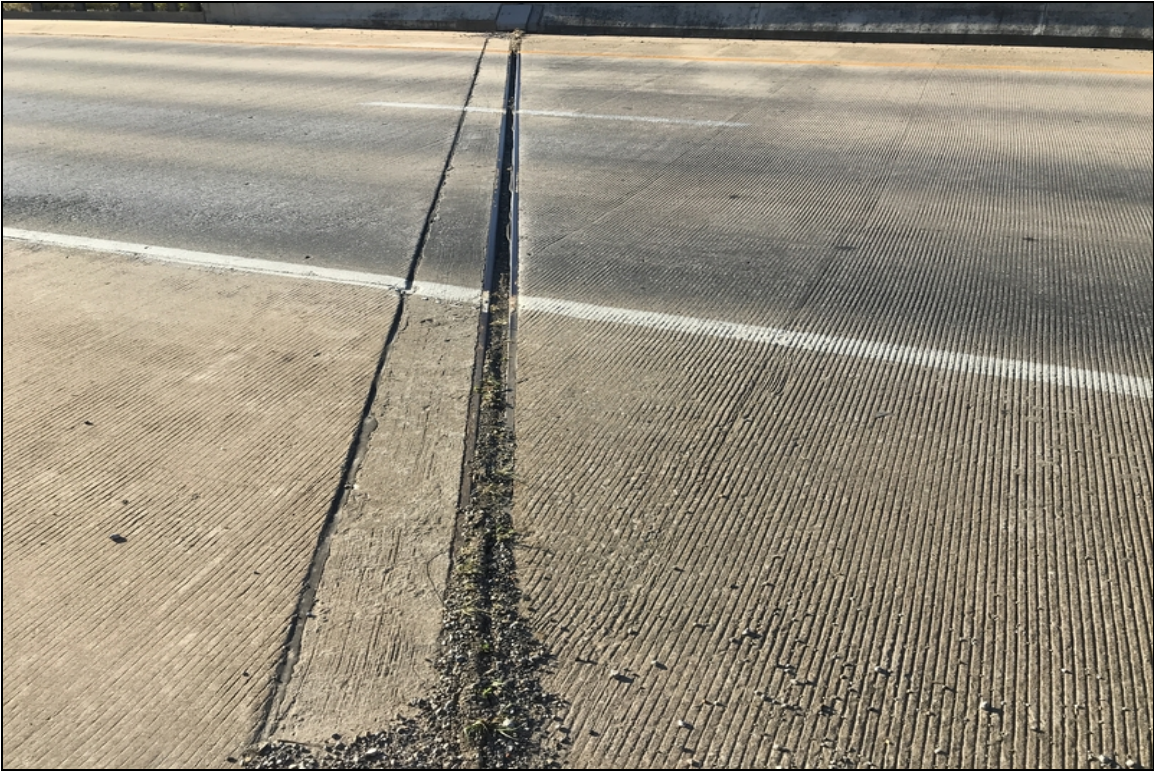
View of abutment #2 expansion joint

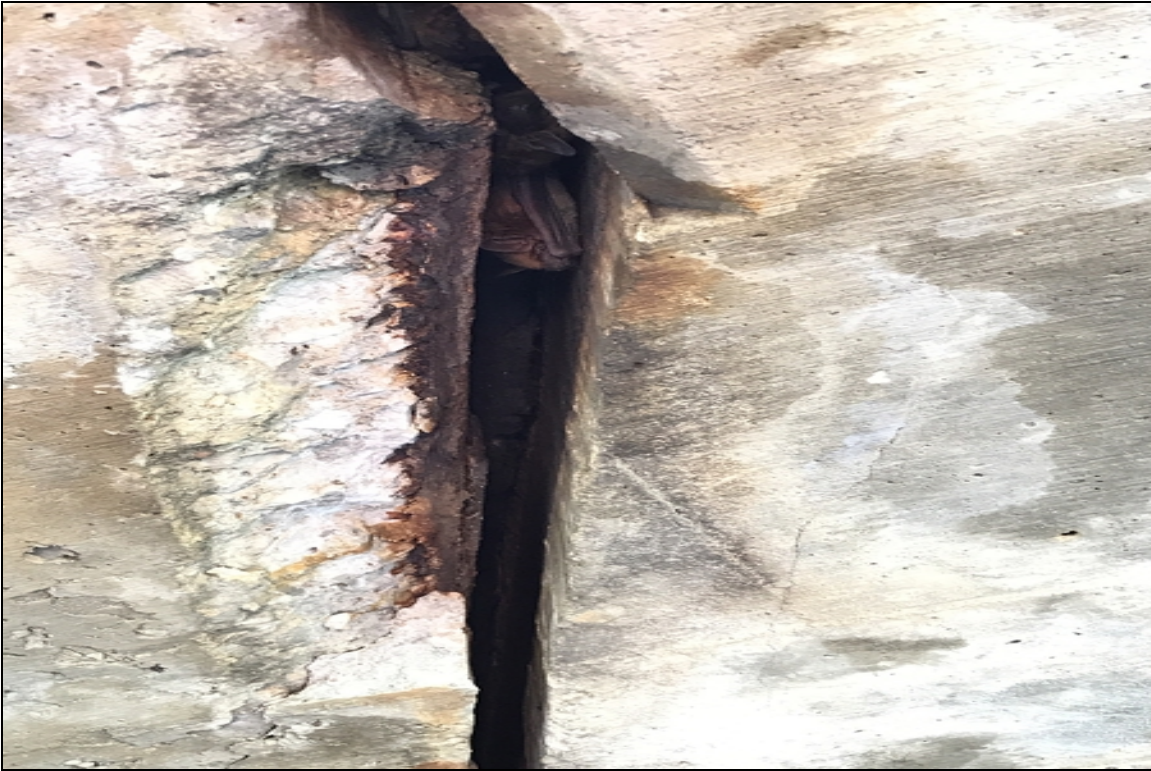
Bats at bent #16 joint

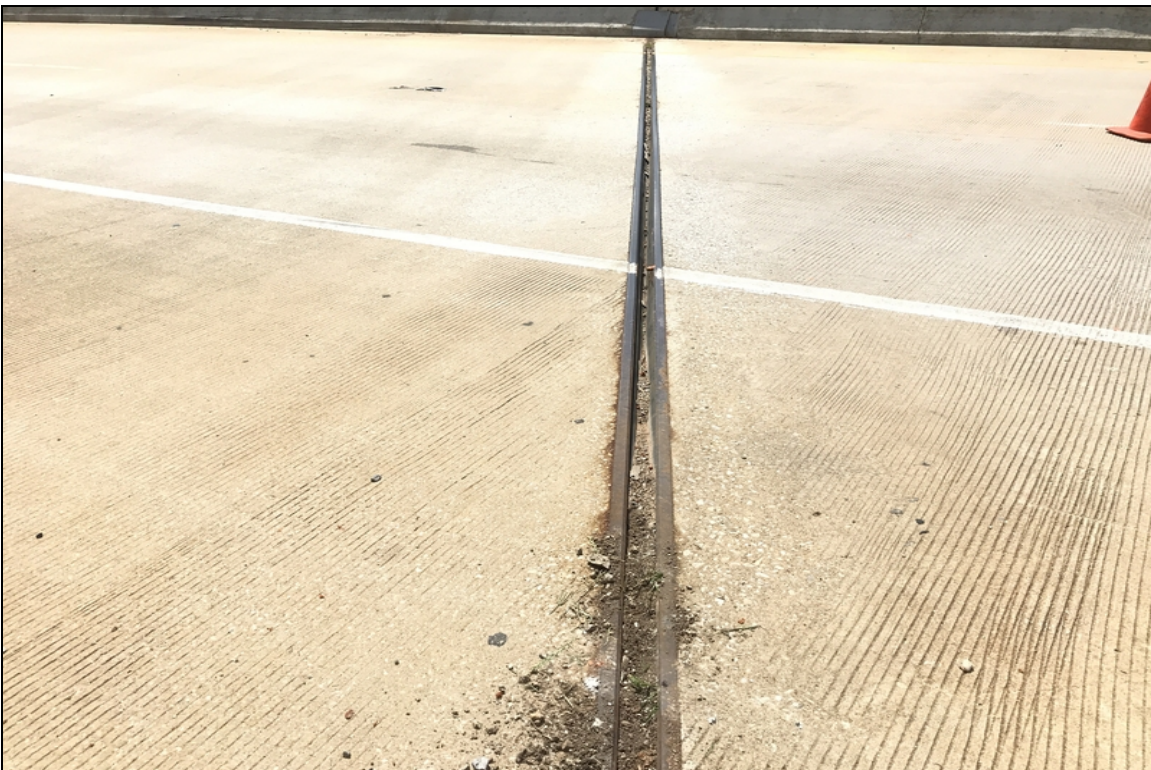
Expansion joint over bent #4 debris impact.

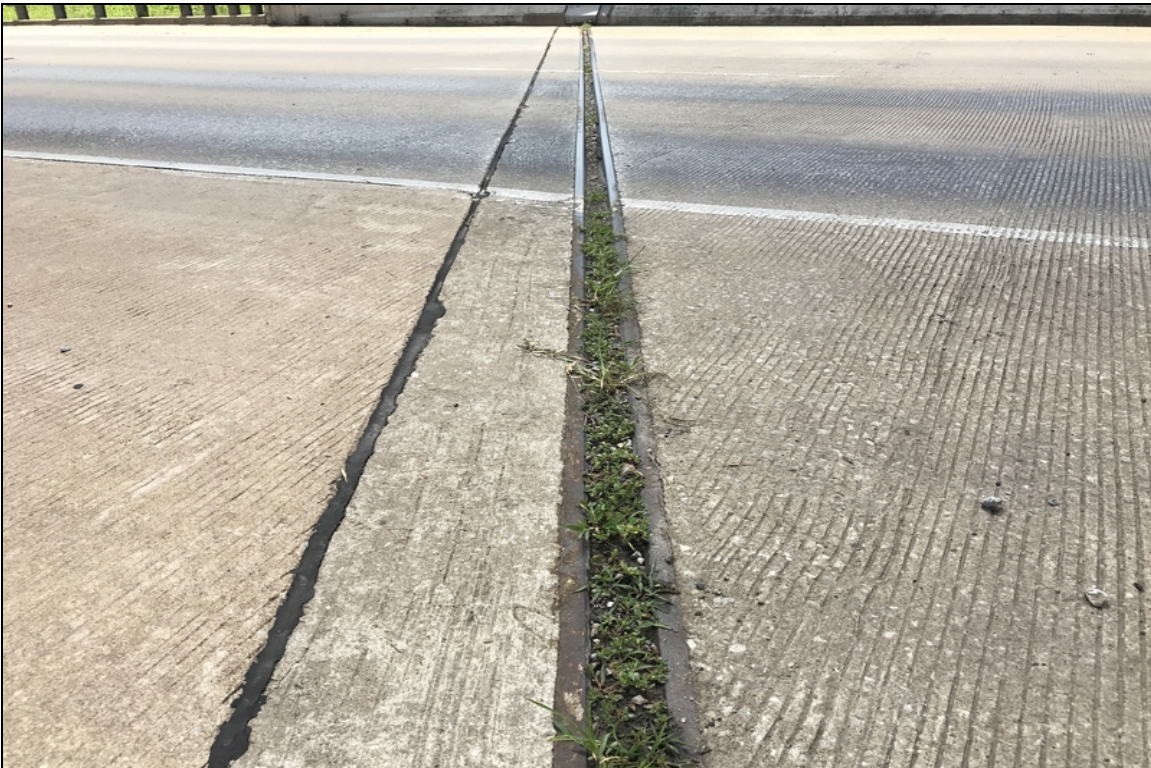
Abutment #2 expansion joint material debris impaction.

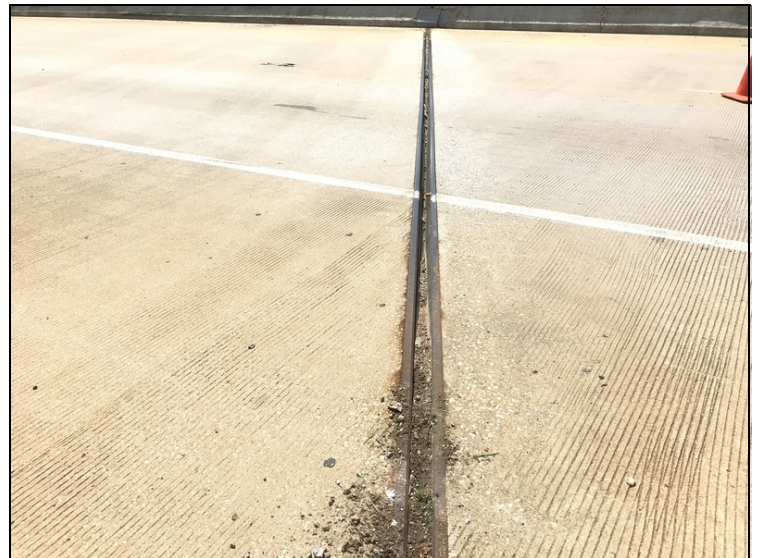
Expansion joint over bent #4 debris impactation.

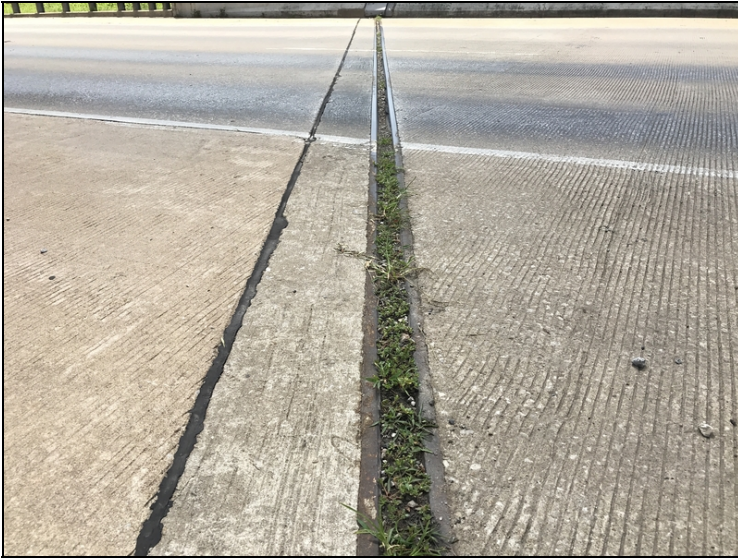
Abutment #2 expansion joint material debris impaction.

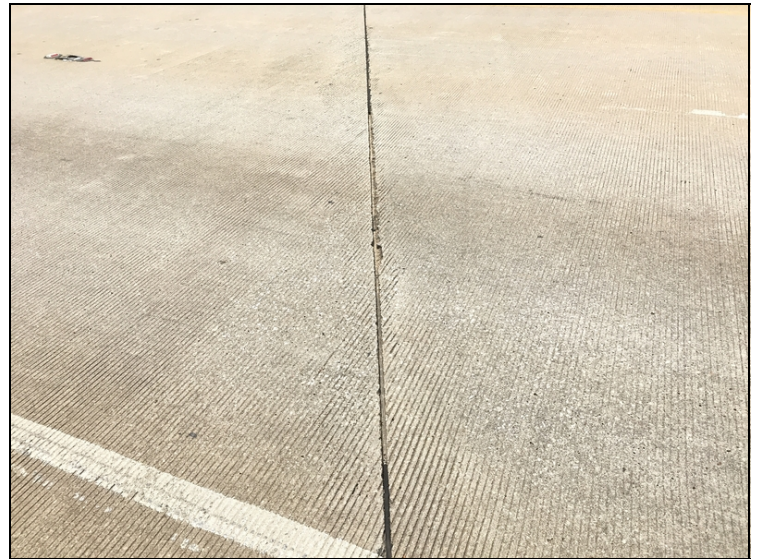
Typical - Joint material for construction joints have bent displaced in random locations.

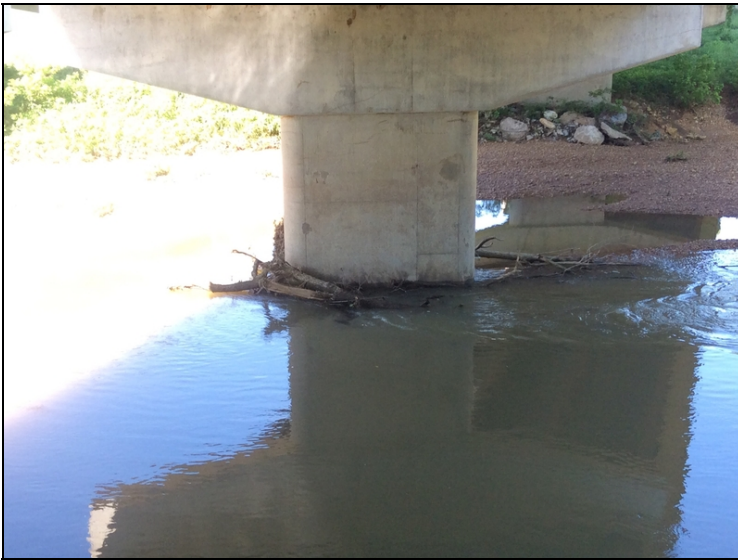
Channel - The channel has light drift accumulation at bent #17.

Bent #17-Drift.

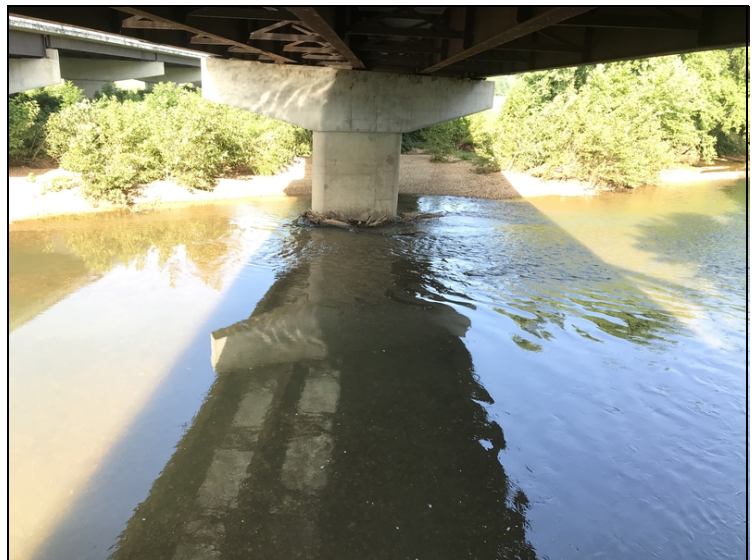
Ahead side of bent #17 - minor drift accumulation.

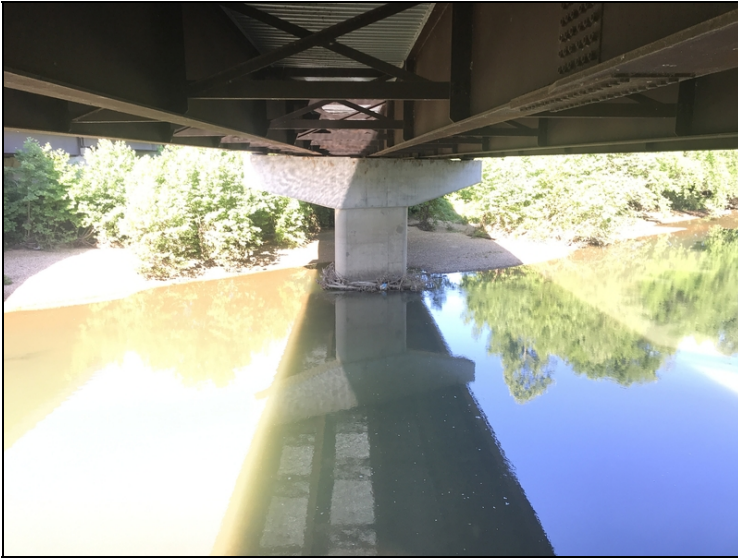
Drift still exists at bent #17

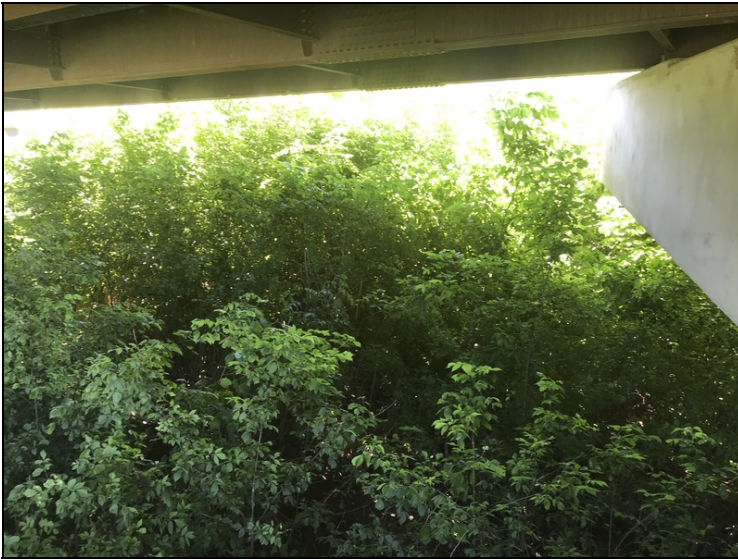
-The spans leading up to the main channel have heavy vegetation.

Heavy vegetation that is starting to grow into structure.
