Asset #05770(NSTM, Routine)

US 62 & US 412 over Norfolk Lake-District 9

Location: 8.49 MI E JCT SH 5

Team Lead: Anthony Wood, Inspection Date: 11/09/2022

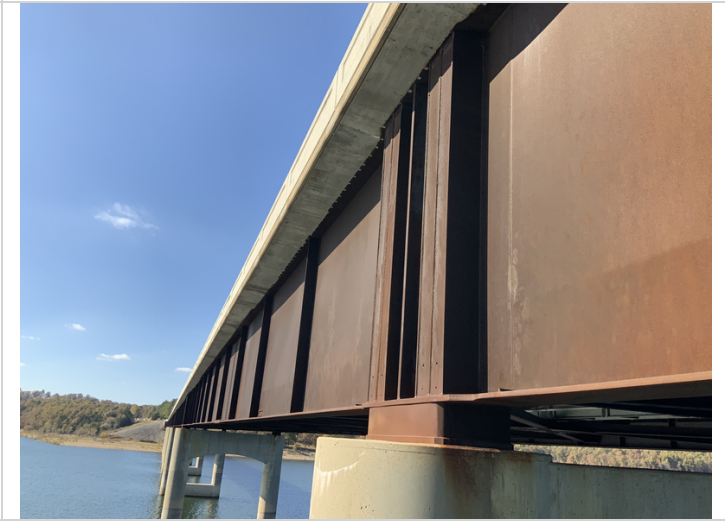
Typical protective coating

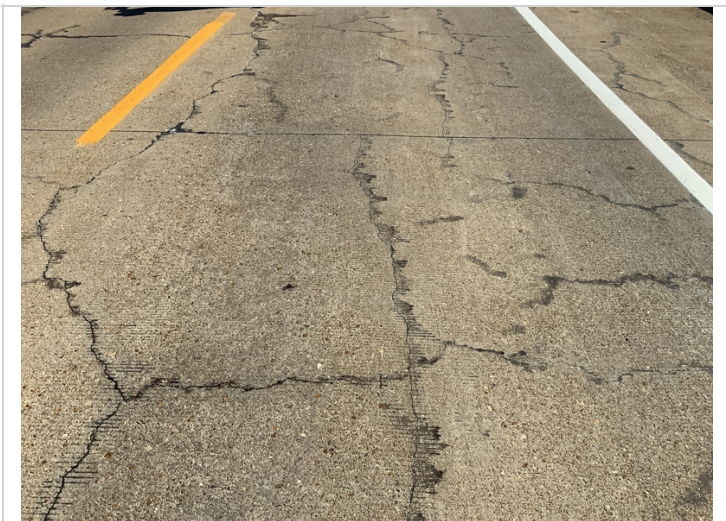
Approach slab has been sealed

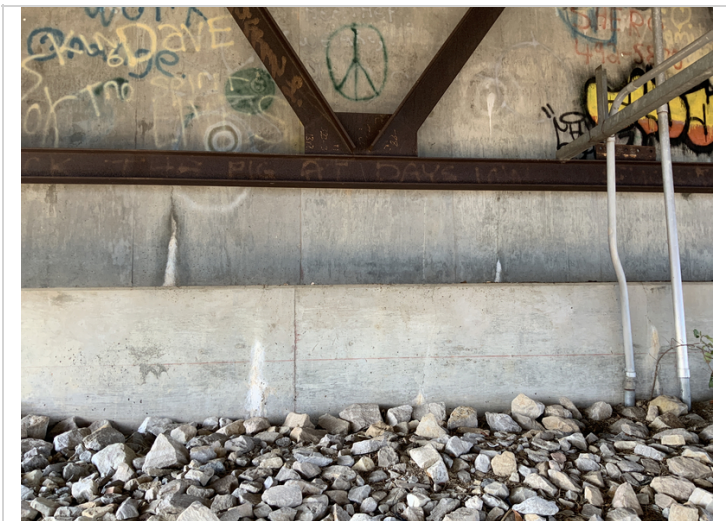
Bent 1 Efflorescence

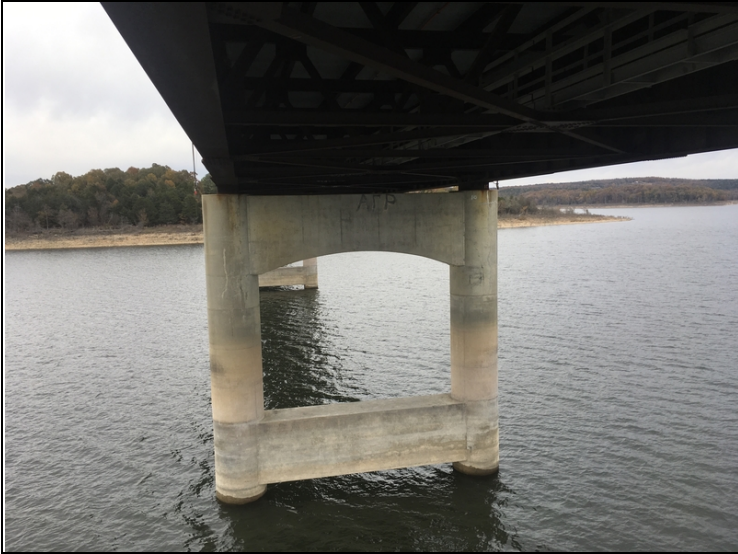
Typical piers.

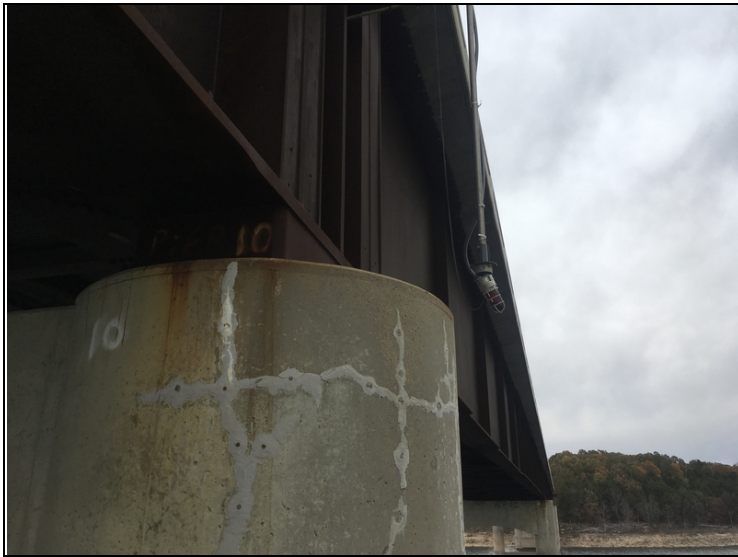
Pier 10, Right: Navigation light out.

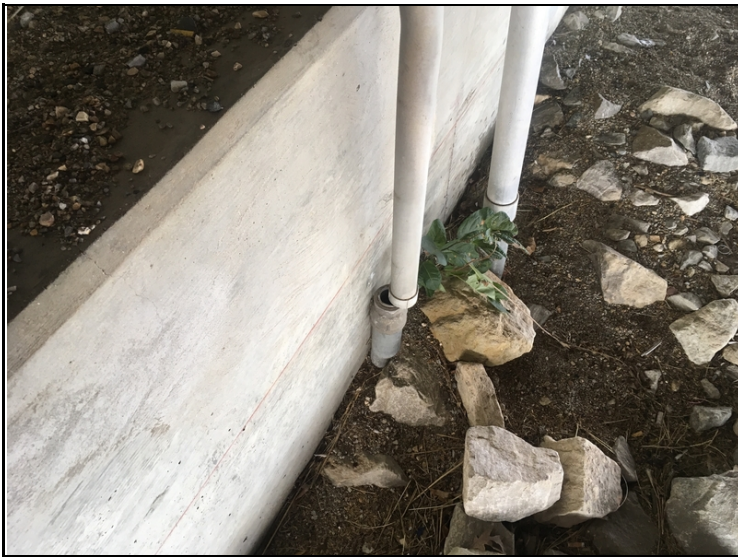
Utility conduit separating at ground level.

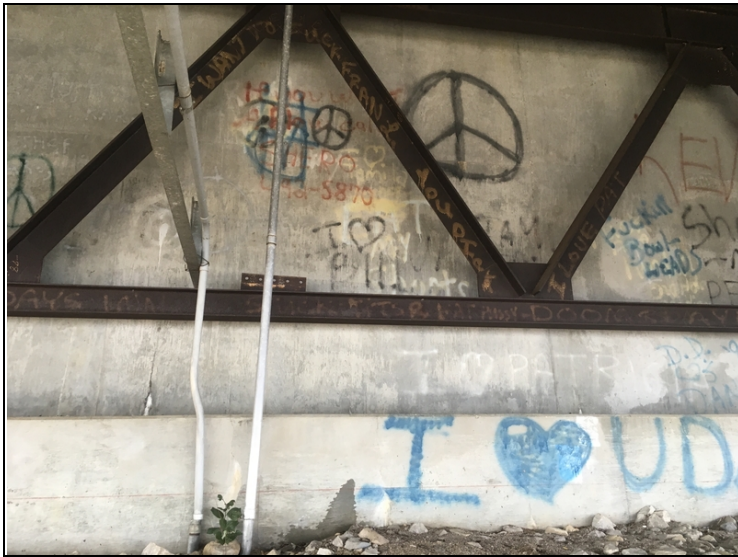
ELEMENTS	DESCRIPTION	UNITS	TOTAL	CS1	CS2	CS3	CS4
(215) 11/09/2022 RWF, APW & KVV - Abutment 1: 8 vertical cracks in back wall. Abutment 2: 6 vertical cracks in back wall. Graffiti on both abutments.							
234	Reinforced Concrete Pier Cap	LF	624	602	22	0	0
1130	Cracking (RC and Other)	LF	22	0	22	0	0

Abutment 1: Graffiti.

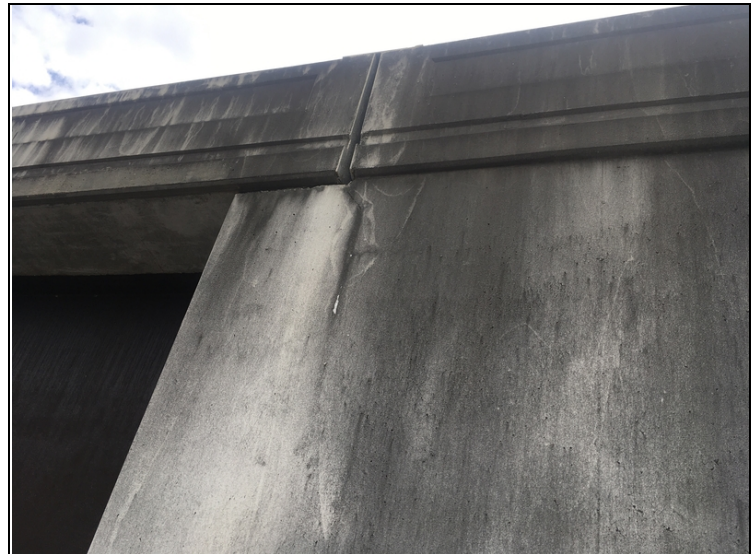
WINGWALL:

Abut. 1: The Lt. and Rt. wing walls have a 45-degree open crack at the top.

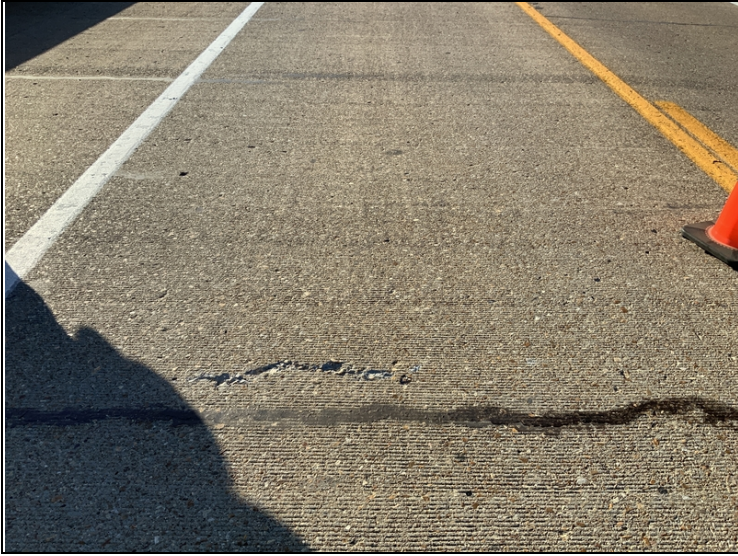
Span 13 Right lane delaminating area

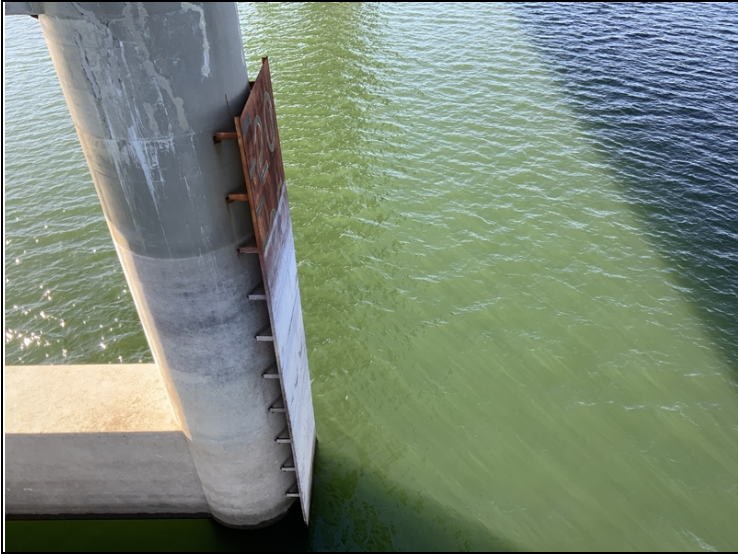
Pier 9 Upstream sign

Pier 9 Navagastion placards are not readable.
