Asset #05571(Routine, Underwater type 2)

SH 143 Carroll over KINGS RIVER

Location: 2.75 MI NW JCT HWY 62

Team Lead: Benjamin Smith Inspection Date: 04/19/2022

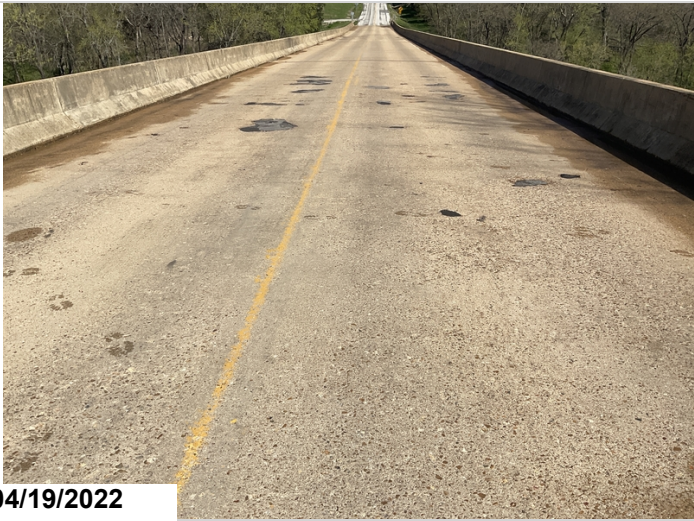
General view of the driving surface

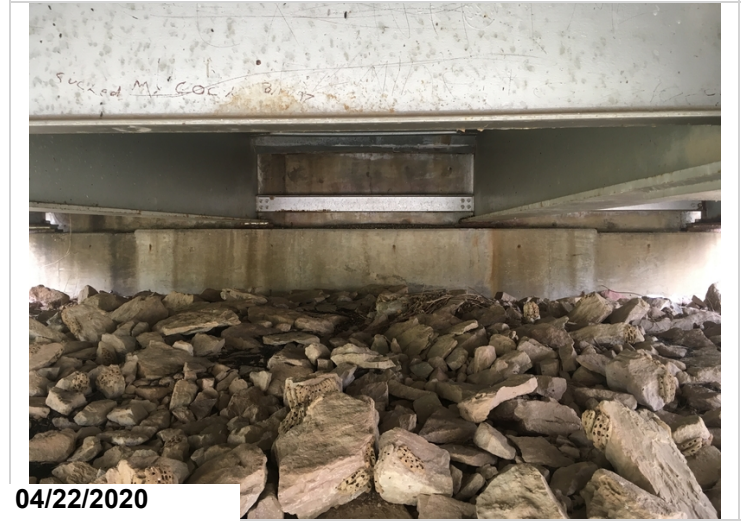
General view of abutment #2.

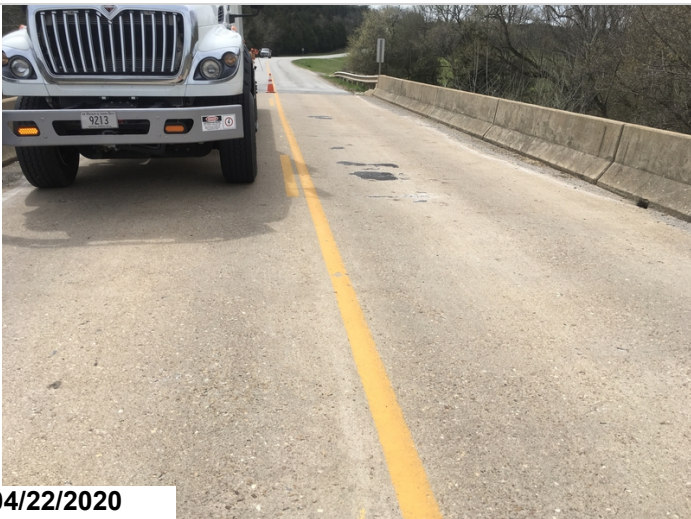
Patched areas in the left lane of span #1

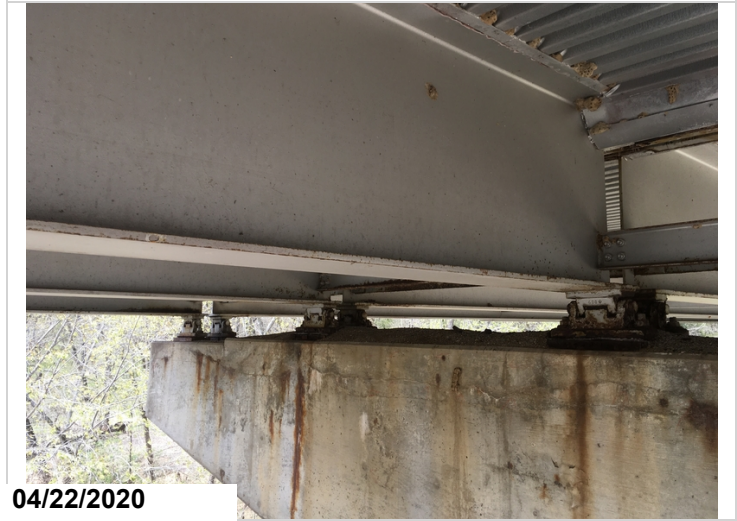
Beam end condition at pier #3.

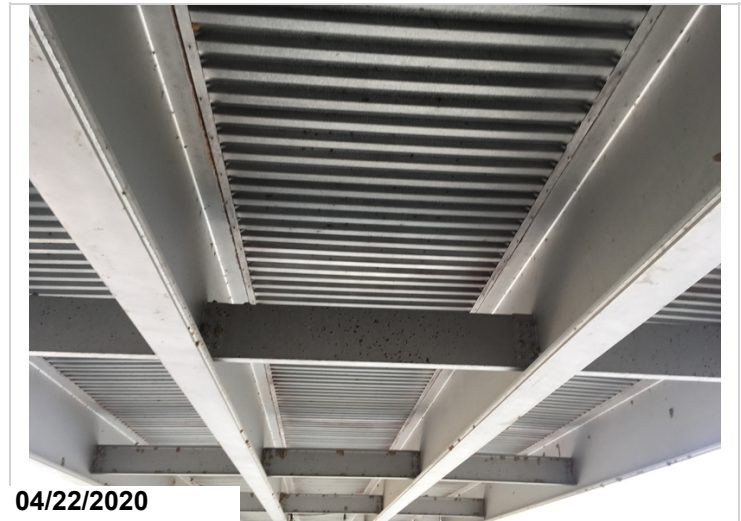
Typical undersurface condition.

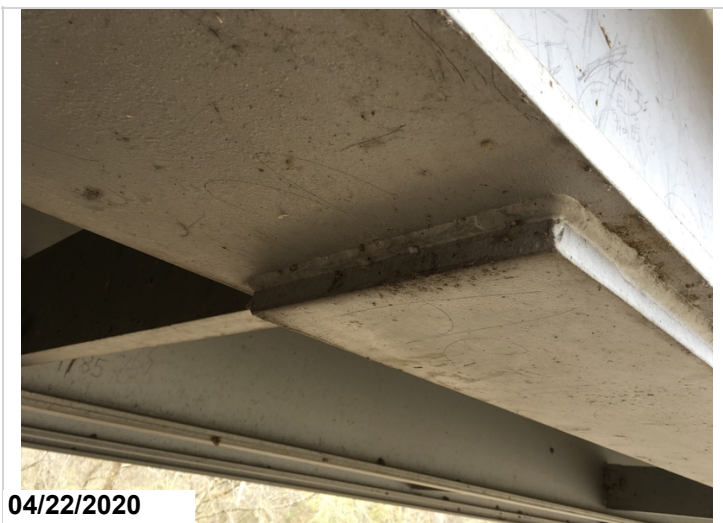
The cover plates are cut square with the bottom flange and welded in all locations.

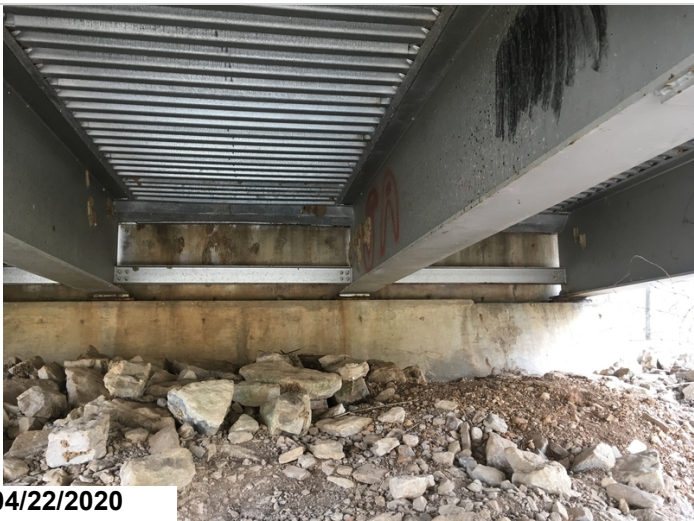
General view of abutment #1.

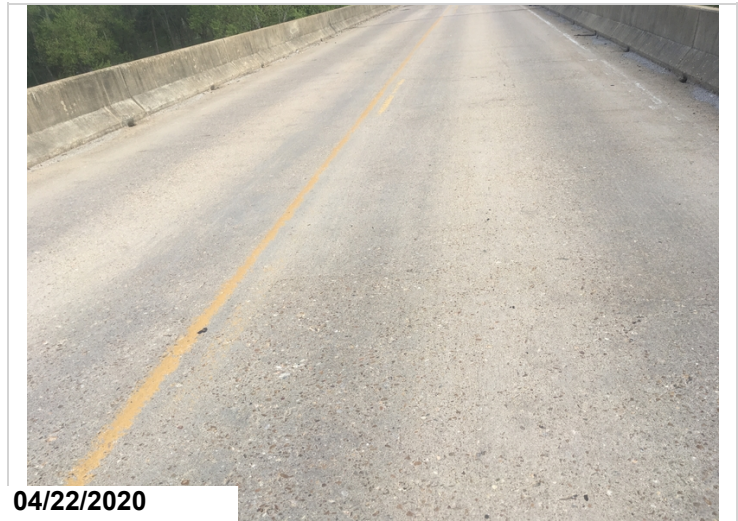
View of span 2 driving surface.

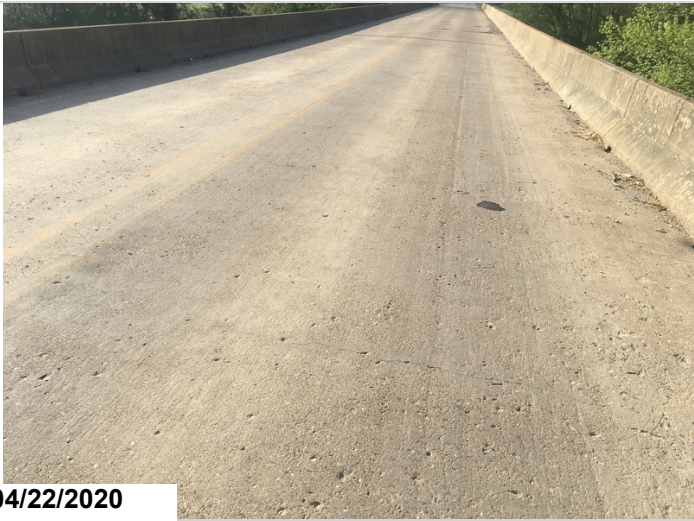
Span 4 driving surface.

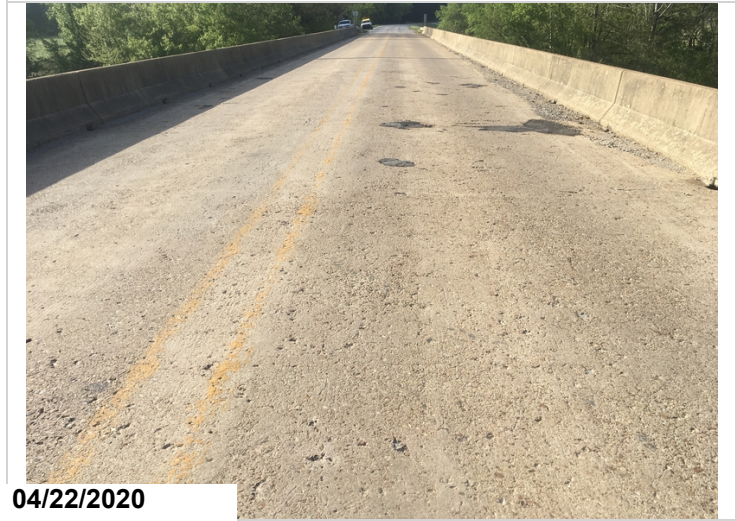
Span 3 driving surface.

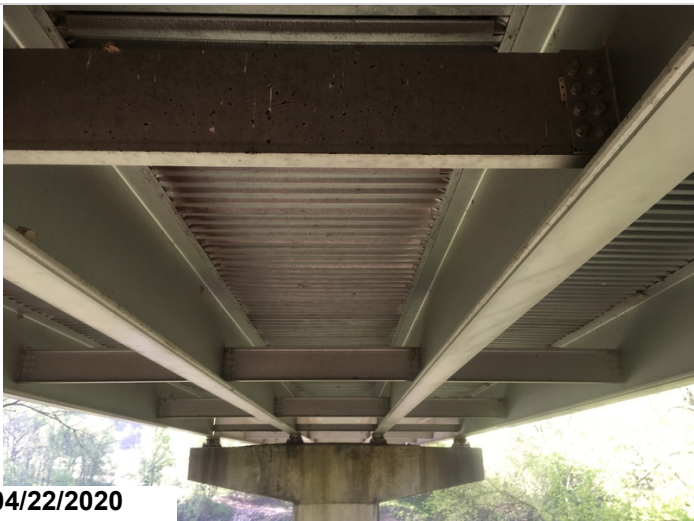
Typical view of the undersurface.

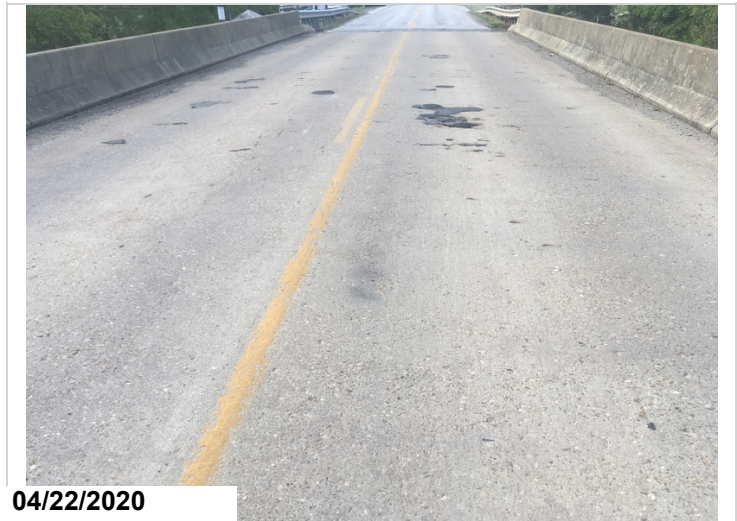
Delamination and pot holes in span 1.

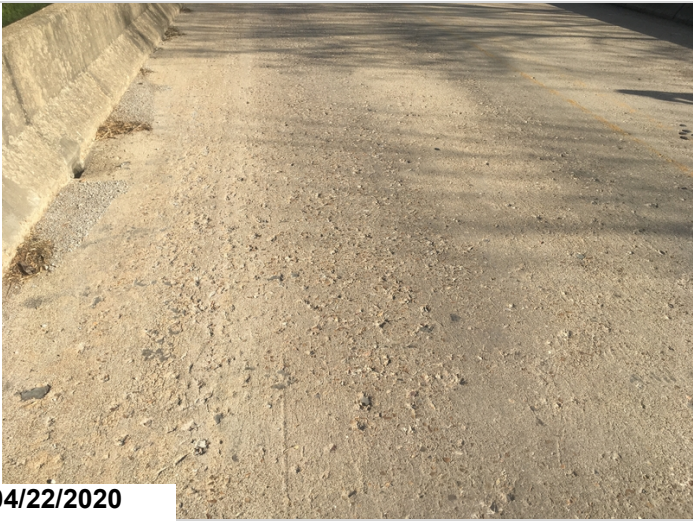
Left lane of span 5 showing scaling and delamination.

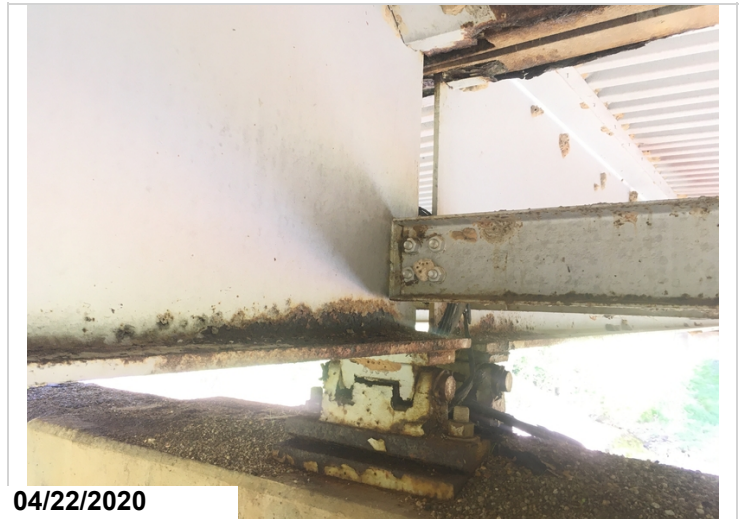
Beam end and bearing condition at pier 1

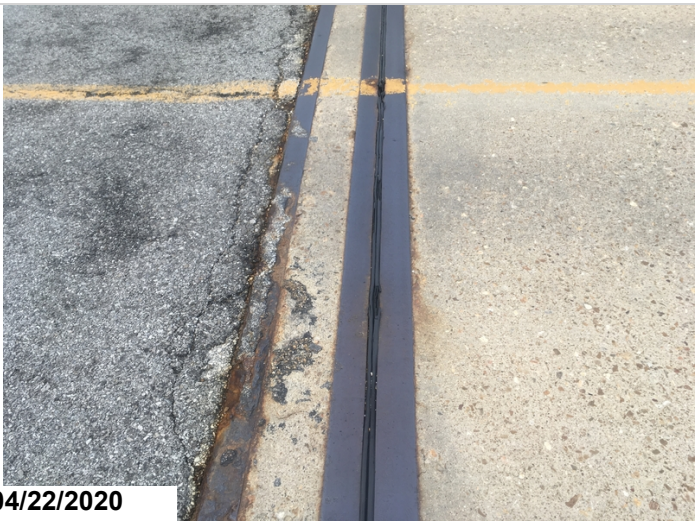
Abutment 1 joint seal condition.

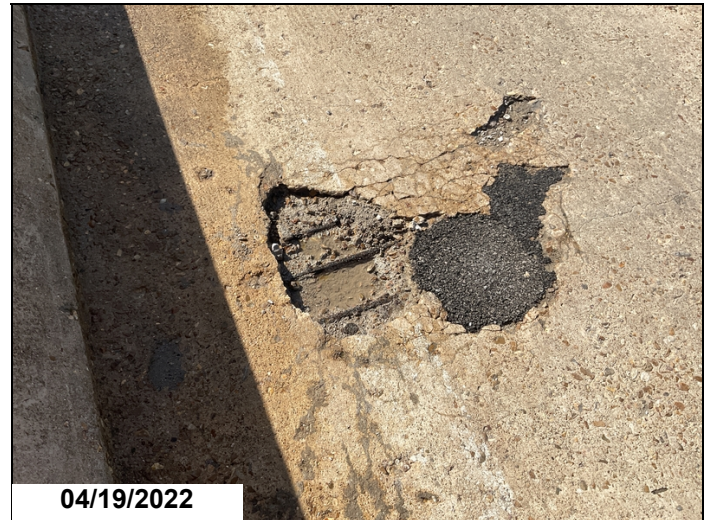
2'x1' area of pot holing with exposed rebar in span #3.

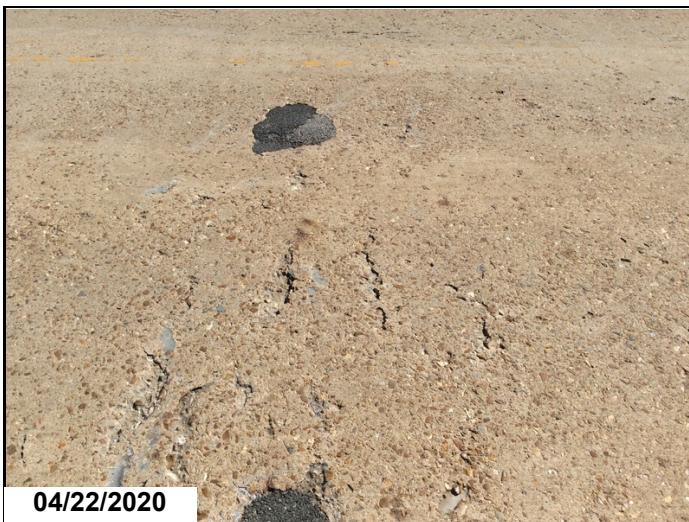
Heavy - moderate deck scaling in span #3

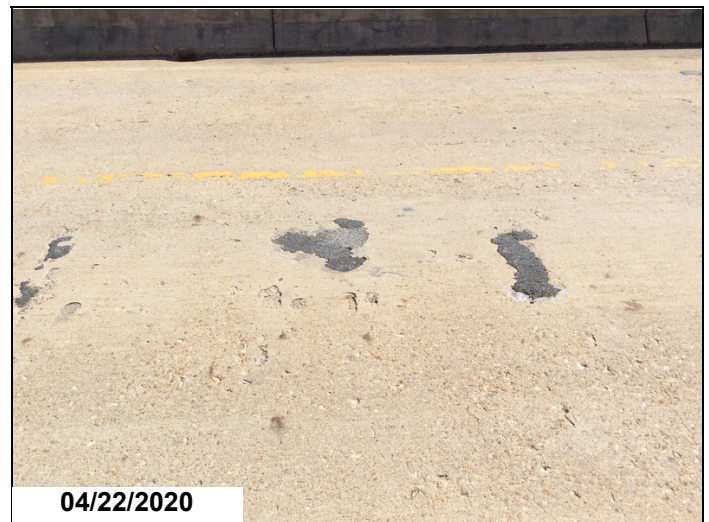
Moderate deck scaling in span #1

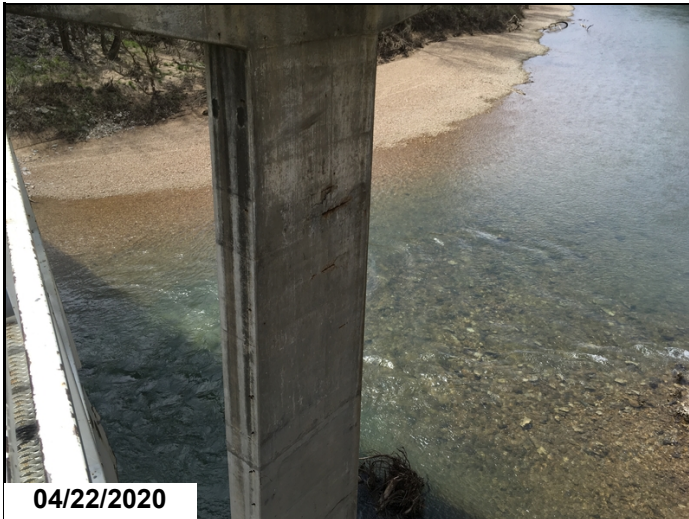
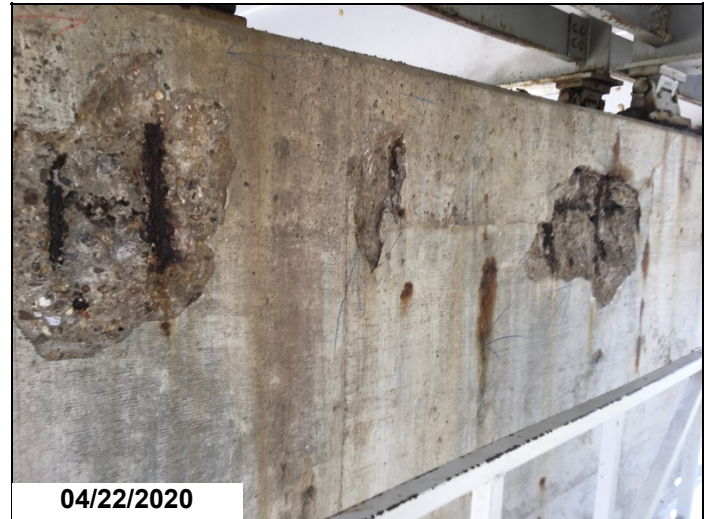
The vertical face of the pier #1 cap has spalls with rebar exposed on the span #1 side.
Large spalls with exposed rebar exist on the back side of the piers #2, #3 columns 15' down from cap on the span #3 side., large delaminations are also present in the same area.

Exposed rebar back side bent #2 column

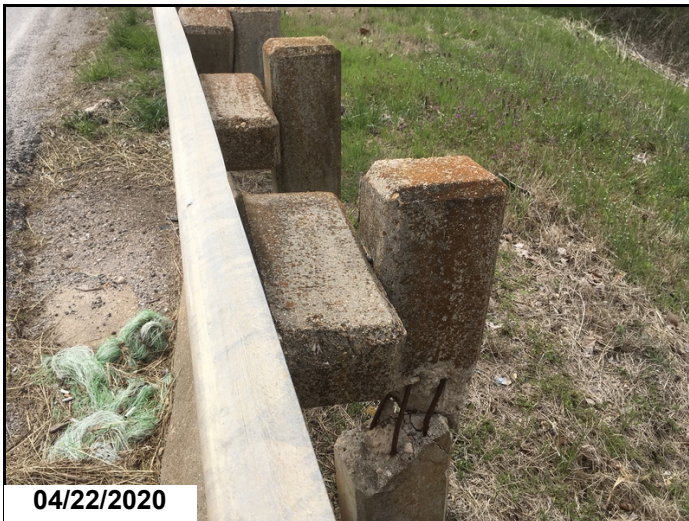
The 8th and 11th approach guard rail post on the left side is broken with exposed rebar due to vehicle damage.

Beginning bridge 2nd guardrail post left side broken
