Asset #05910(Routine, Underwater type 2)

SH 112 Benton 2 over SPRING CREEK

Location: 2.32 MI N WASHINGTON CO L

Team Lead: Nathan Rowland Inspection Date: 05/02/2024

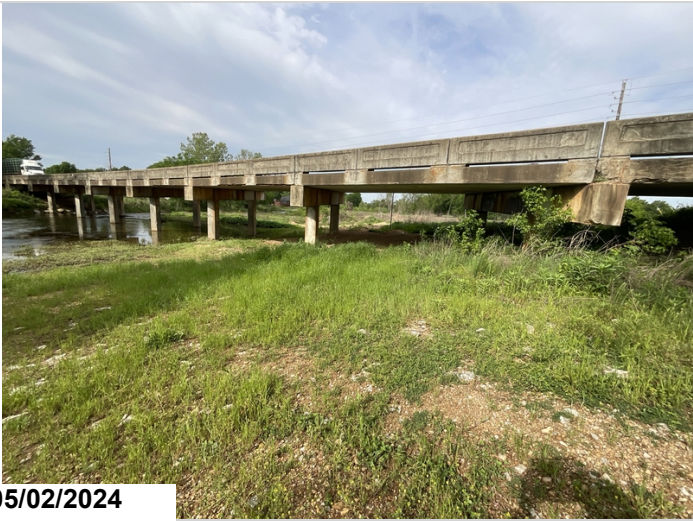
Elevation looking west

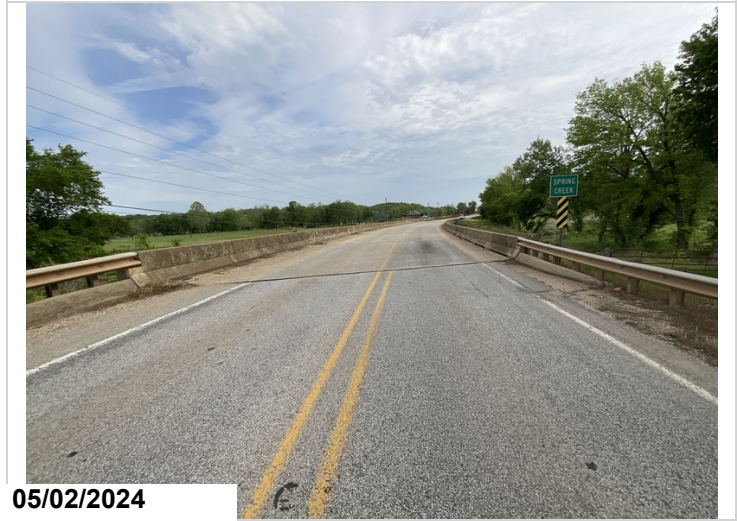
Inventory looking north

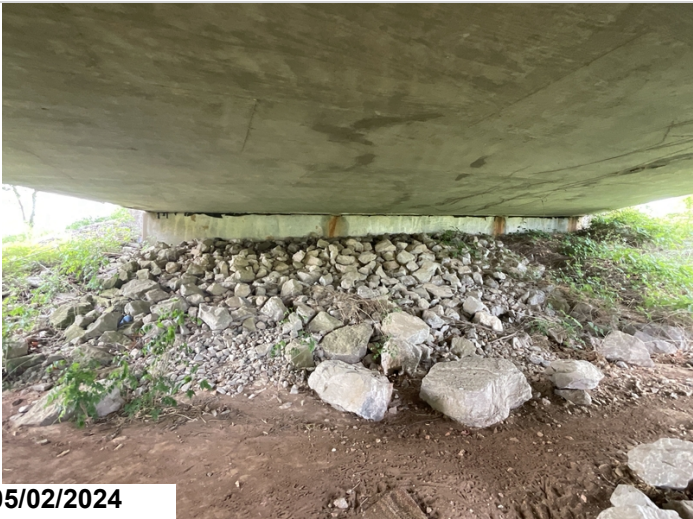
View of abutment #1

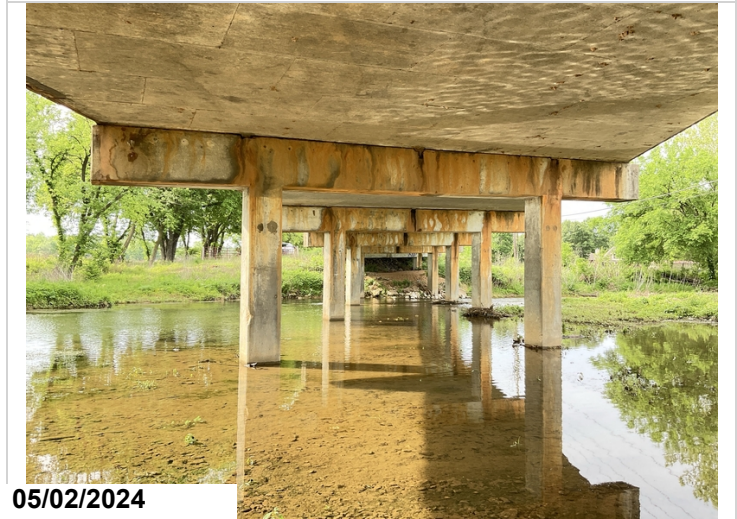
General view of intermediate bents

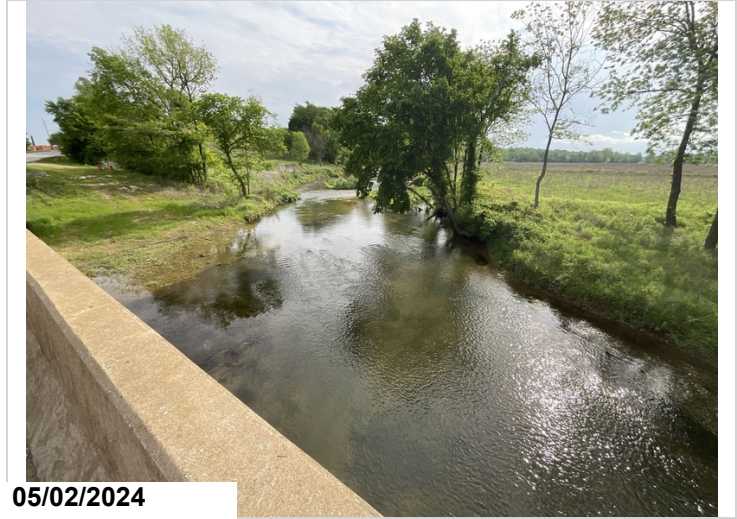
Upstream view

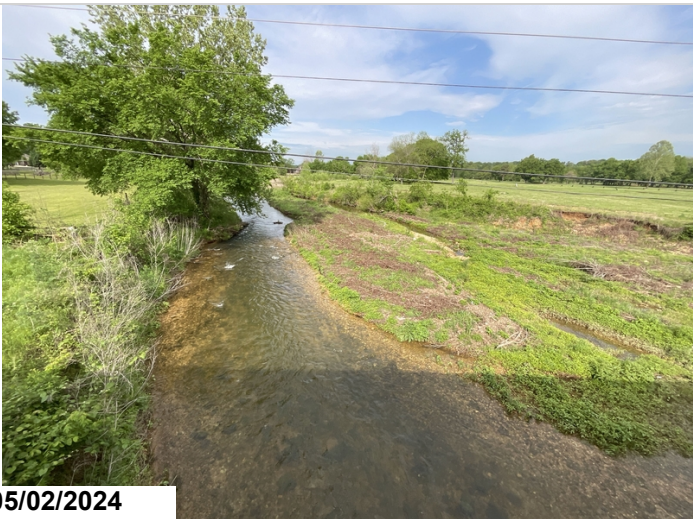
Downstream view

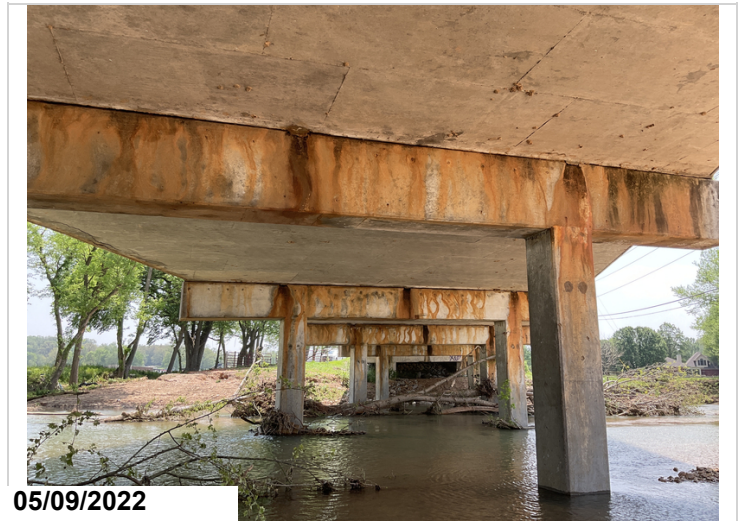
Typical of caps

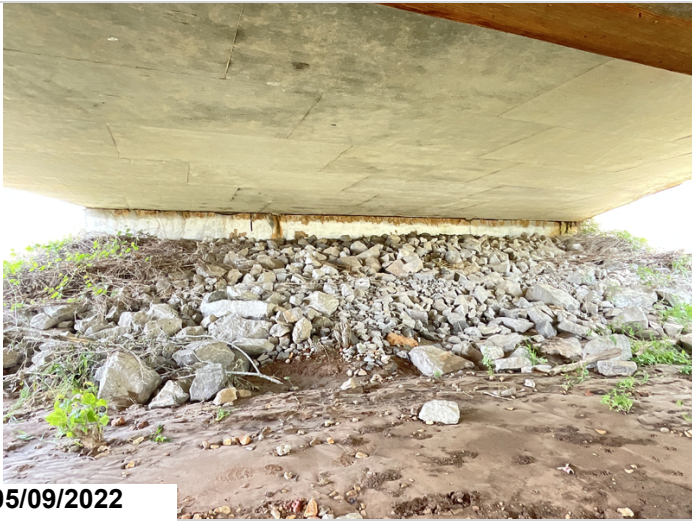
View of abutment #2

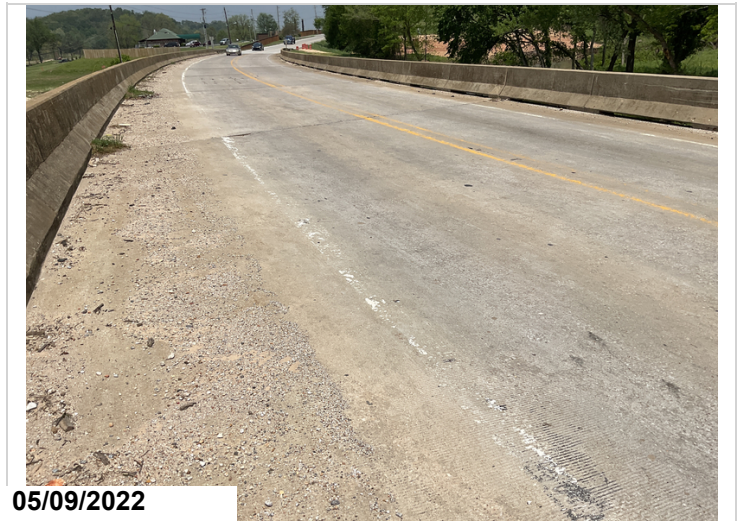
General view of deck

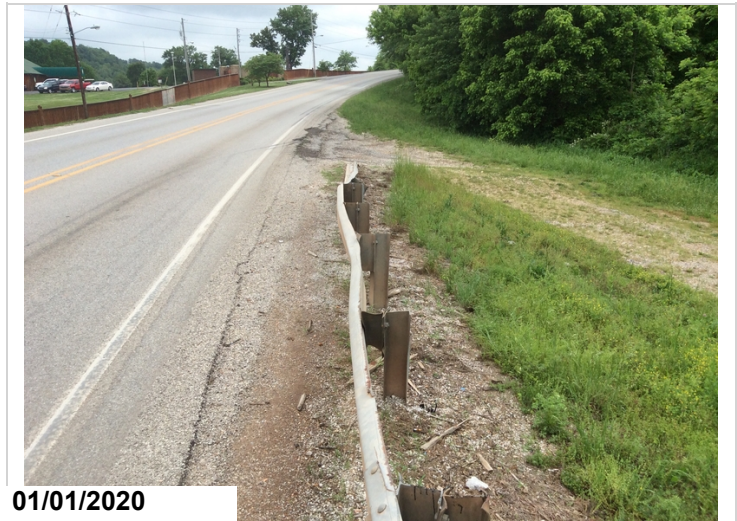
01/01/2020

Abutment #2 right approach railing has vehicle damage.

- Deck railing left at bent #5 has large spall with steel exposed.
- The North West approach railing has vehicle damage.

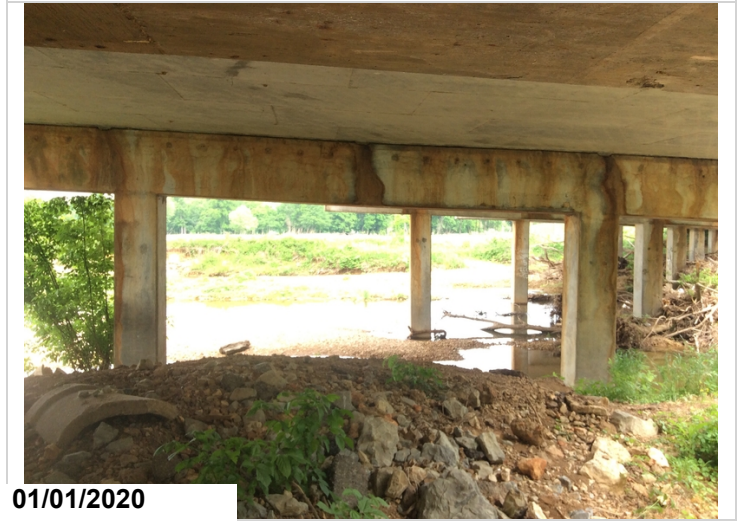
General view of bent #2.

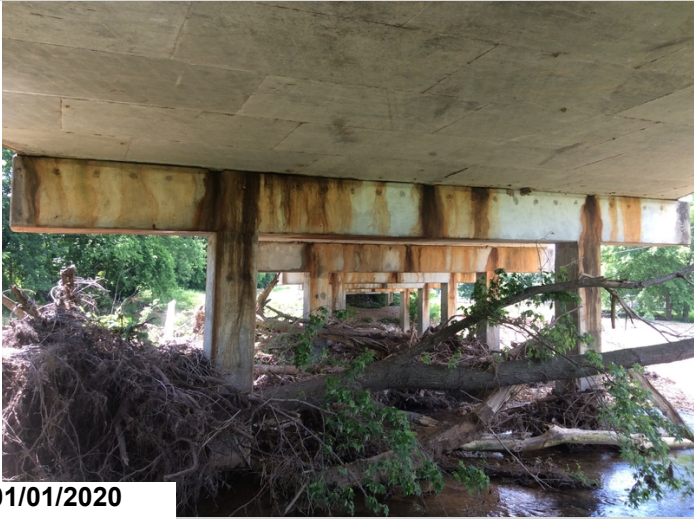
01/01/2020

General view of bents leakage.

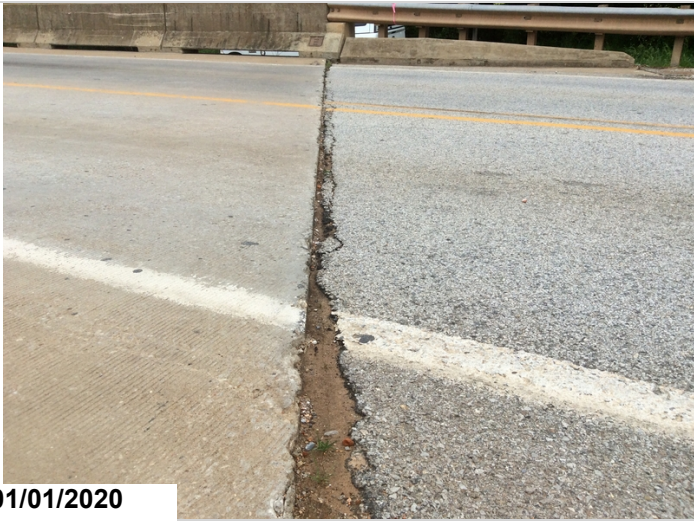
Abutment #1 general view of joint.

Deck pourable joint seal has lost adhesion and is displaced in some location allowing water to accumulate in joints and on top of caps.

Type of Work: Repair (General)

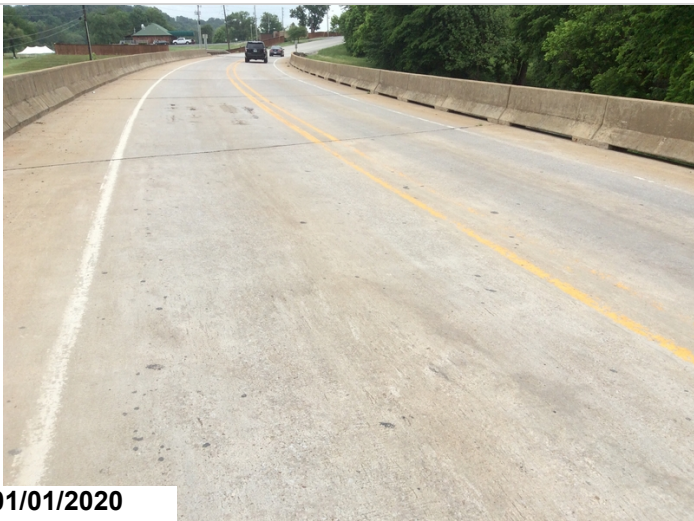
General View of span #2 and #3.

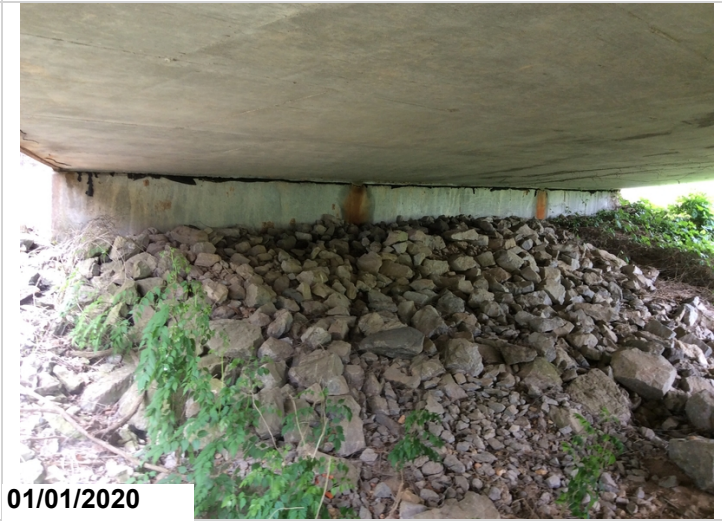
General view of abutment #1.

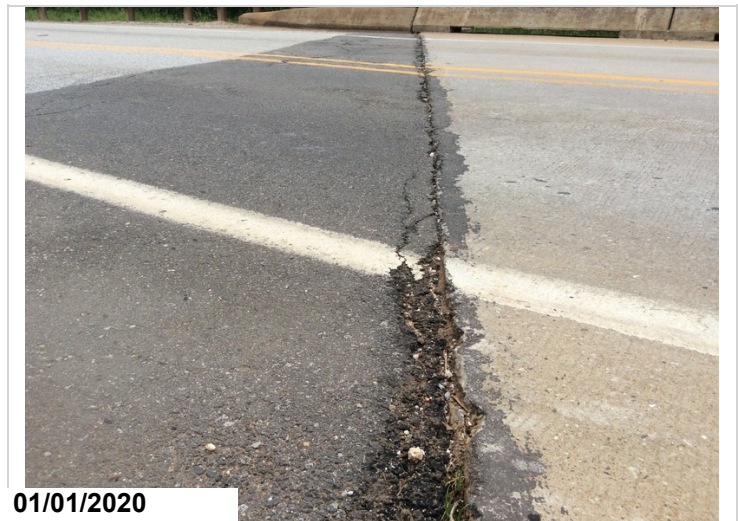
Abutment #2 has leveling at the approach roadway.

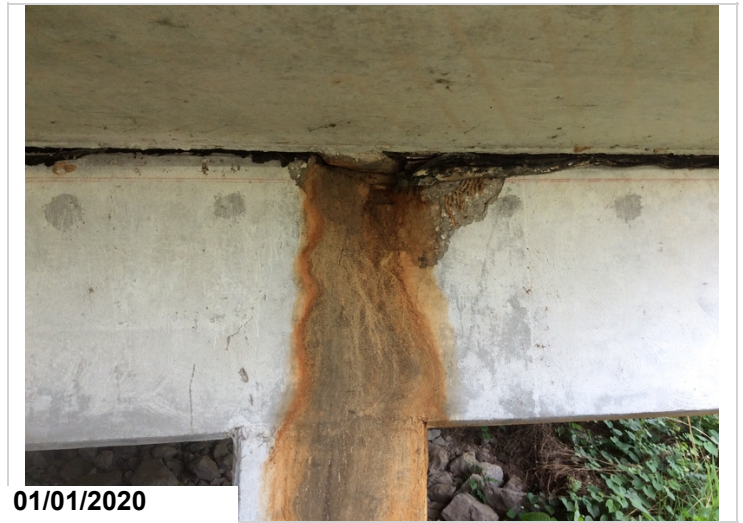
Spalling at key way bent 1 ahead side above column #1.

- The vertical face of caps at keyways for all bent caps have small to large spalls.
- The right vertical face of the bridge deck over bents #1,2,3,5,6, and 8 has spalls with steel exposed in some locations.

Type of Work: Repair (General)

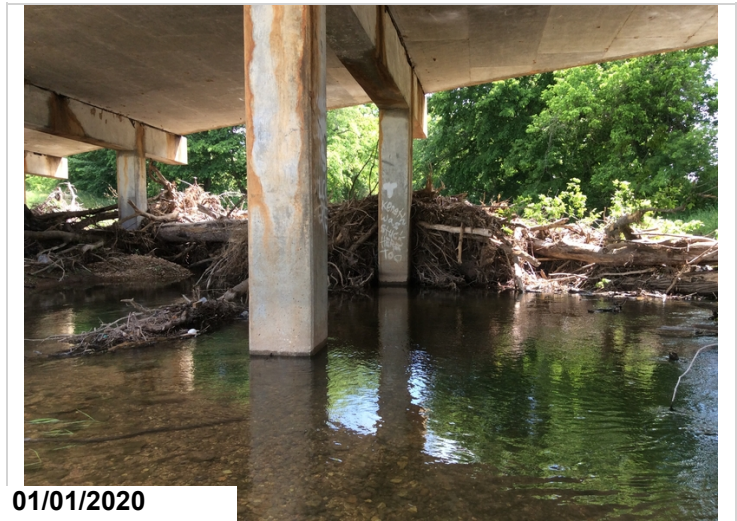
Drift

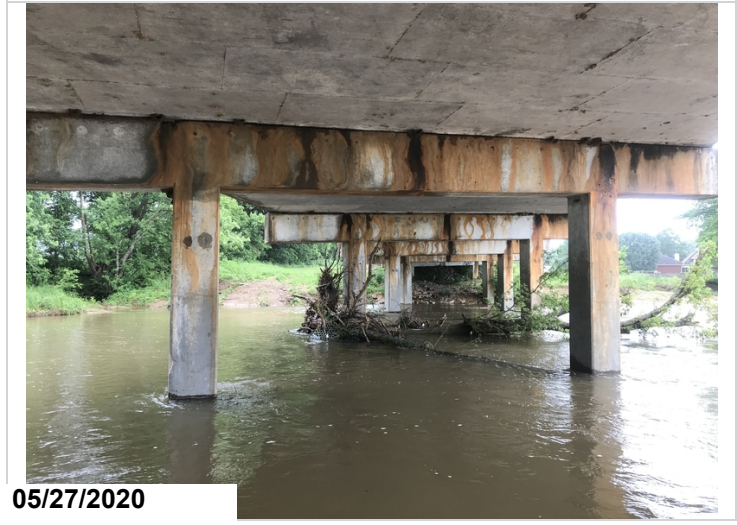
05/27/2020

View of bents ahead side.

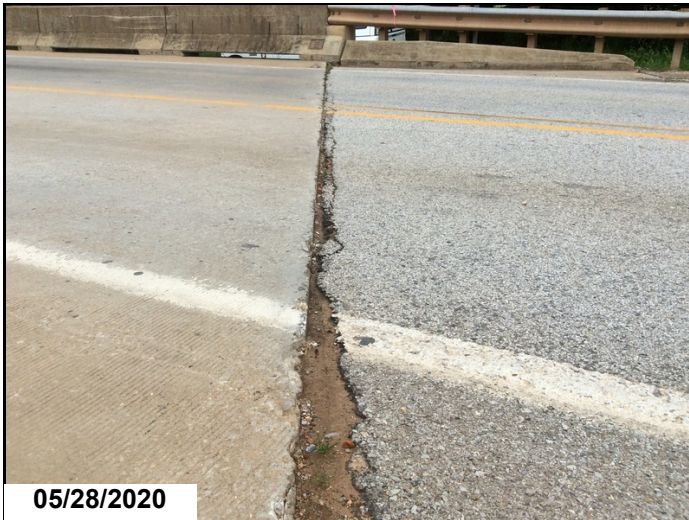
Abutment #1 general view of joint.

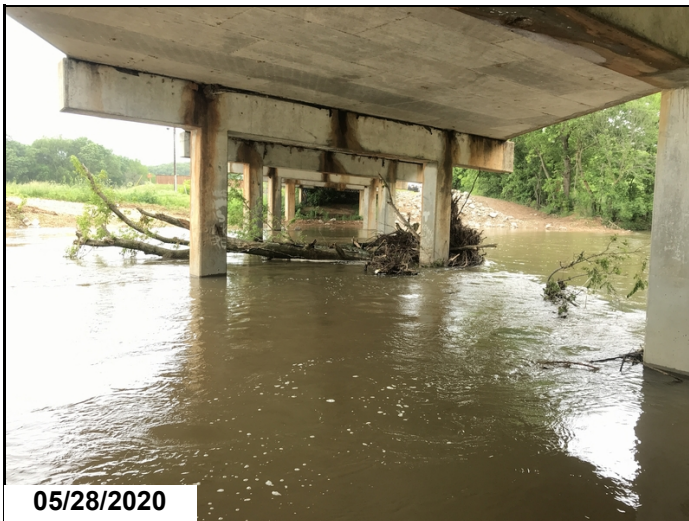
Span #5 channel has large trees causing localized scour.

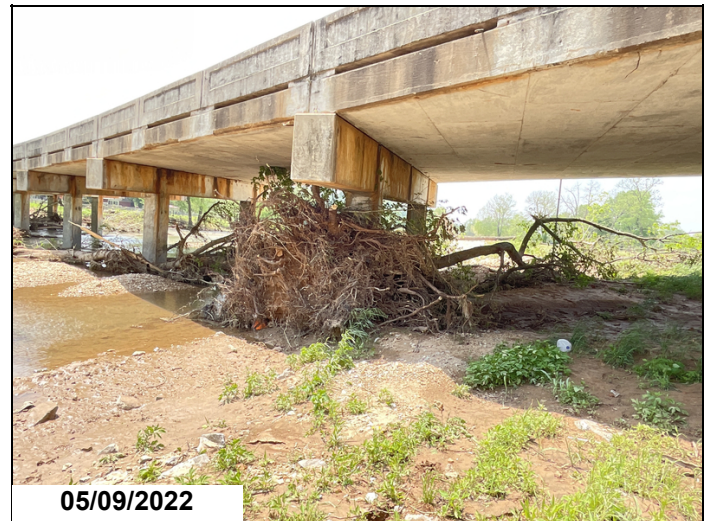
Large drift has wedge against substructure causing localized scour.

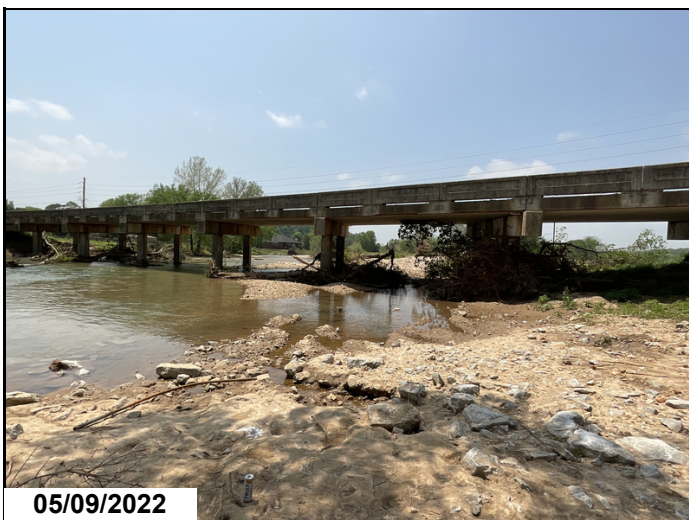
Large drift has wedge against substructure causing localized scour.
