Asset #04244(Routine, Underwater type 2)

CR 40-Benton Co. over LITTLE SUGAR CREEK

Location: .5 M E HWY 71

Team Lead: Anthony Wood Inspection Date: 01/13/2025

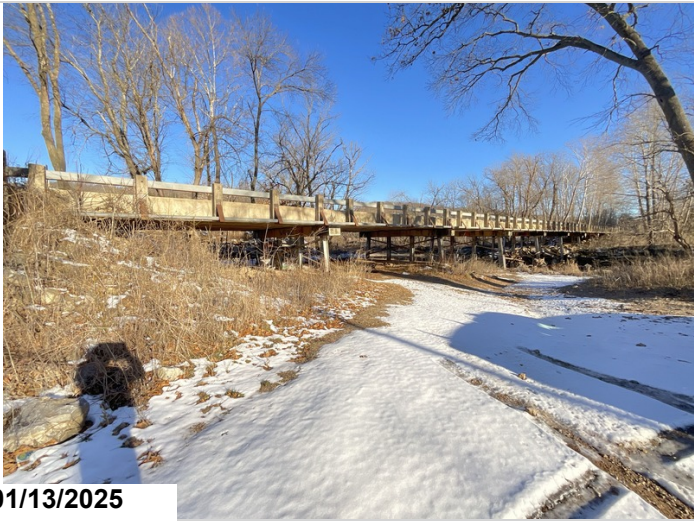
Elevation.

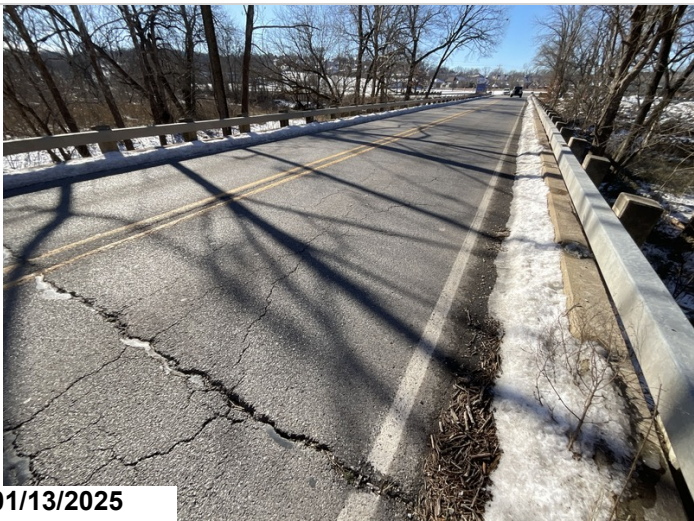
Overall, the deck is in satisfactory condition with moderate cracking in the wearing surface.

Spans 1 - 8, Wearing Surface: Moderate cracking.

Typical deck.

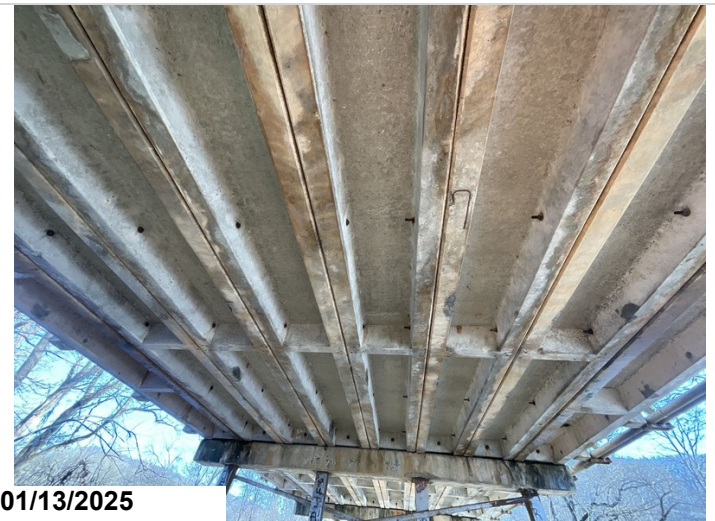
Overall, the superstructure is in satisfactory condition with cracking, cracking with efflorescence, delams, spalling, and spalling with exposed reinforcing steel.

Typical undersurface.

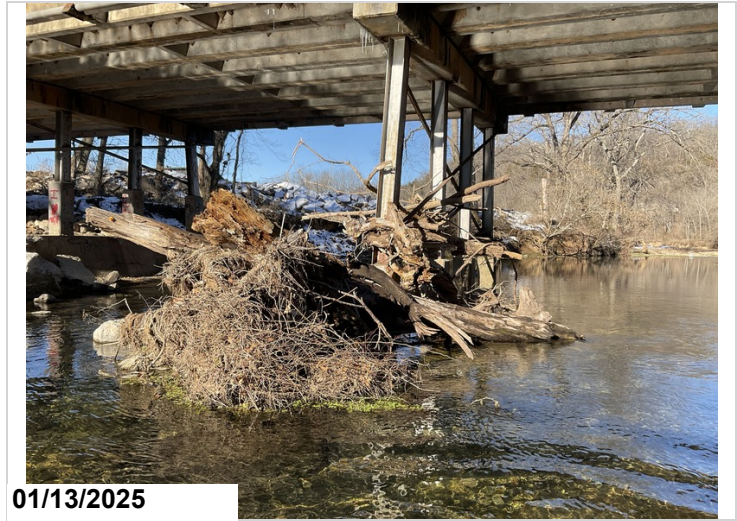
Bent 4, Right: Large brush.

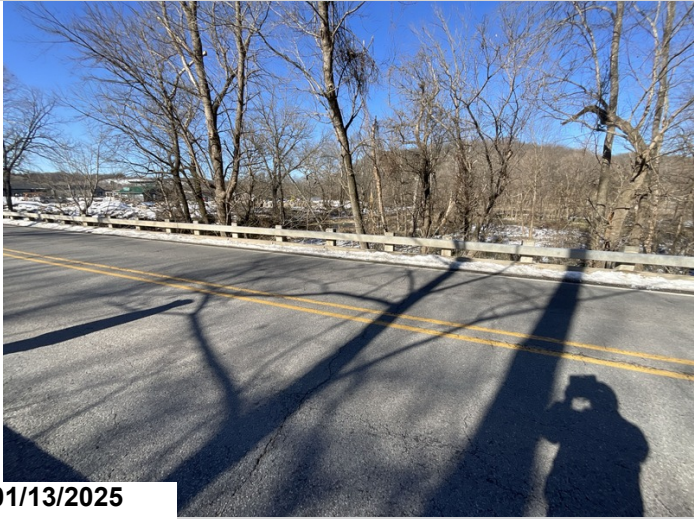
Typical bridge rail.

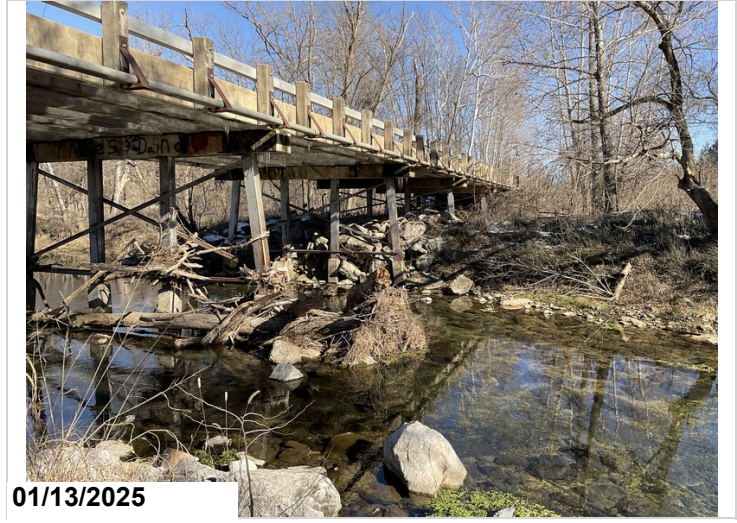
Large boulders added to channel.
